# EAST PARK ENERGY

## Outline Construction Traffic Management Plan

**Document Reference: EN010141/DR/7.4**

**September 2026**

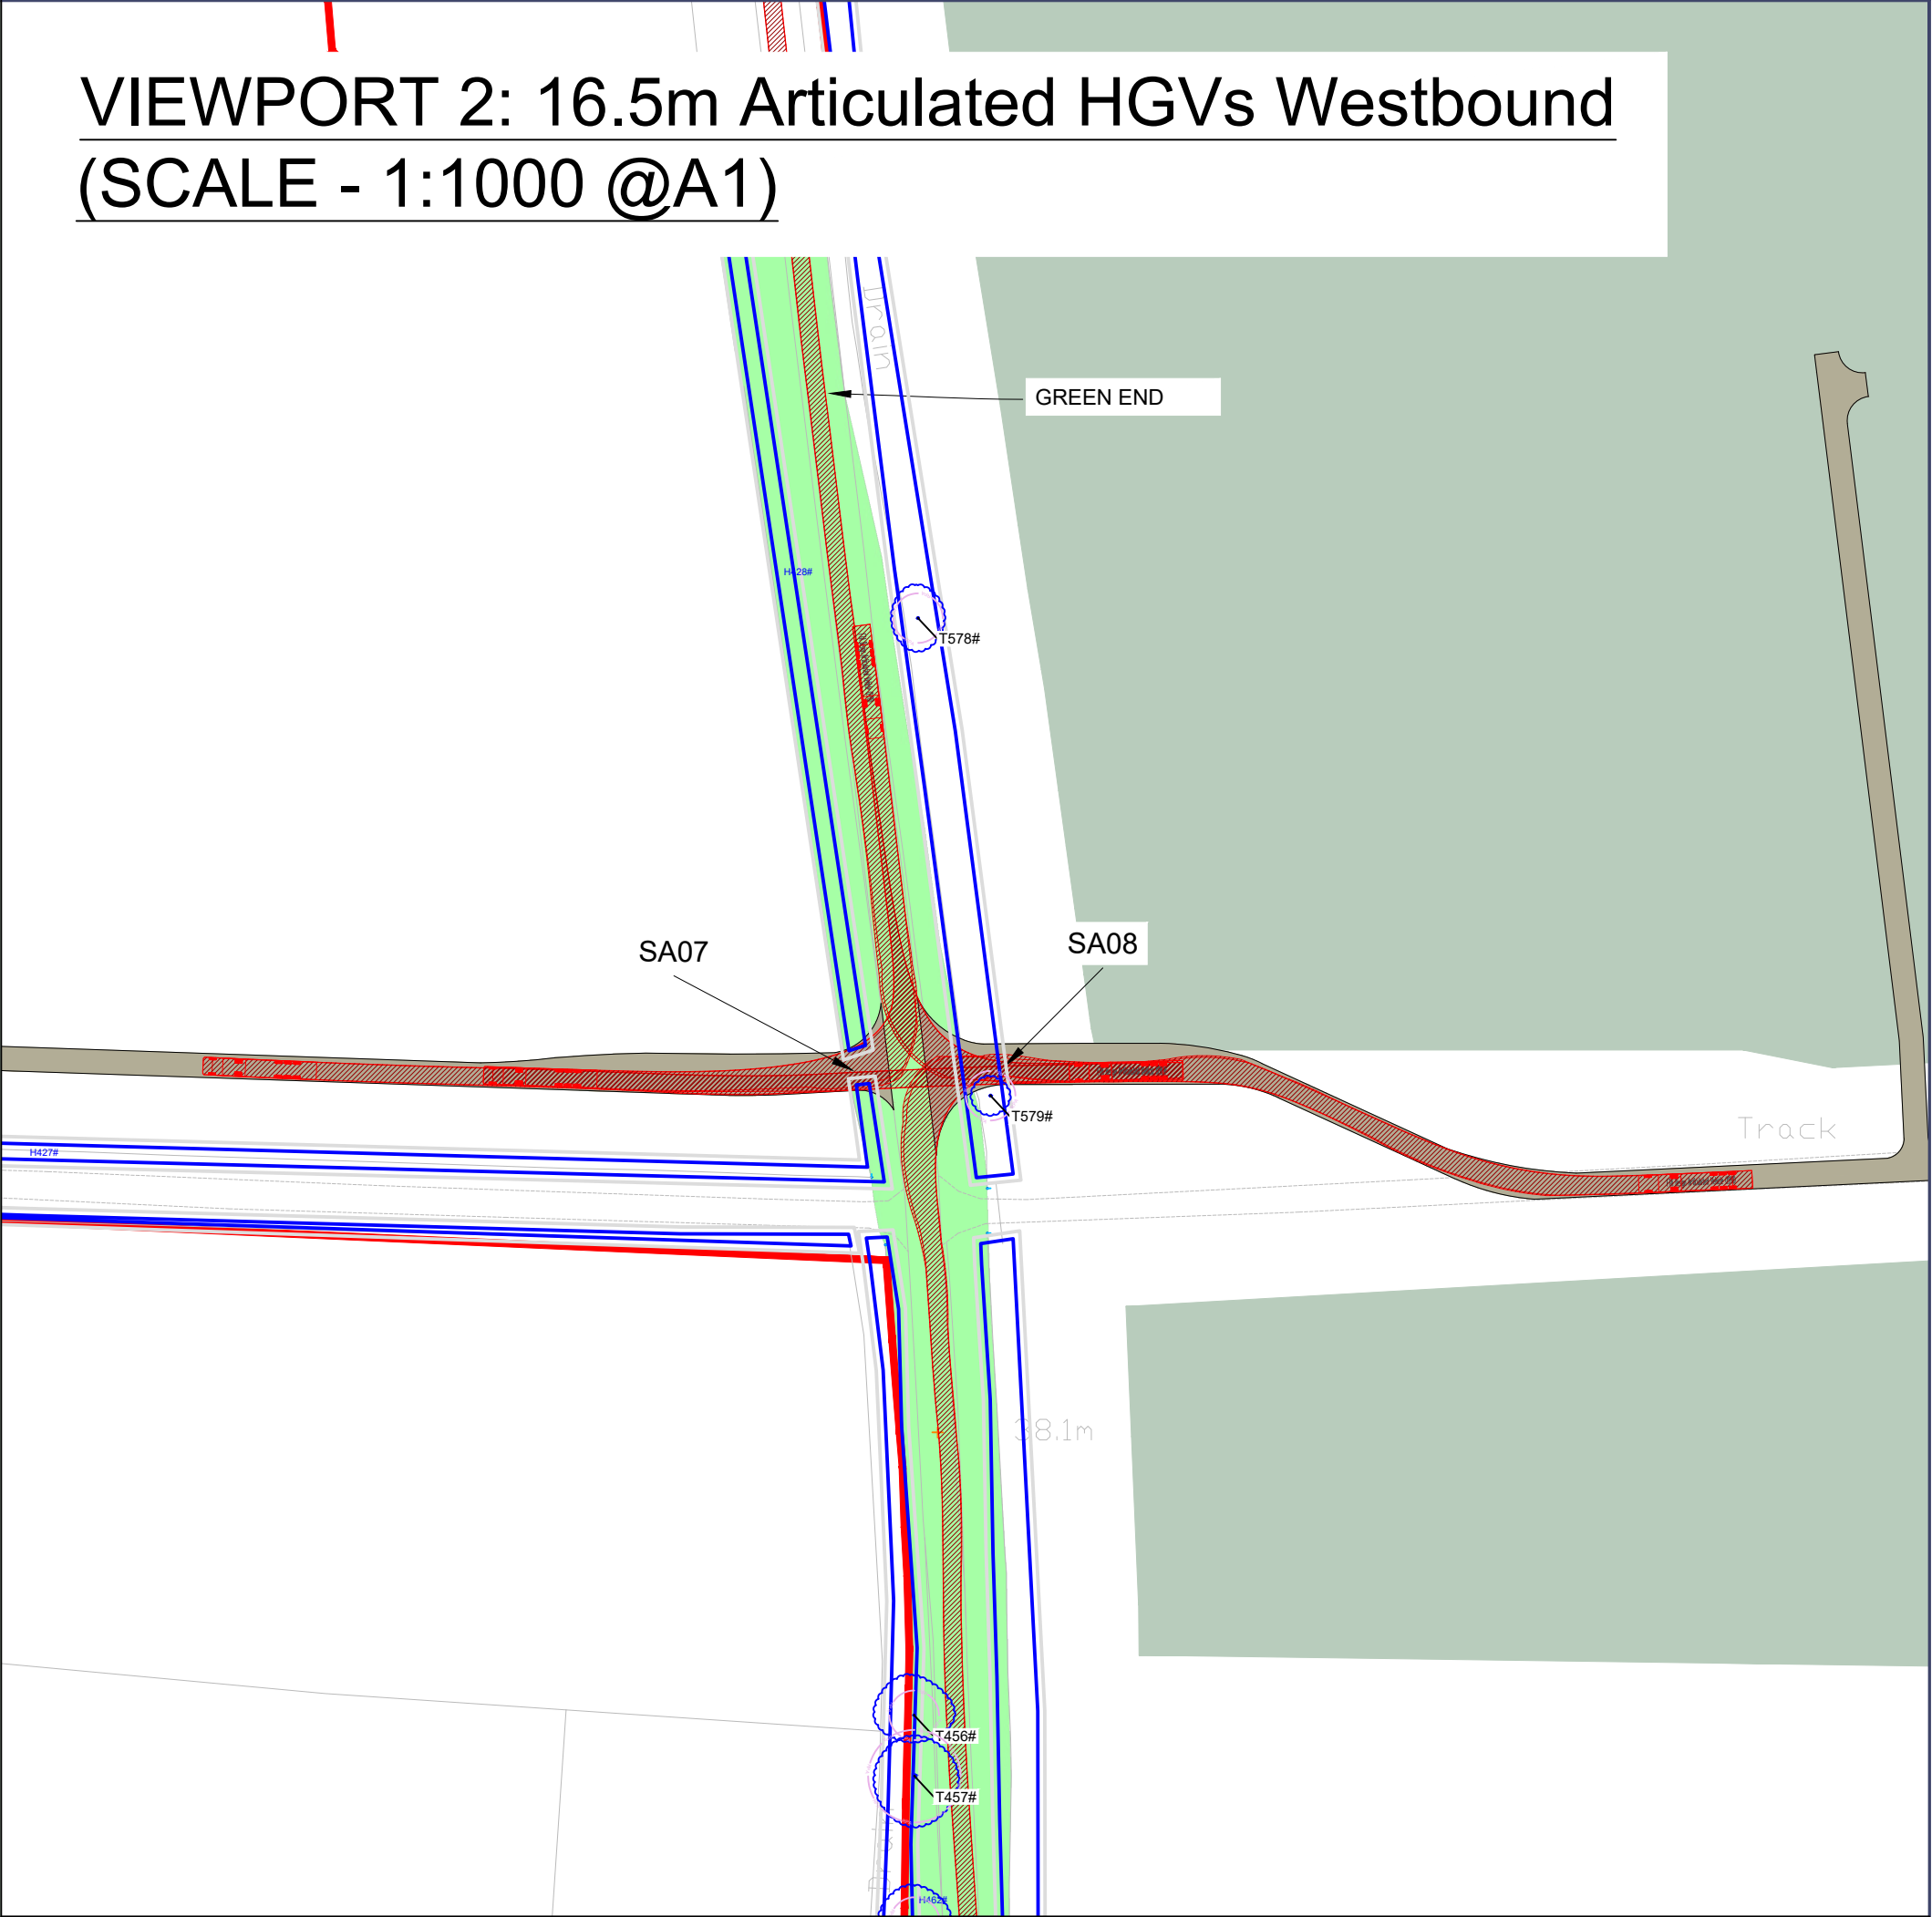
VIEWPORT 2: 16.5m Articulated HGVs Westbound  
(SCALE - 1:1000 @A1)

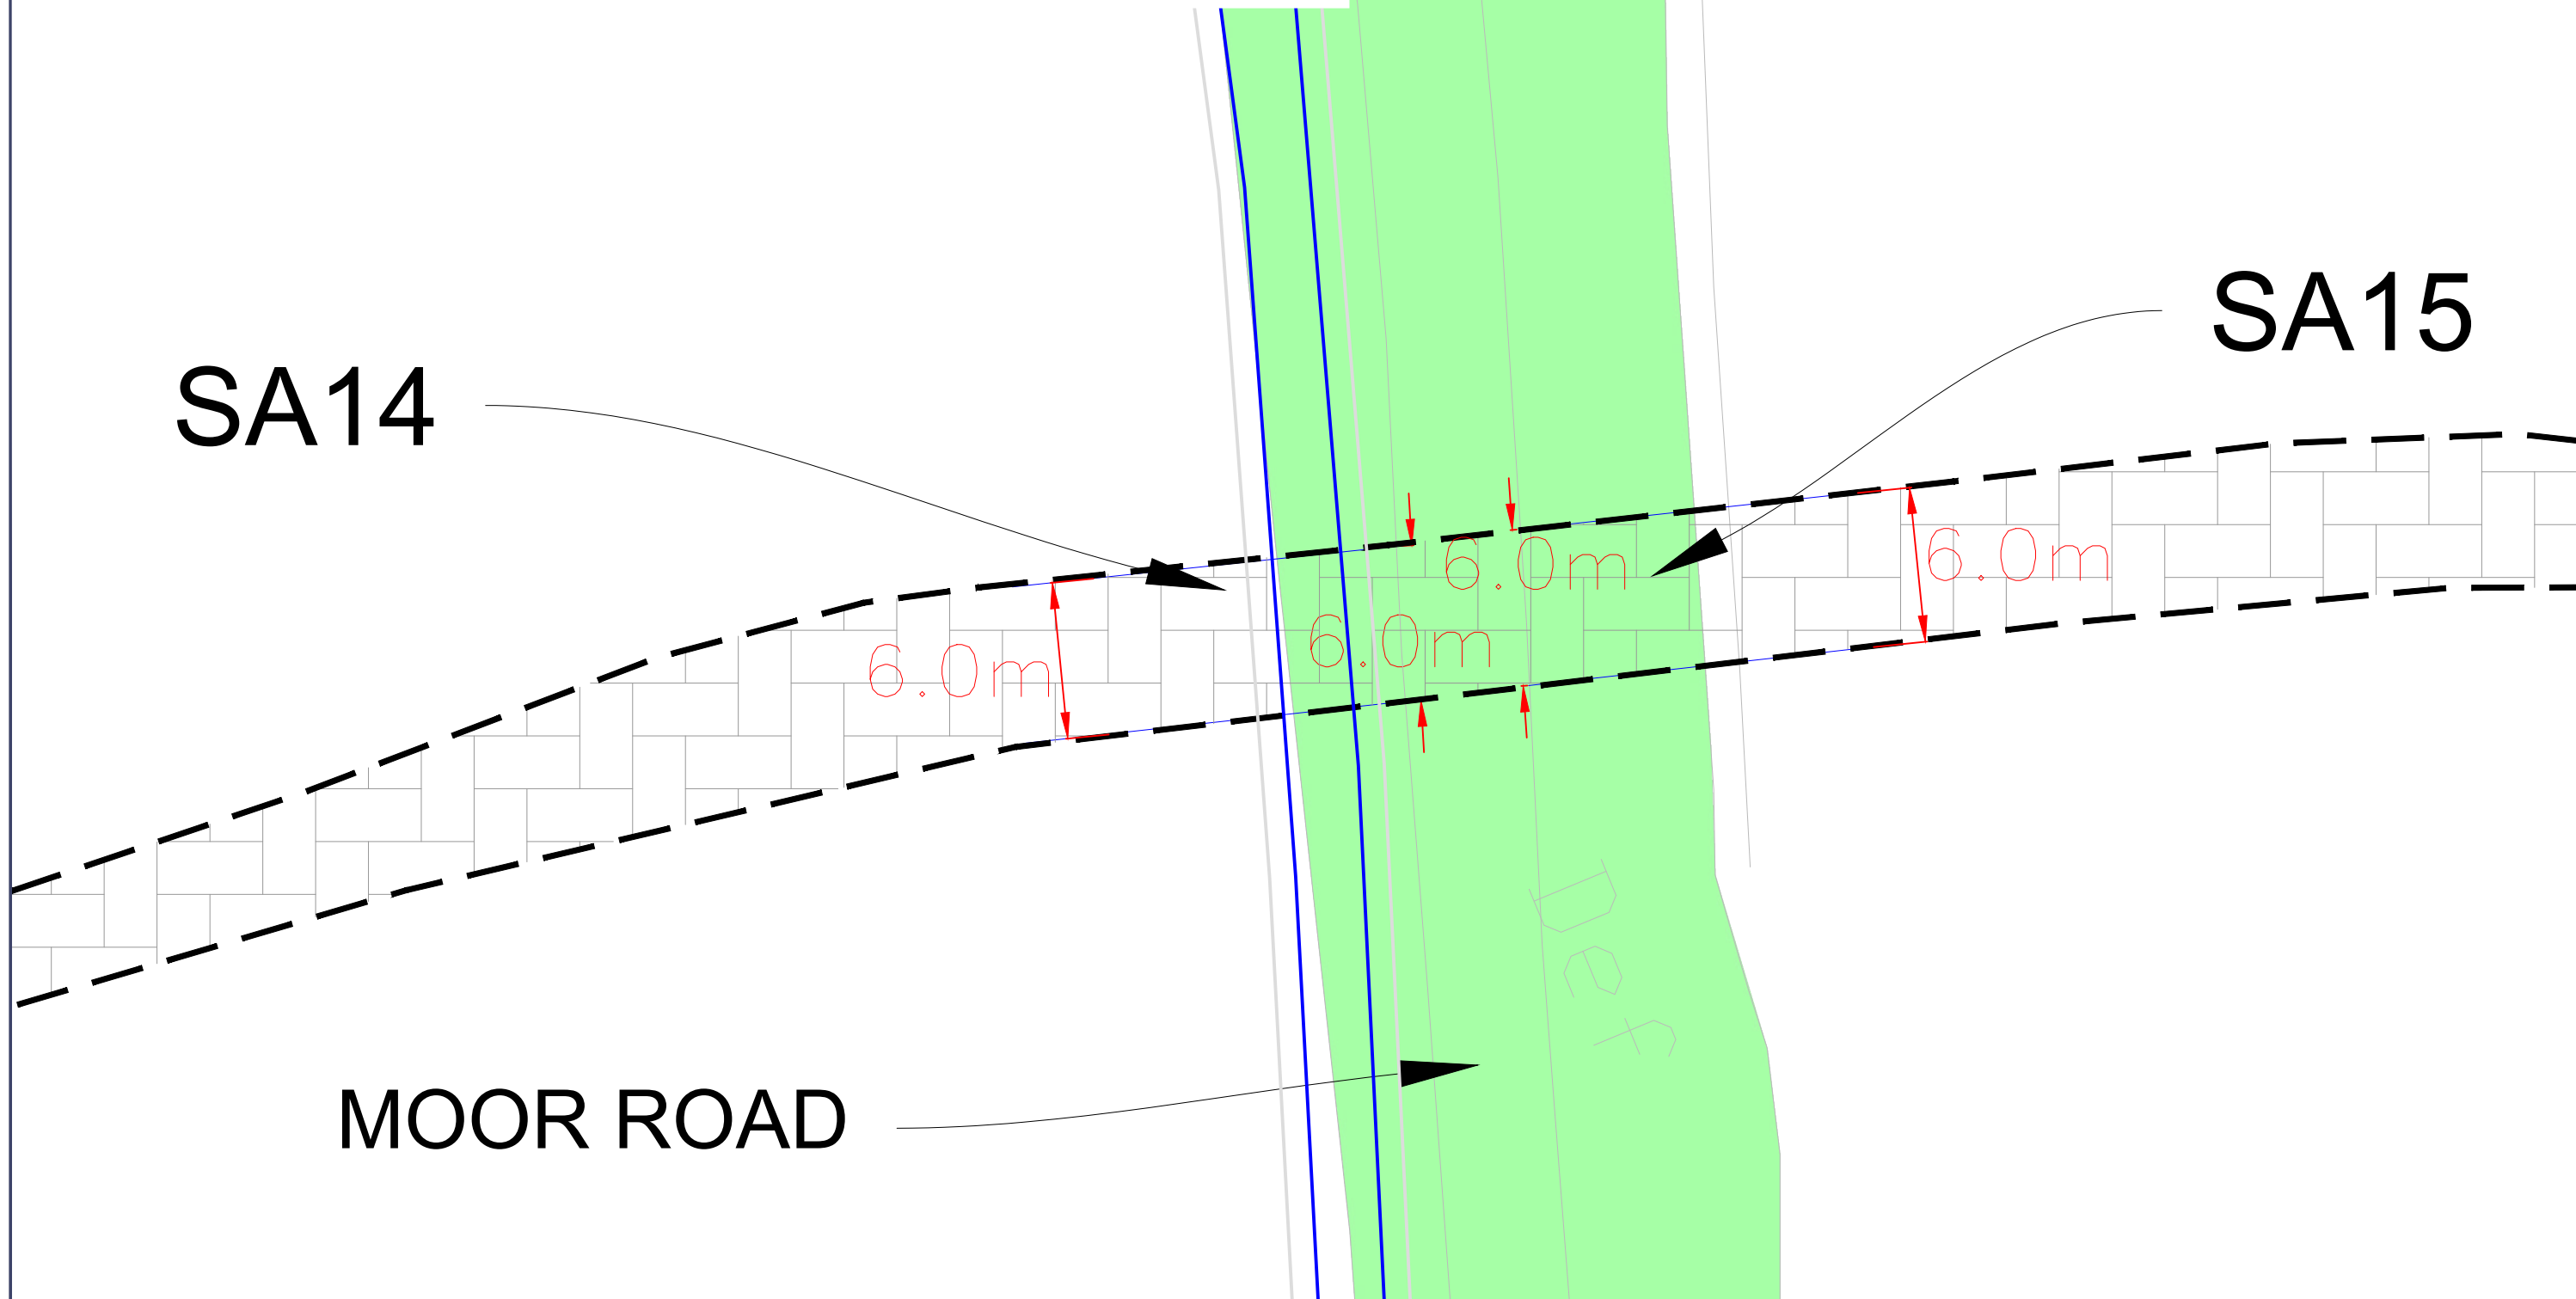
VIEWPORT 2: Site Access Arrangement  
(Accesses SA14 & SA15 - Dimensions)  
SCALE - 1:250 @A1

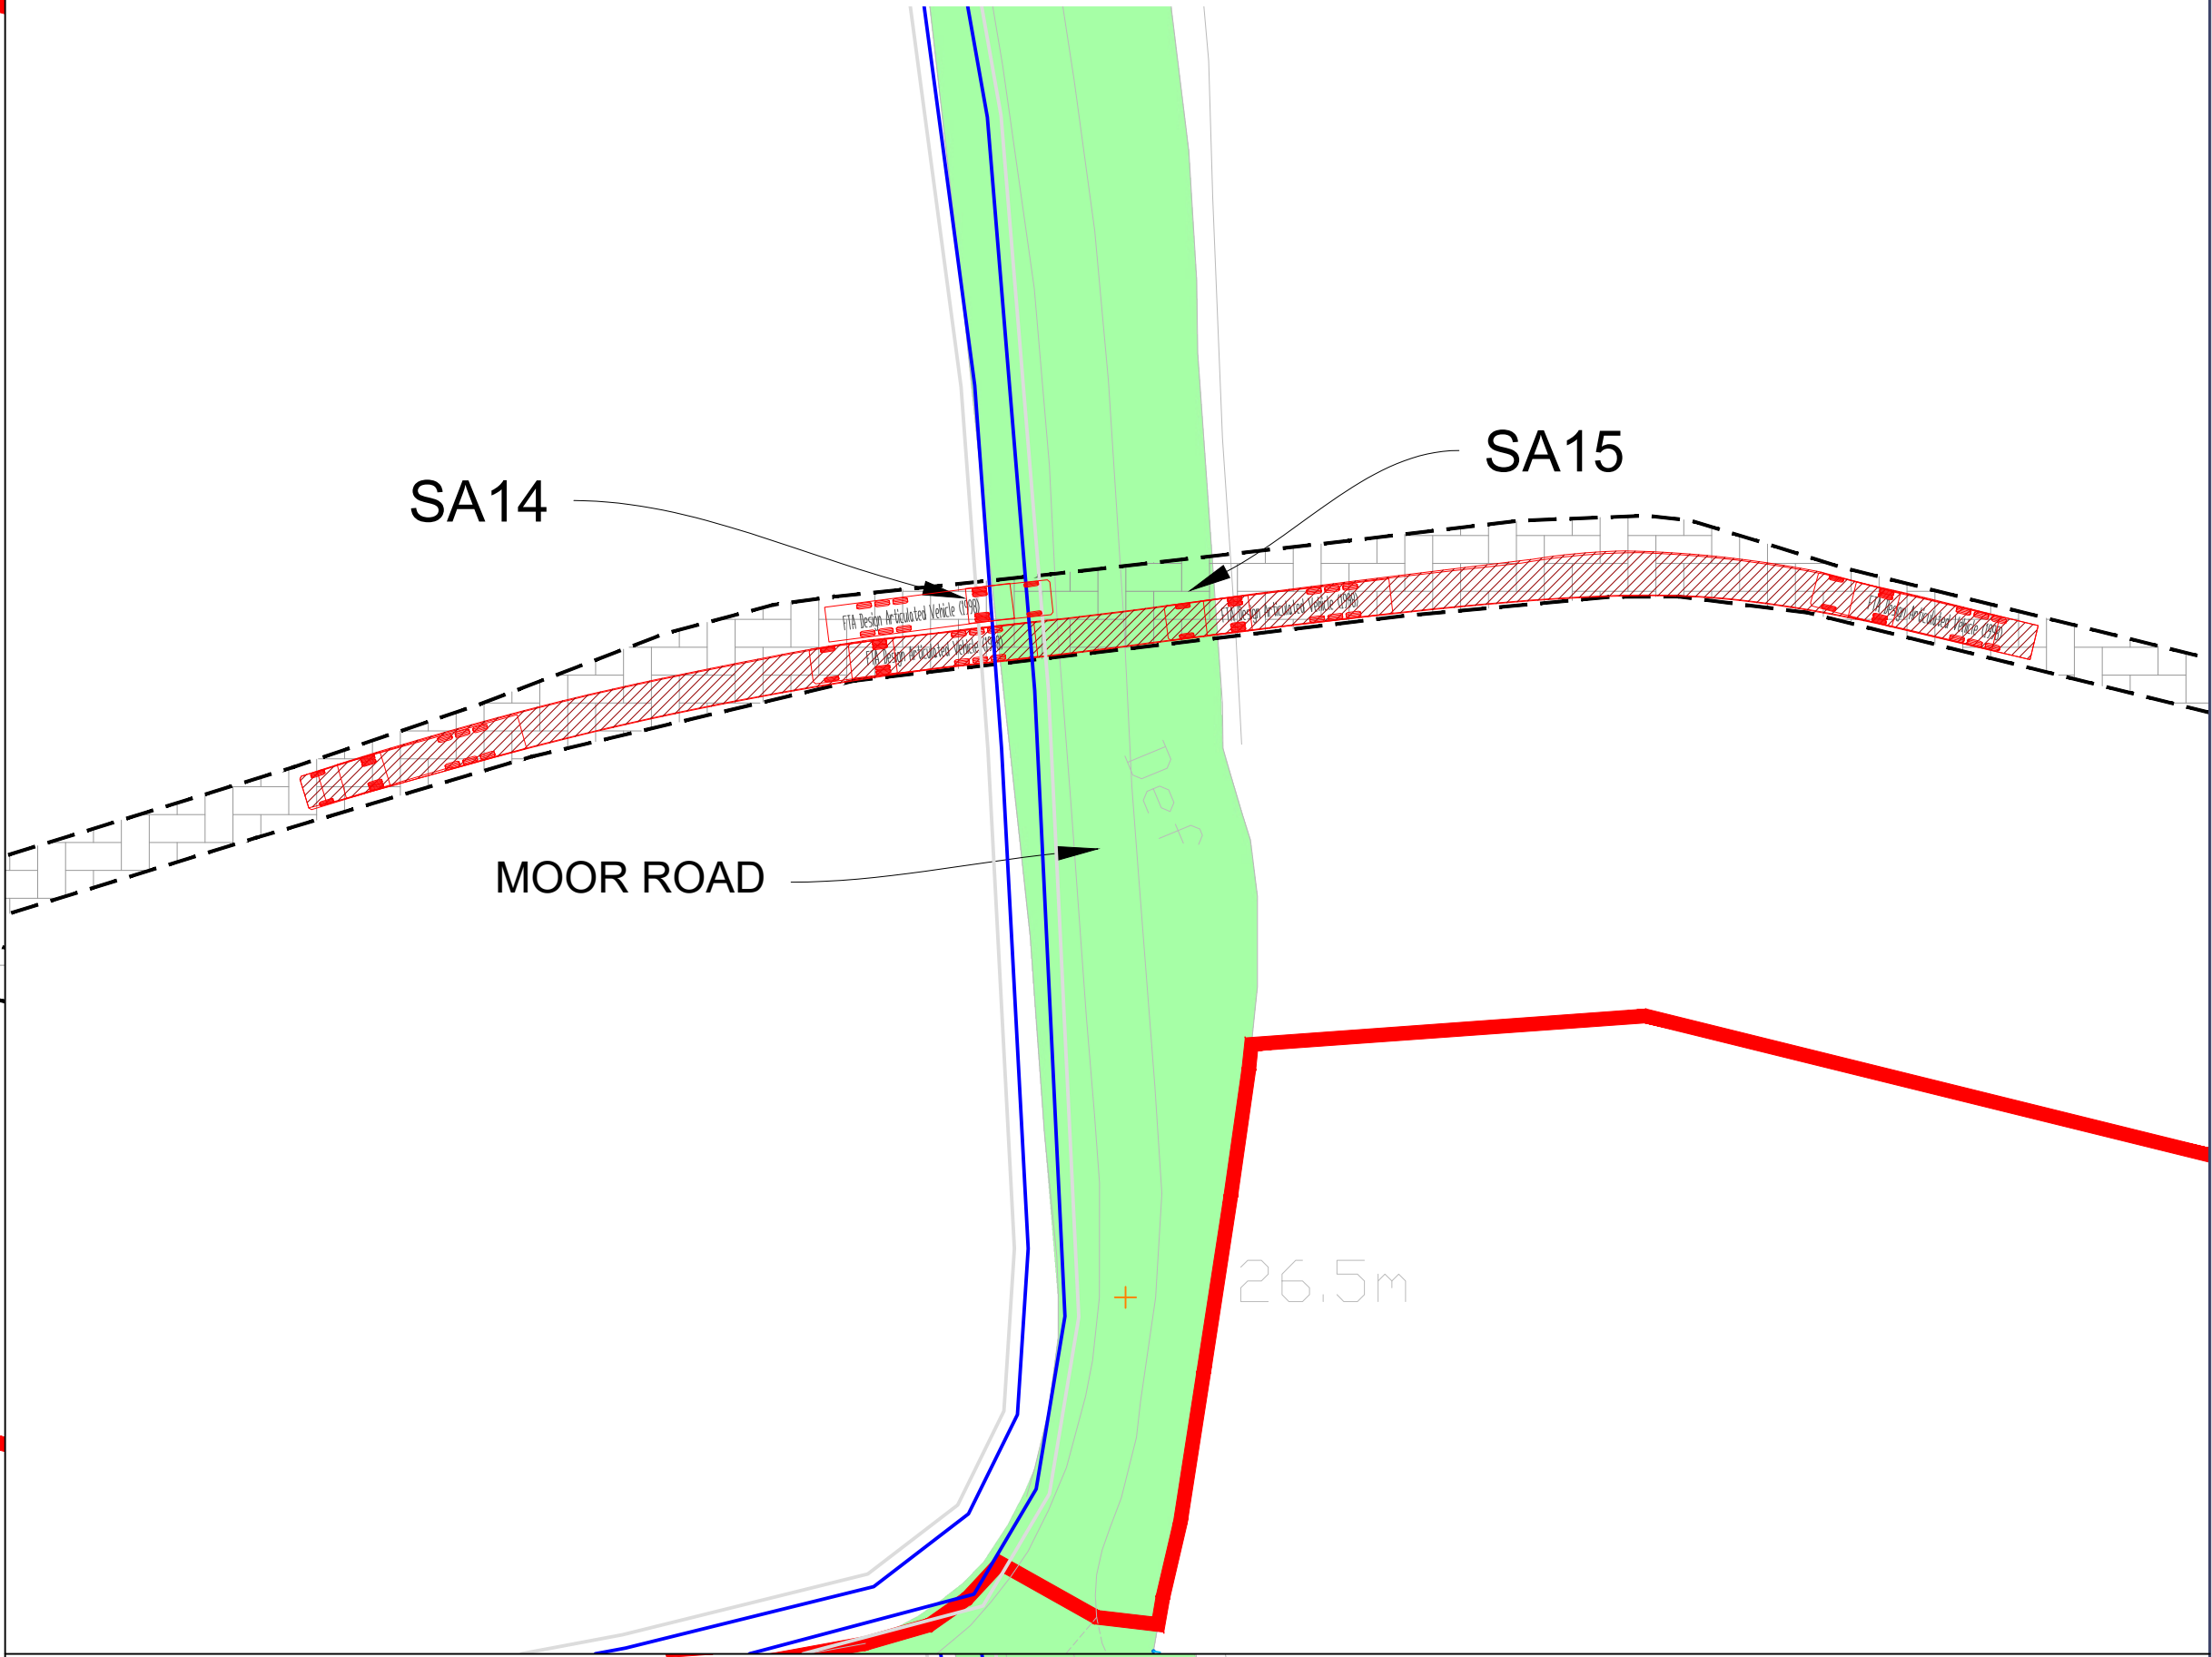
VIEWPORT 3: 16.5m Articulated HGVs Westbound

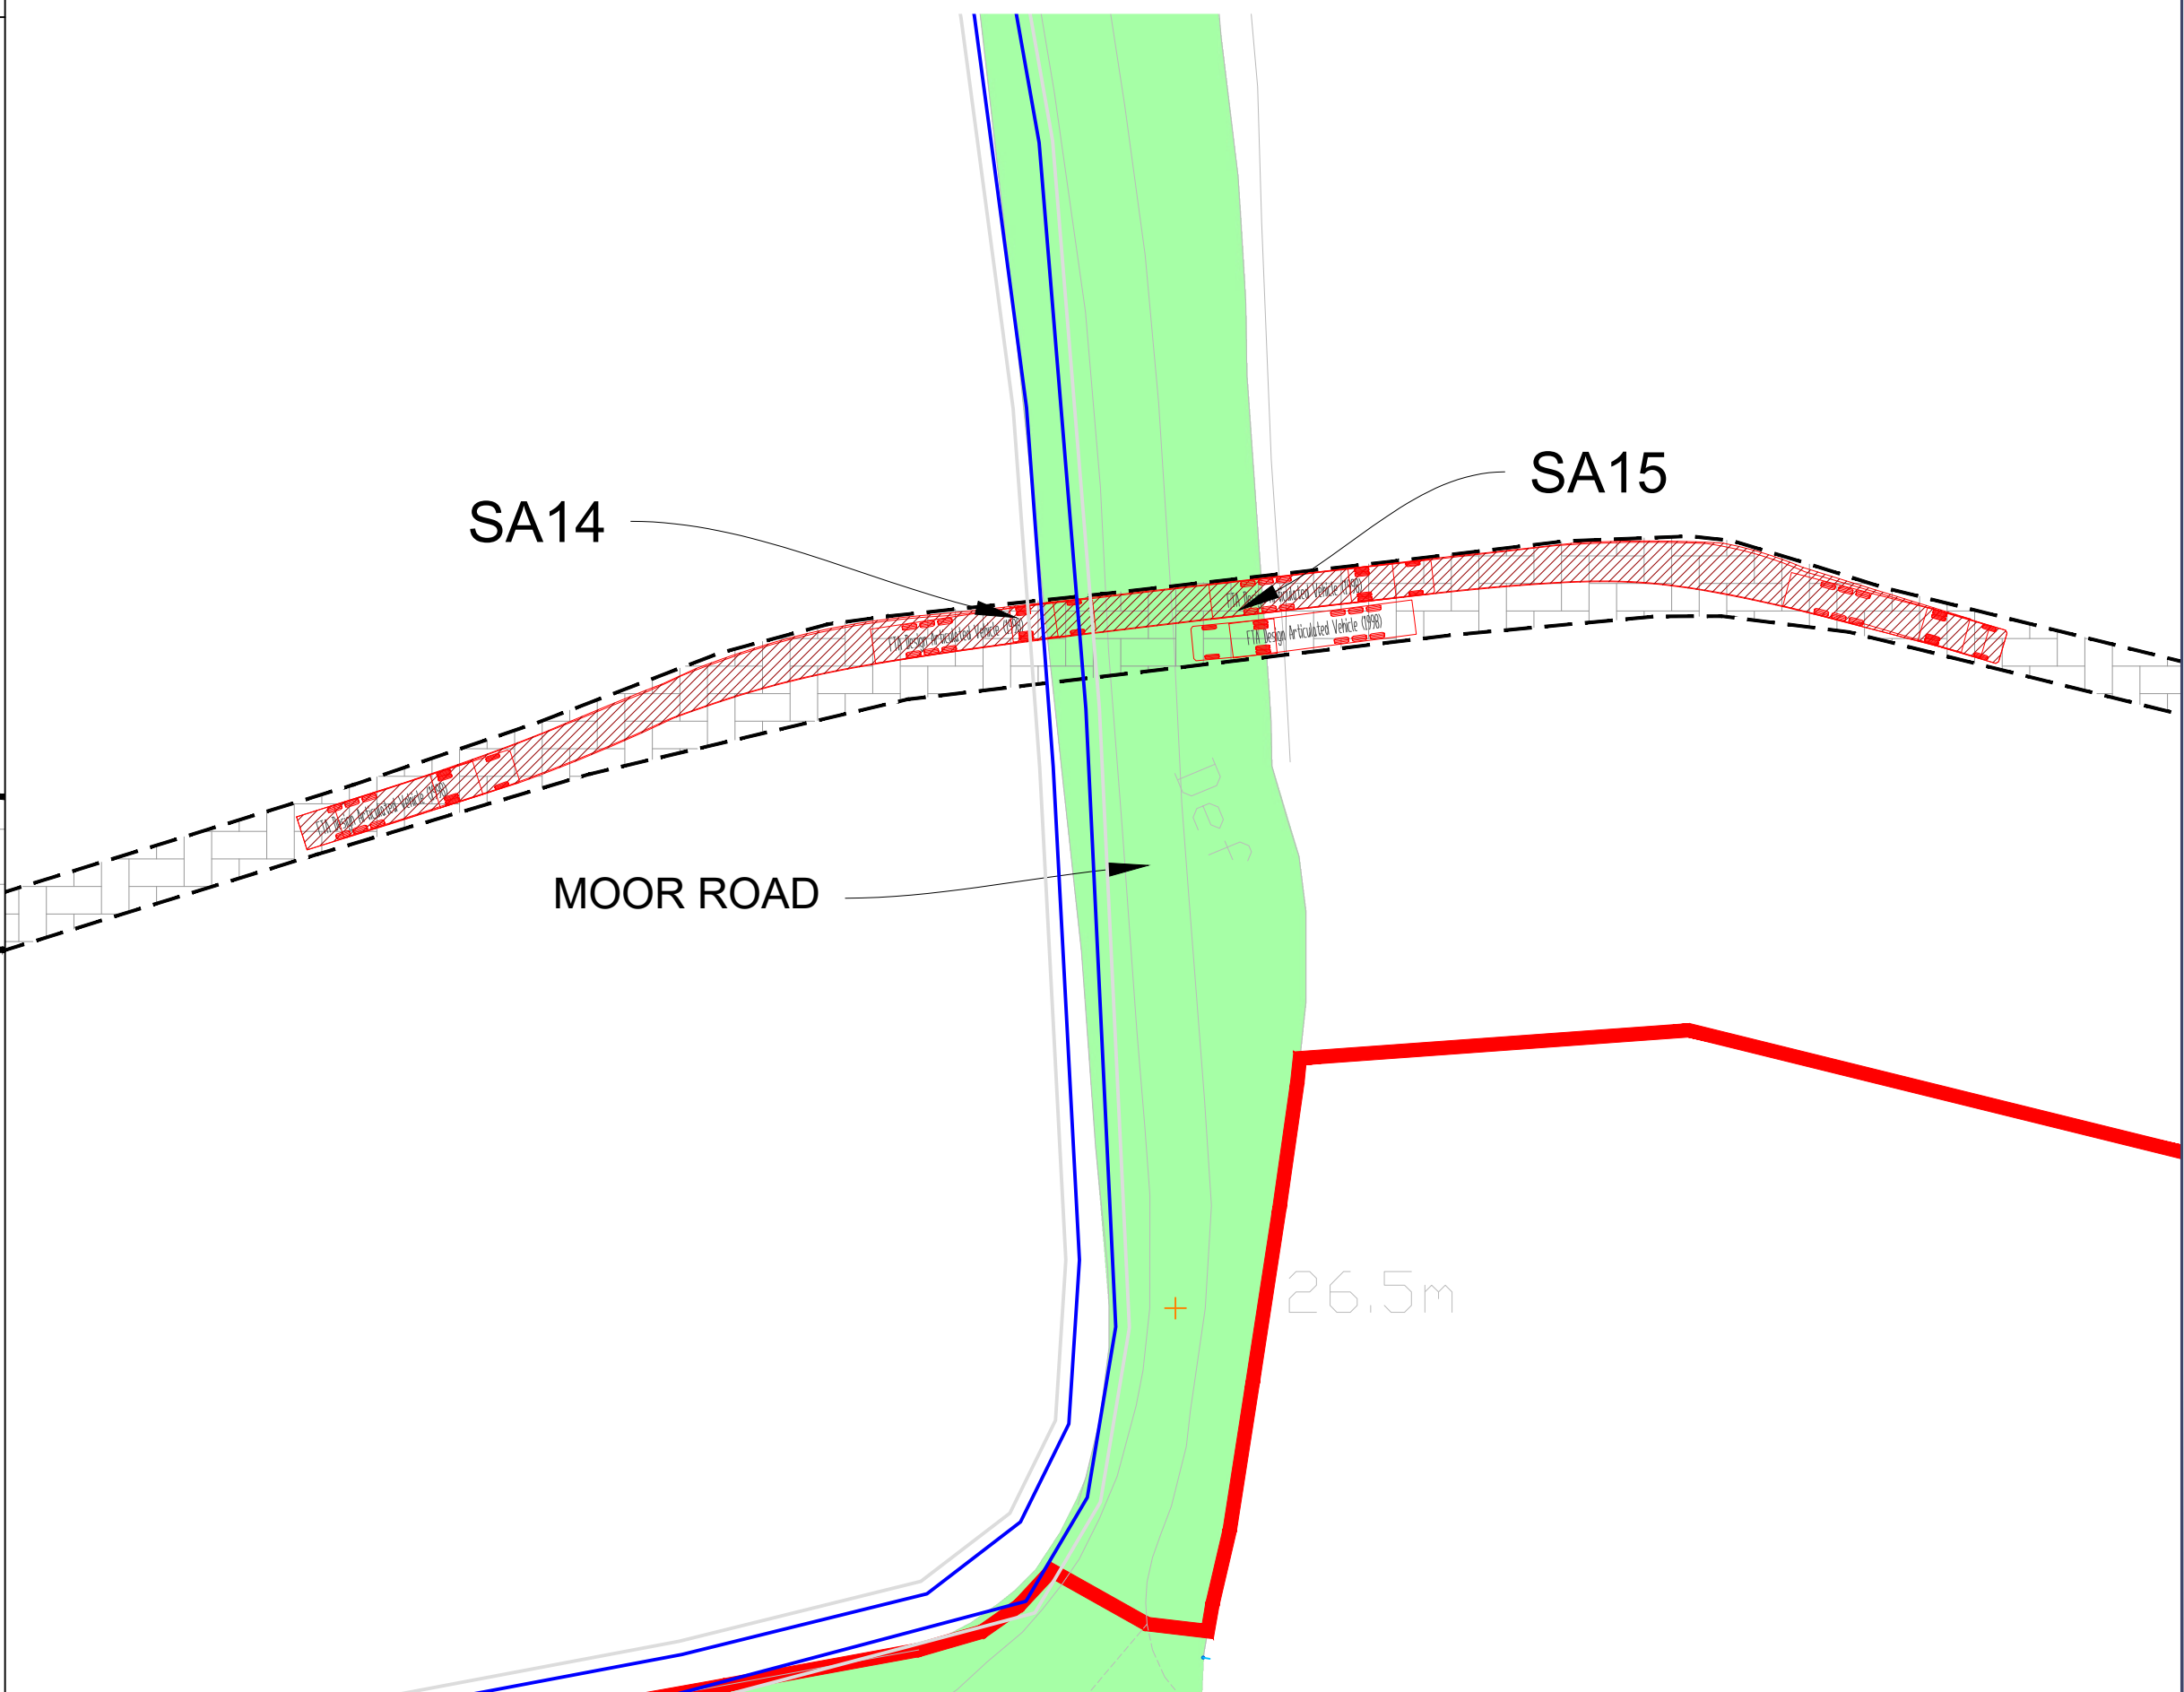
VIEWPORT 4: 16.5m Articulated HGVs Eastbound

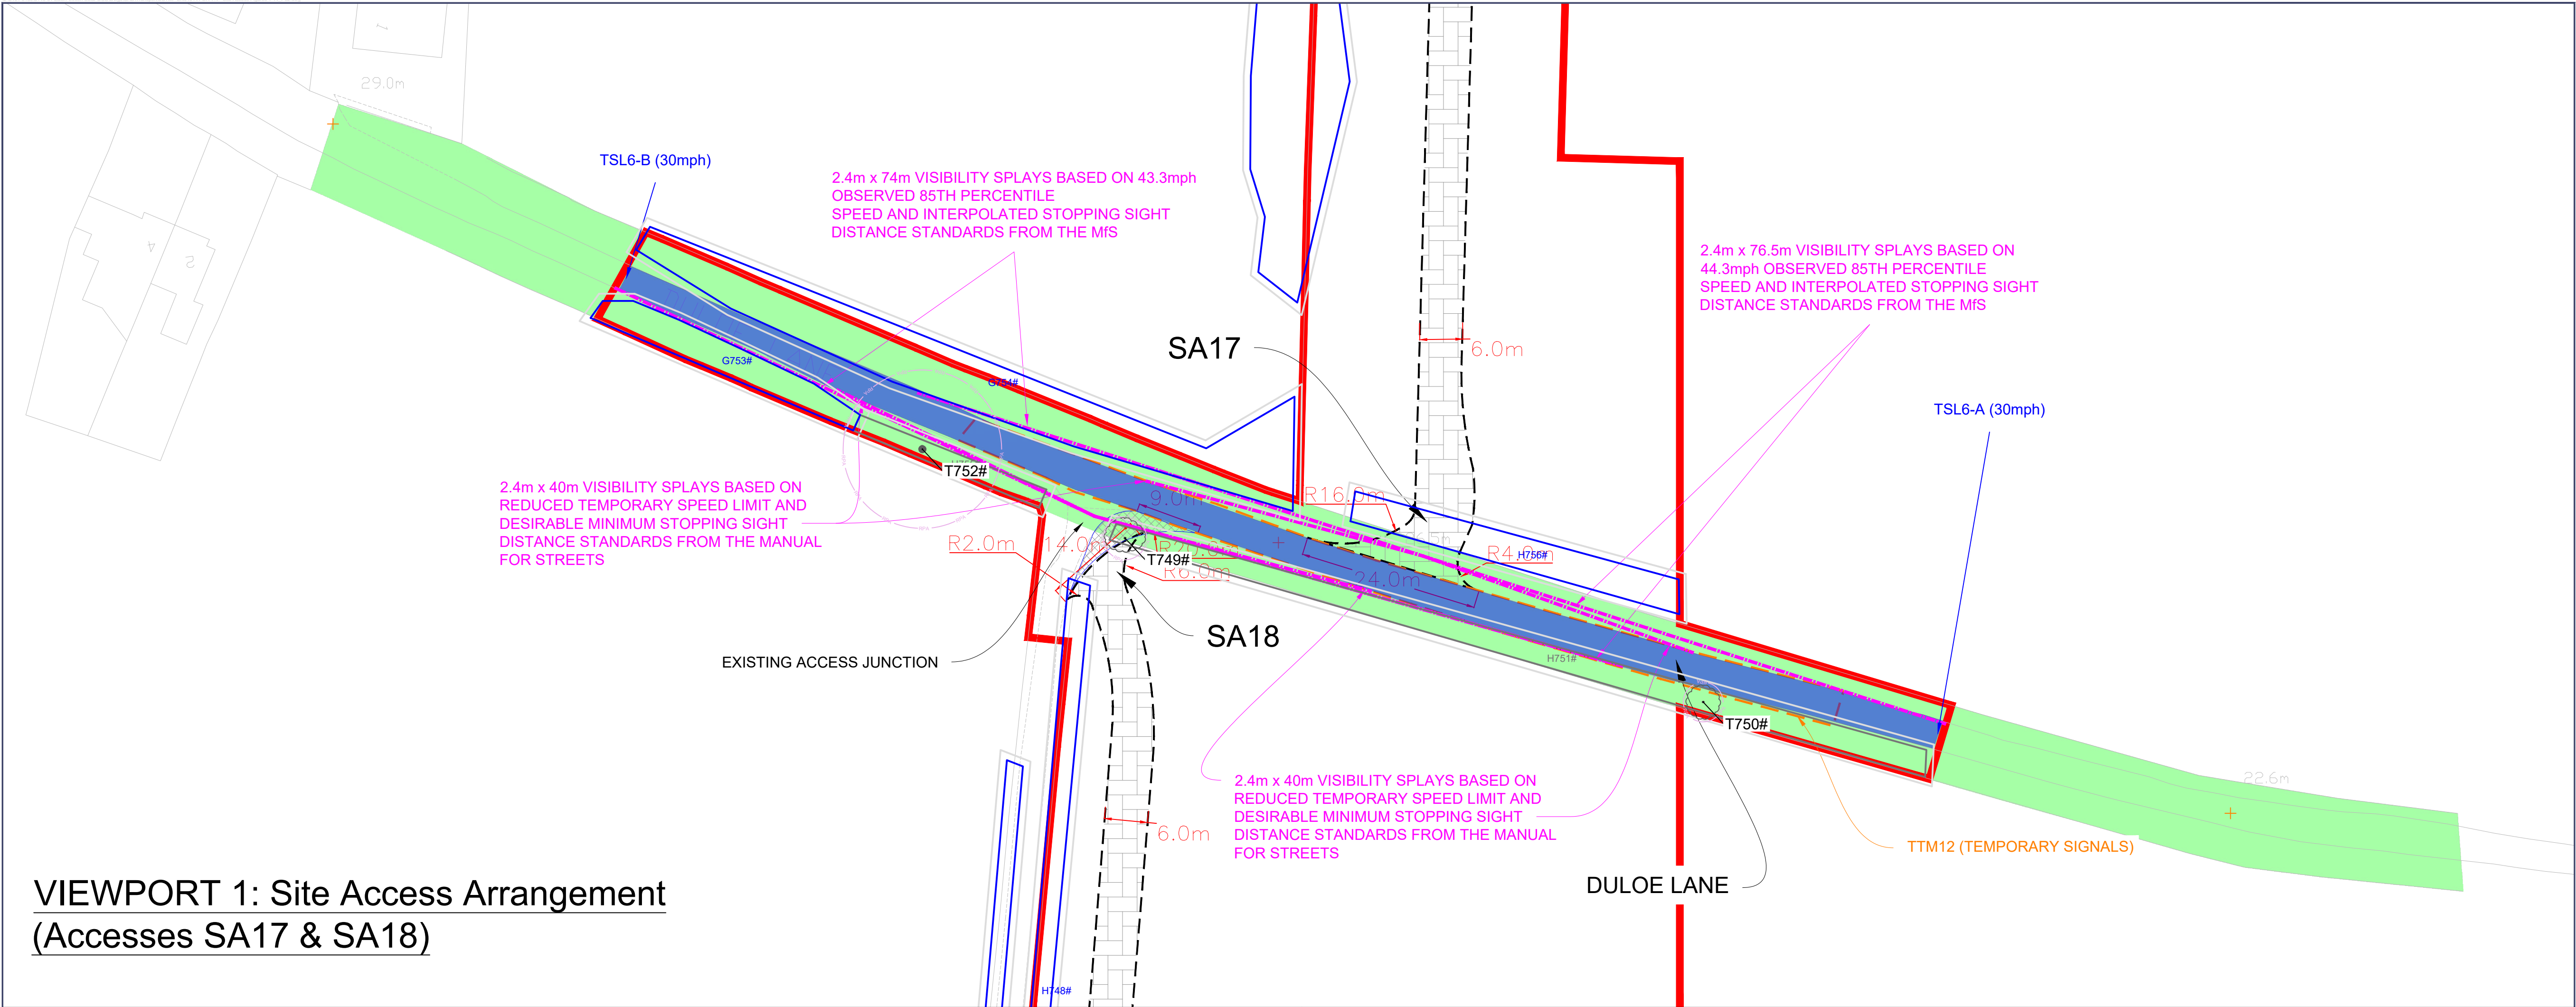
VIEWPORT 1: Site Access Arrangement  
(Accesses SA17 & SA18)

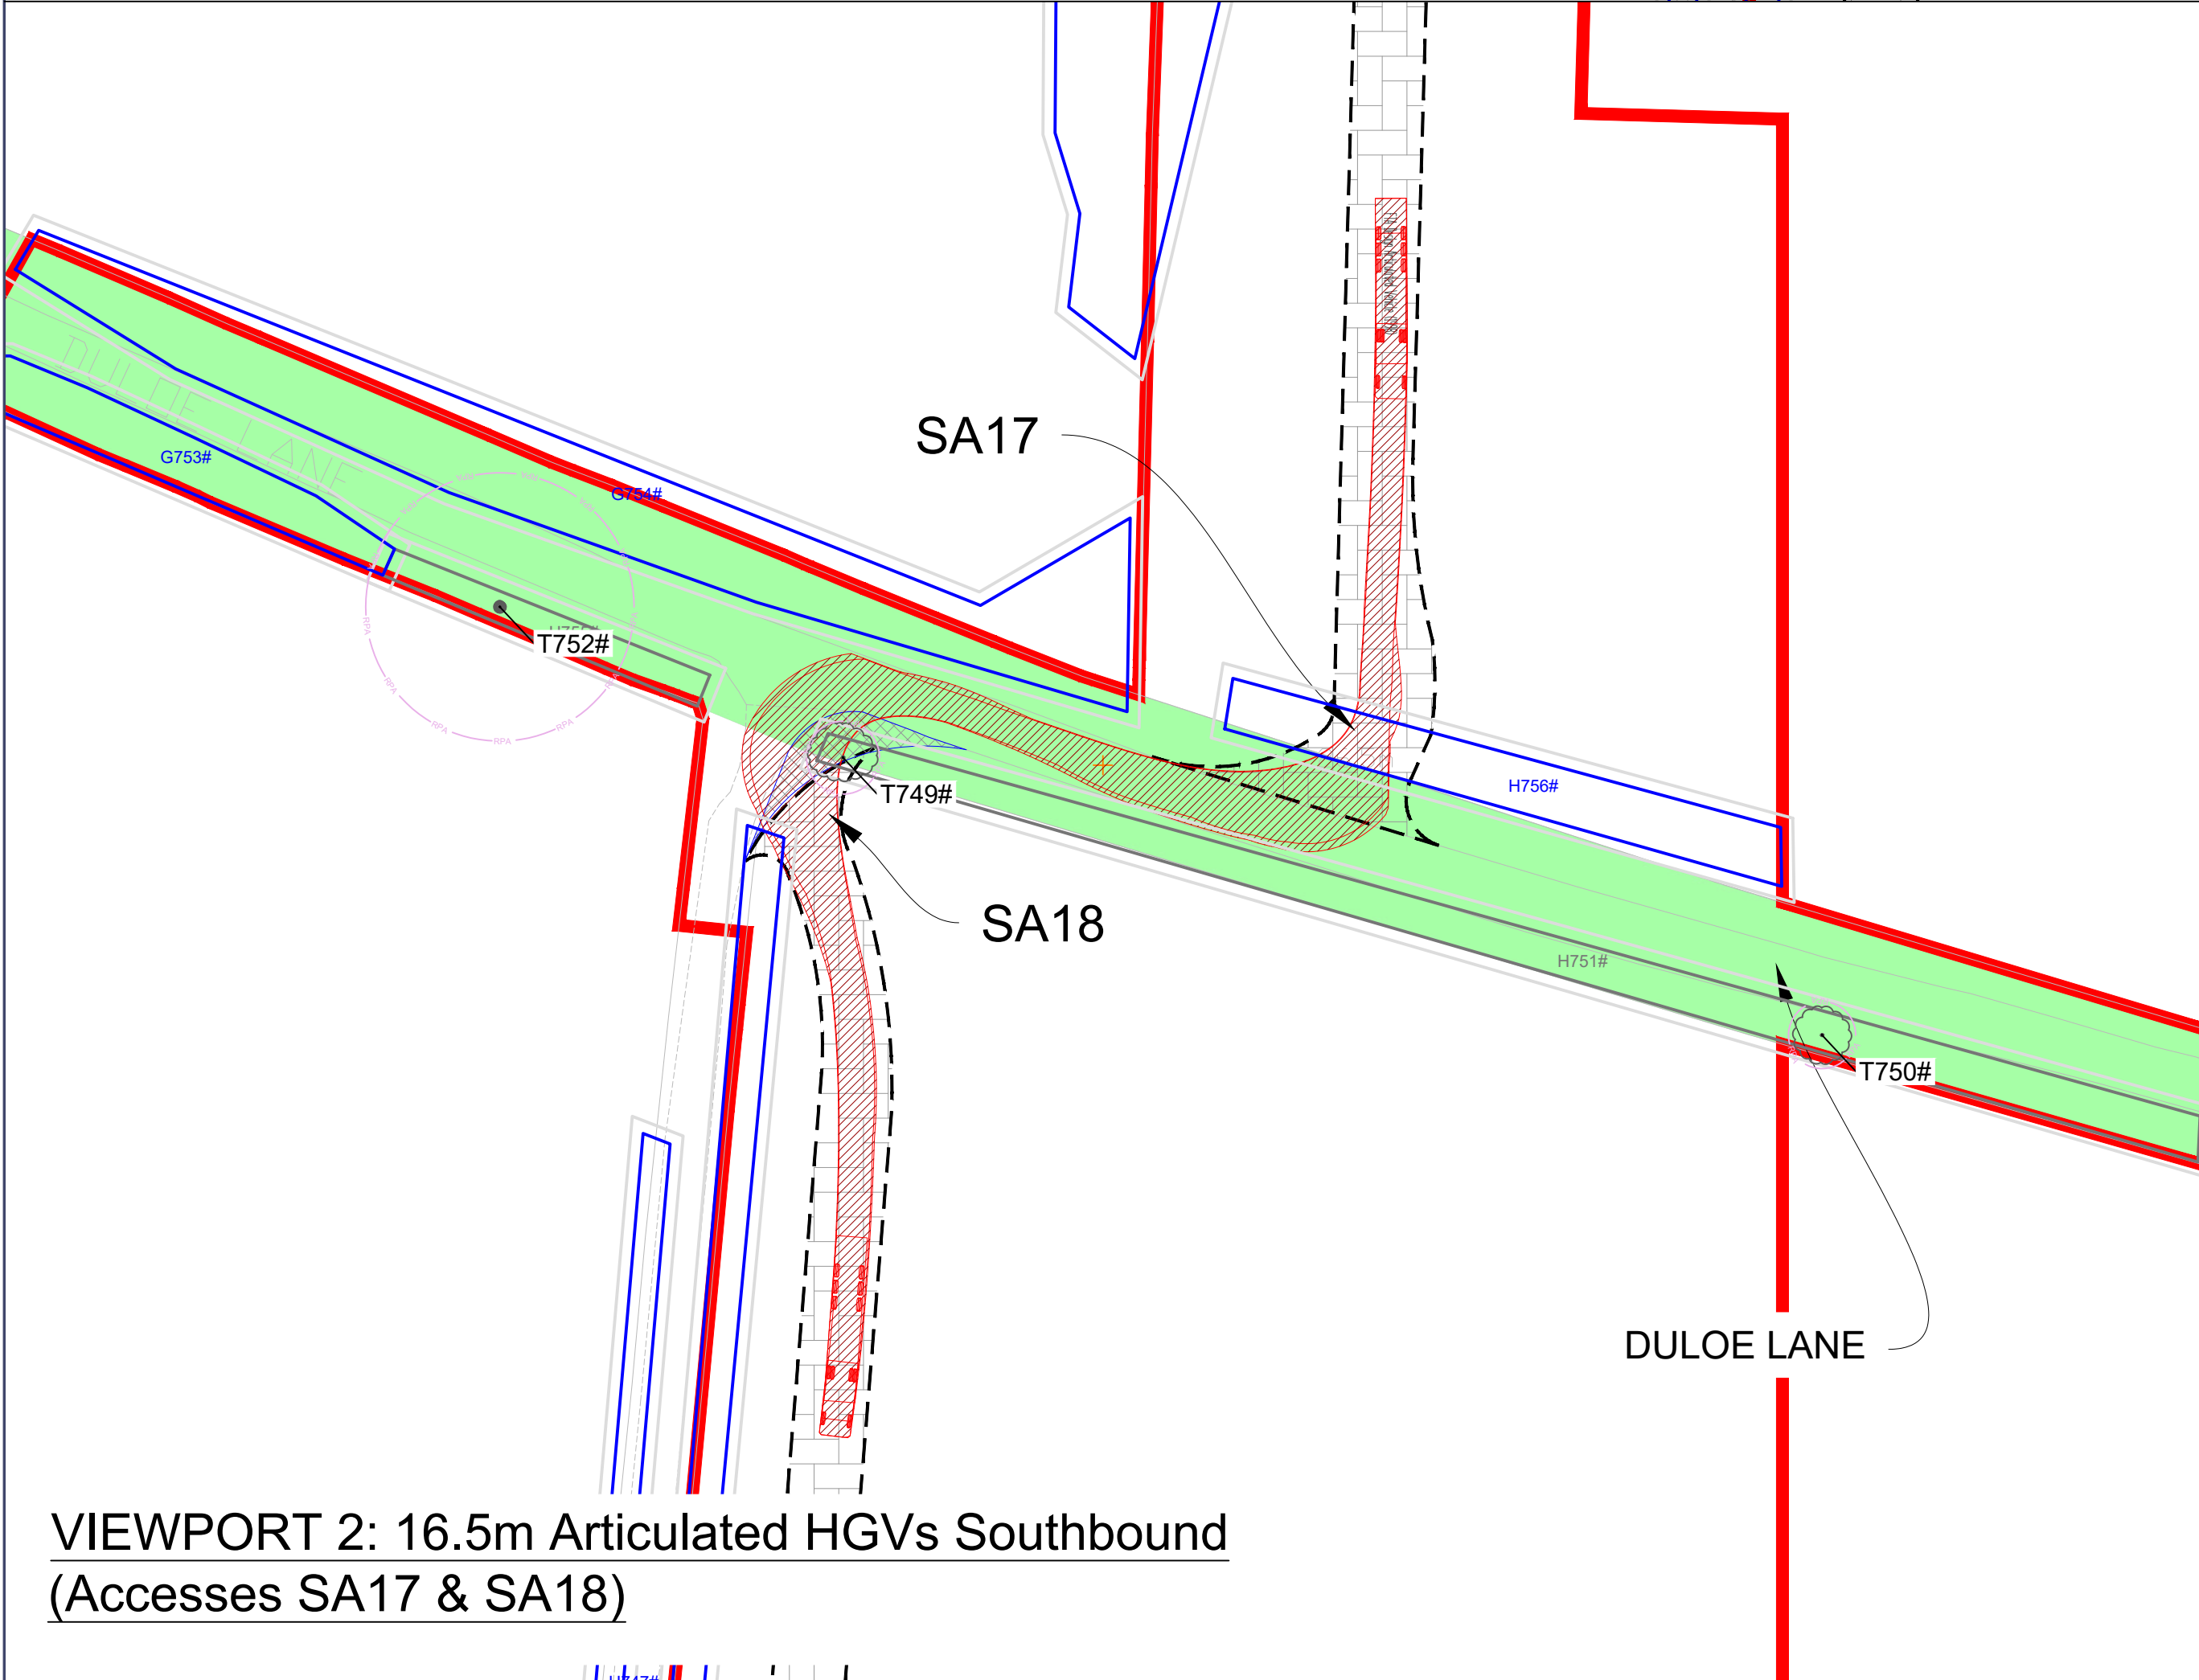
VIEWPORT 2: 16.5m Articulated HGVs Southbound  
(Accesses SA17 & SA18)
