# EAST PARK ENERGY

## Outline Construction Traffic Management Plan

**Document Reference: EN010141/DR/7.4**

**September 2026**

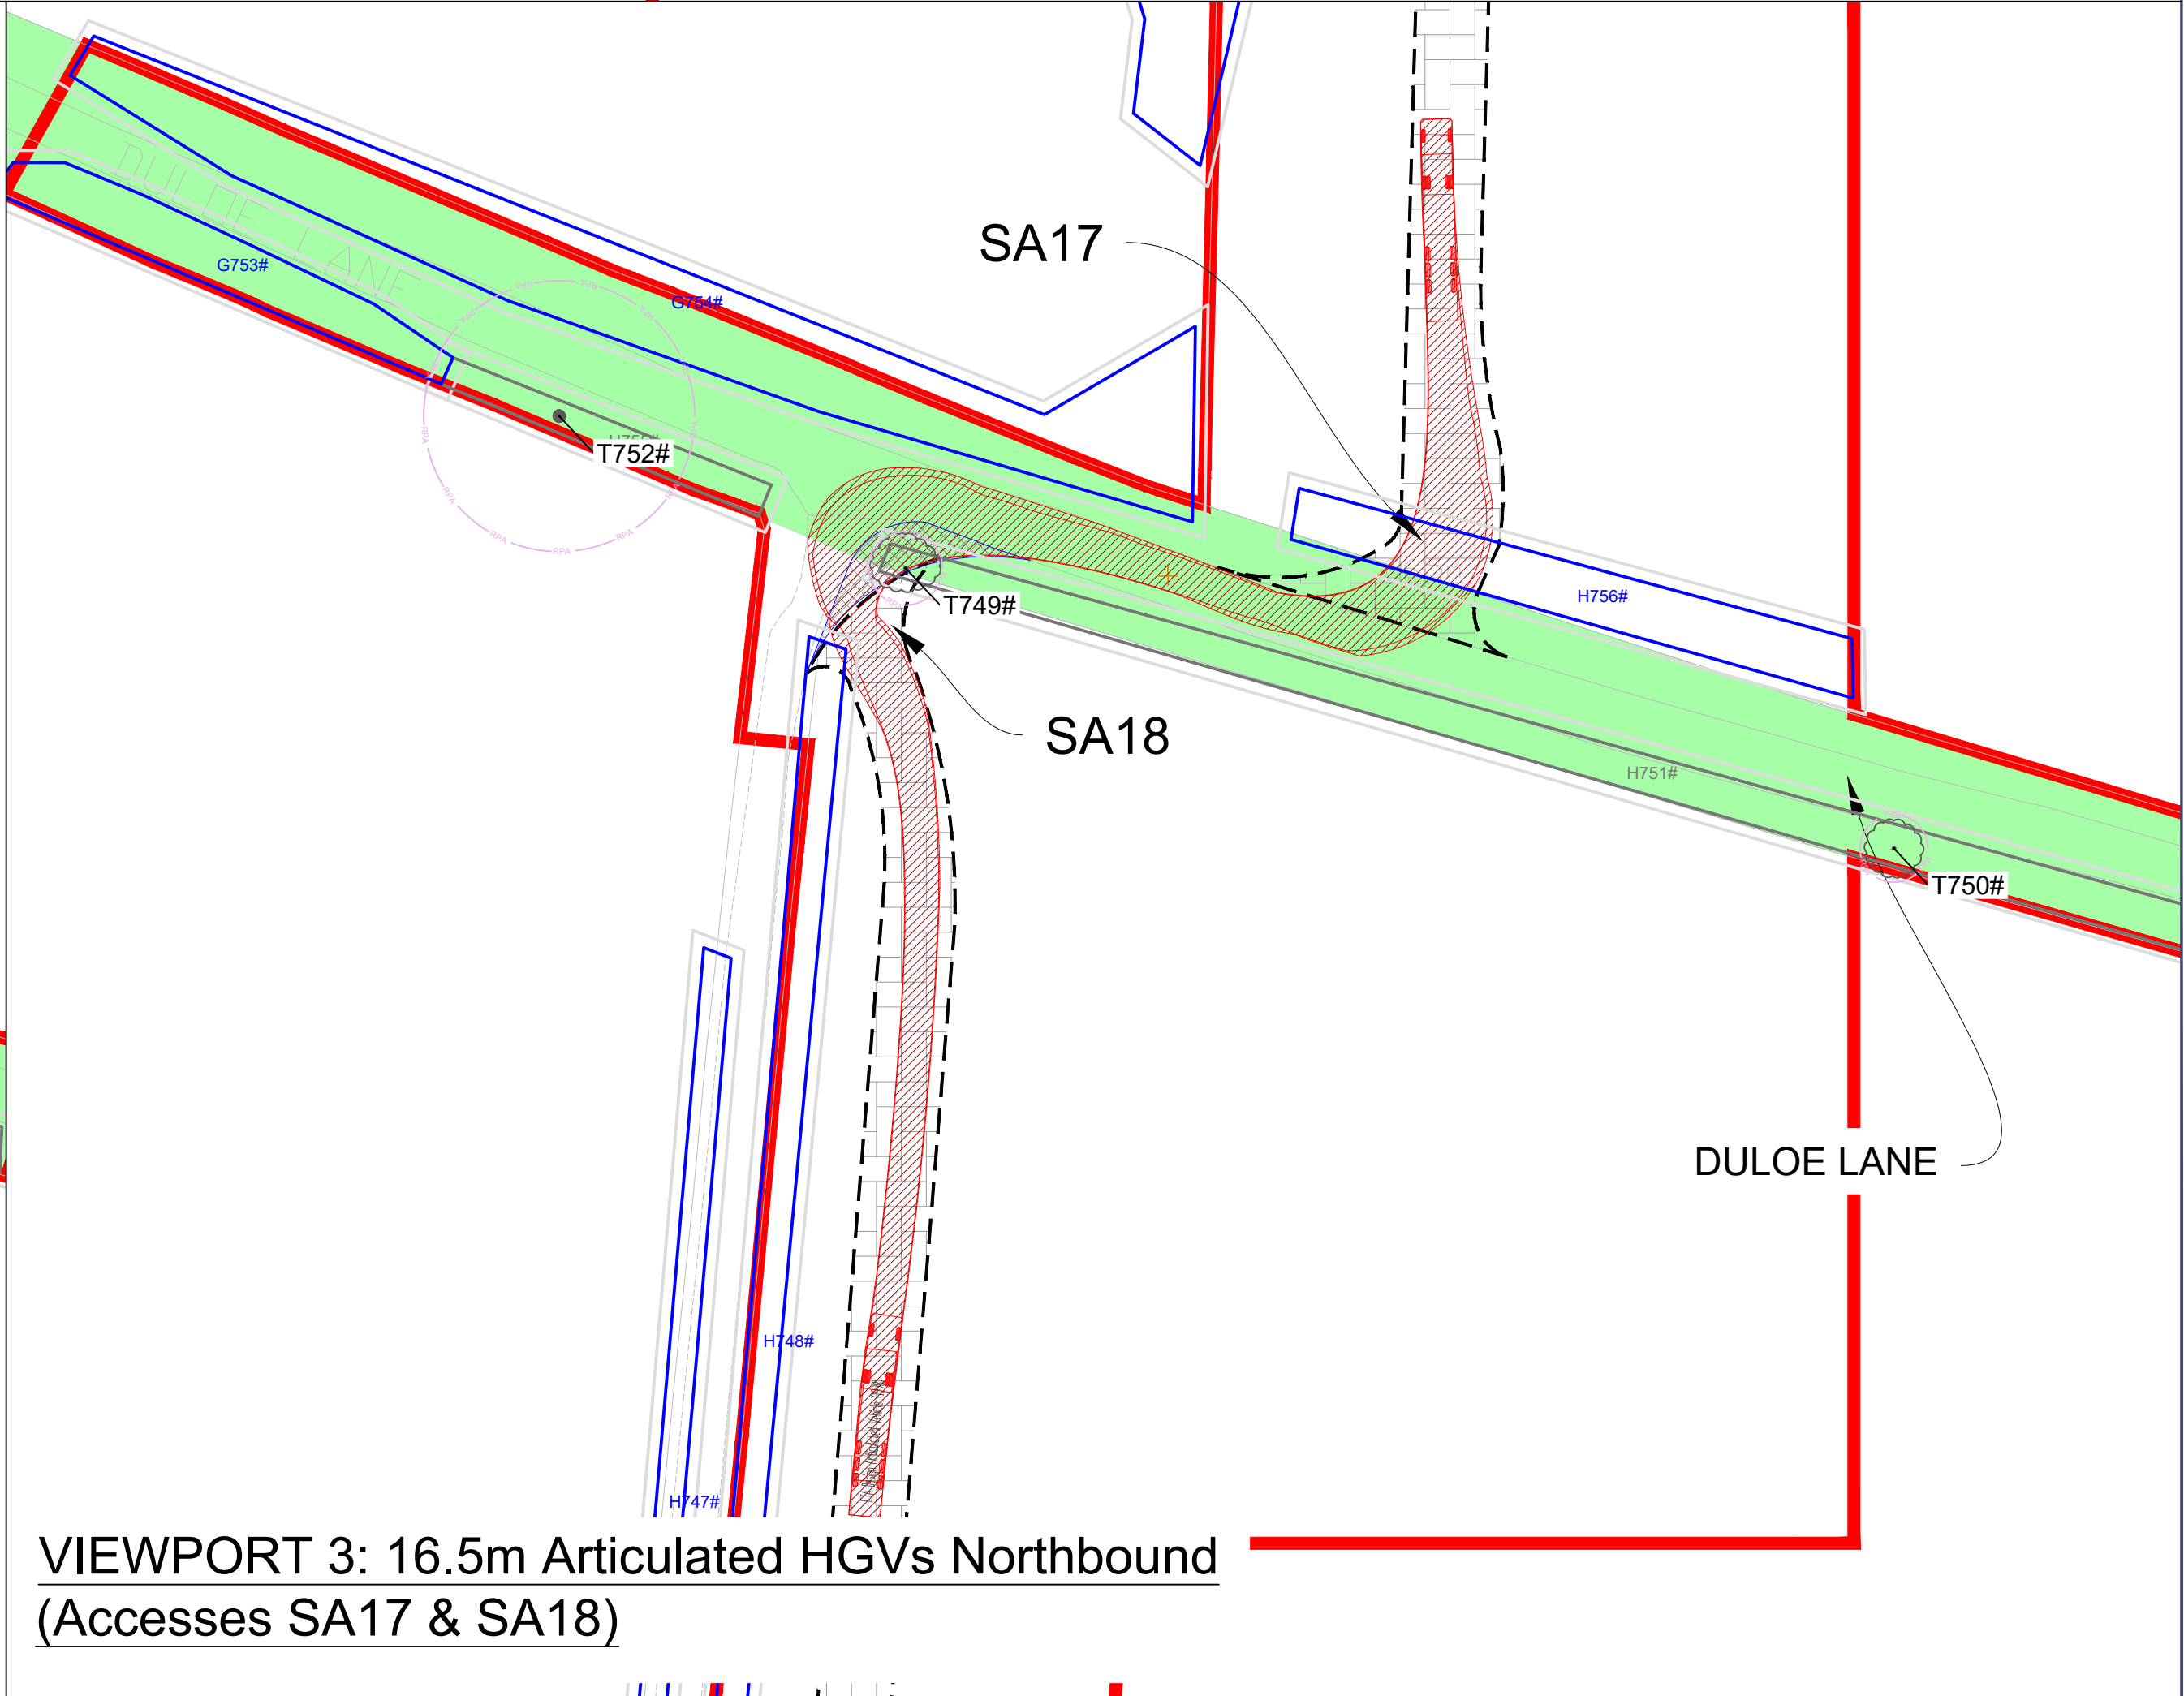
VIEWPORT 3: 16.5m Articulated HGVs Northbound  
(Accesses SA17 & SA18)
