# Lime Down

Solar Park

Volume 3, Appendix 19-4: Lime Down D  
Desk Study (Tracked)

## Appendix 19-4: Lime Down D, Phase 1 Desk Study, Conceptual Site Model and Preliminary Risk Assessment

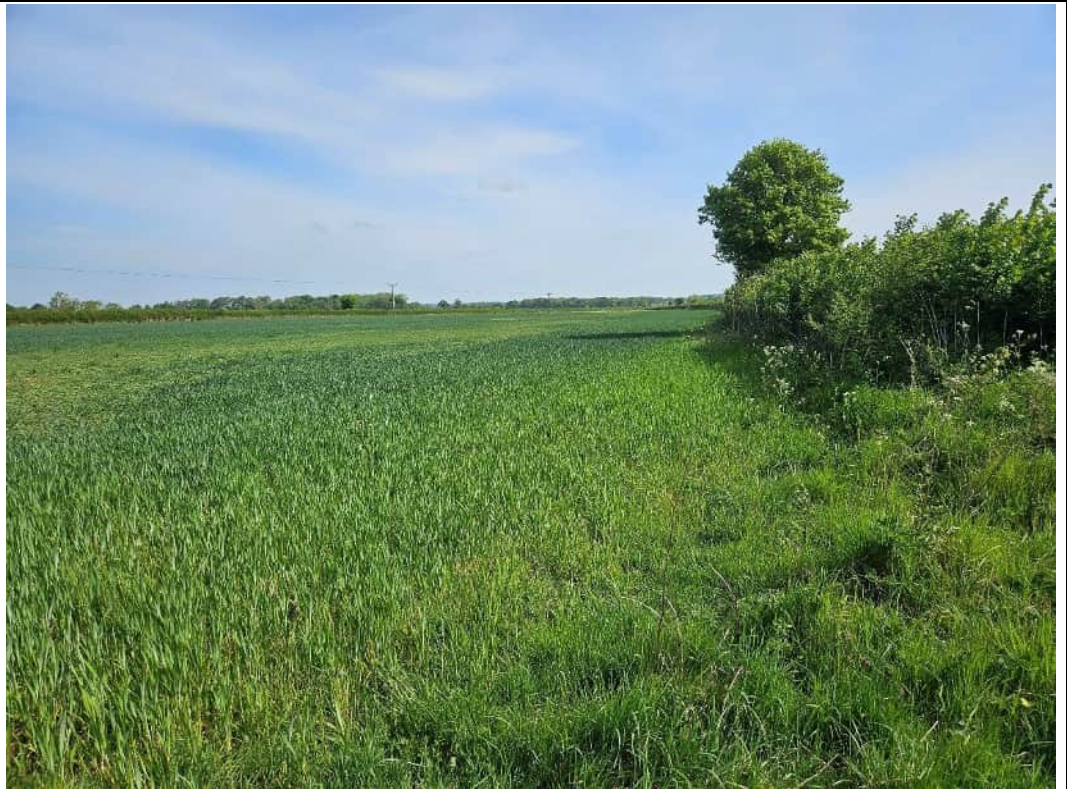
**Comments:** Field D2 is a typical crop field in Zone D. Fields D3, D4, D7, D8, D11, D13, D14, D15, D19, D22 and D24 look similar to this field.

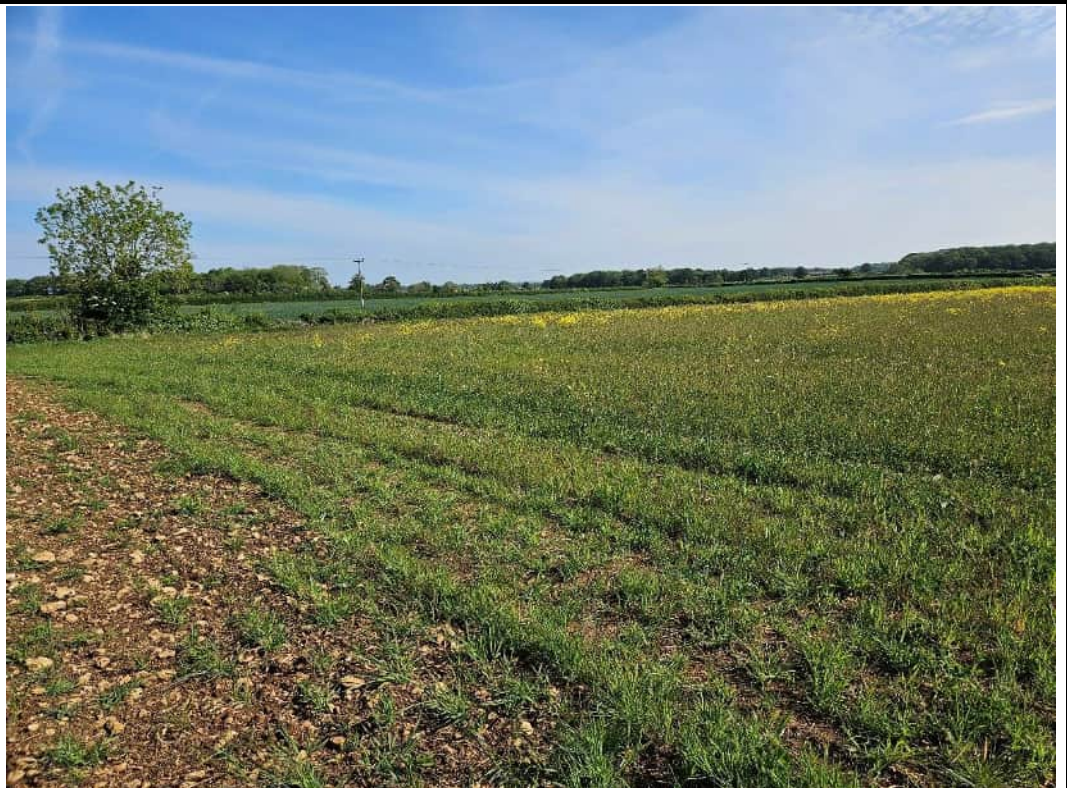
**Photograph 2**

**Comments:** Field D5 is a typical planted grass field in Zone D. Note the wild mustard present. Fields D1, D6, D9, D10, D12, D16, D17, D18, D21, and D23 look similar to this field, excluding the wild mustard.

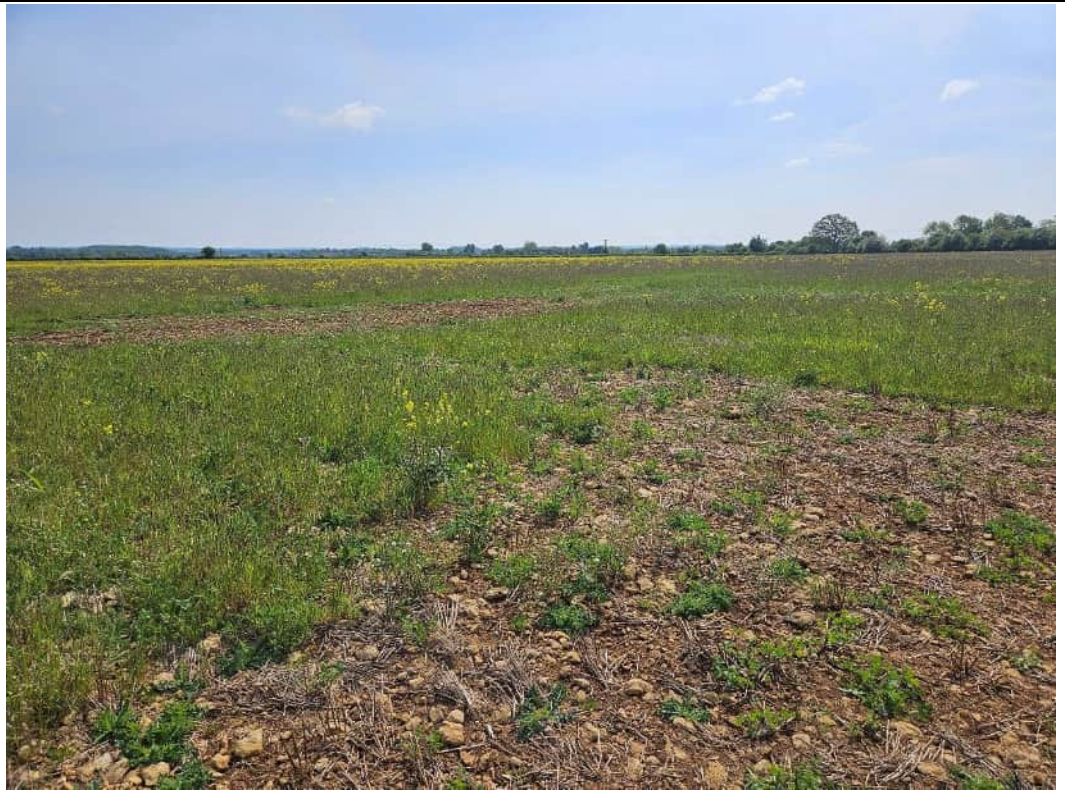
**Comments:** D1 patches of disturbed land that contain oolitic limestone gravel. Disturbed ground looks similar in fields D6, D7, D12, D13, D14, and D20.

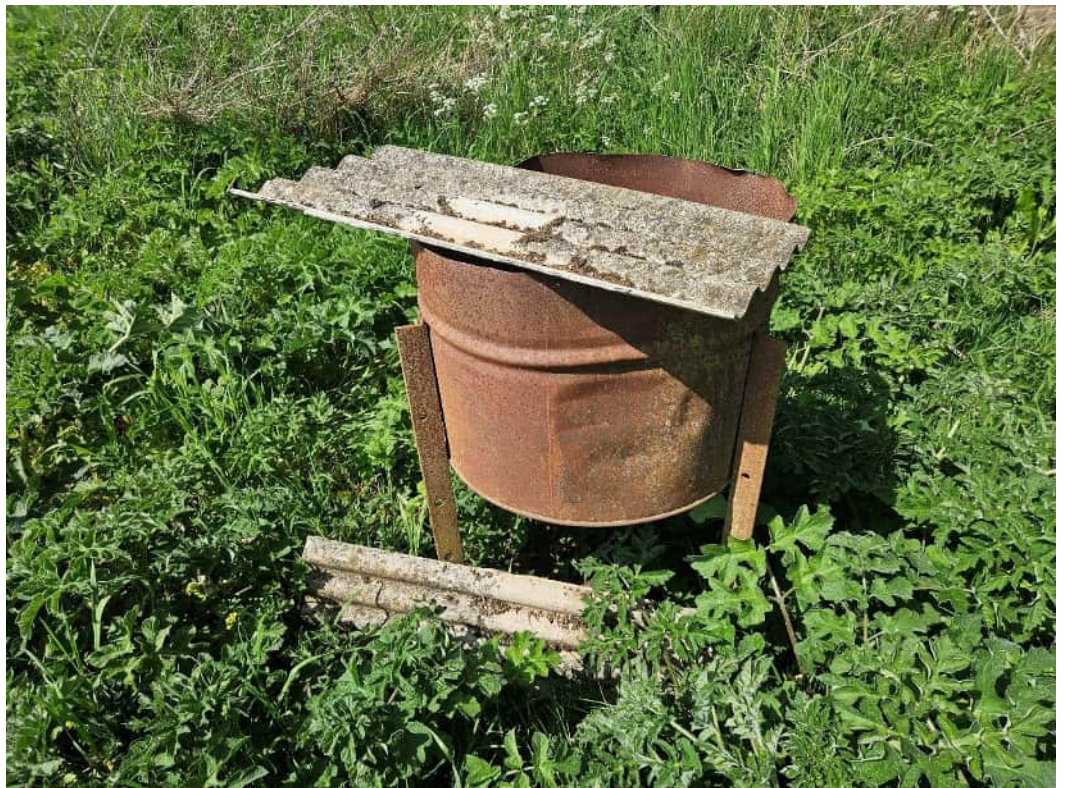
**Photograph 4**

- 1.2.20 D1 contains a patch of disturbed ground, a dried pond in northern boundary. Suspected asbestos cement sheets, metal tanks covered in pallets, and metal barrels on stilts covered with an asbestos sheeting are observed east of the dried pond. The field also contains an overhead powerline running east to west along the eastern boundary shared with D2.

**Comments:** D1 contains metal barrel on stilts covered with asbestos sheeting. D8, D9 and D11 also includes similar barrels with asbestos sheets.

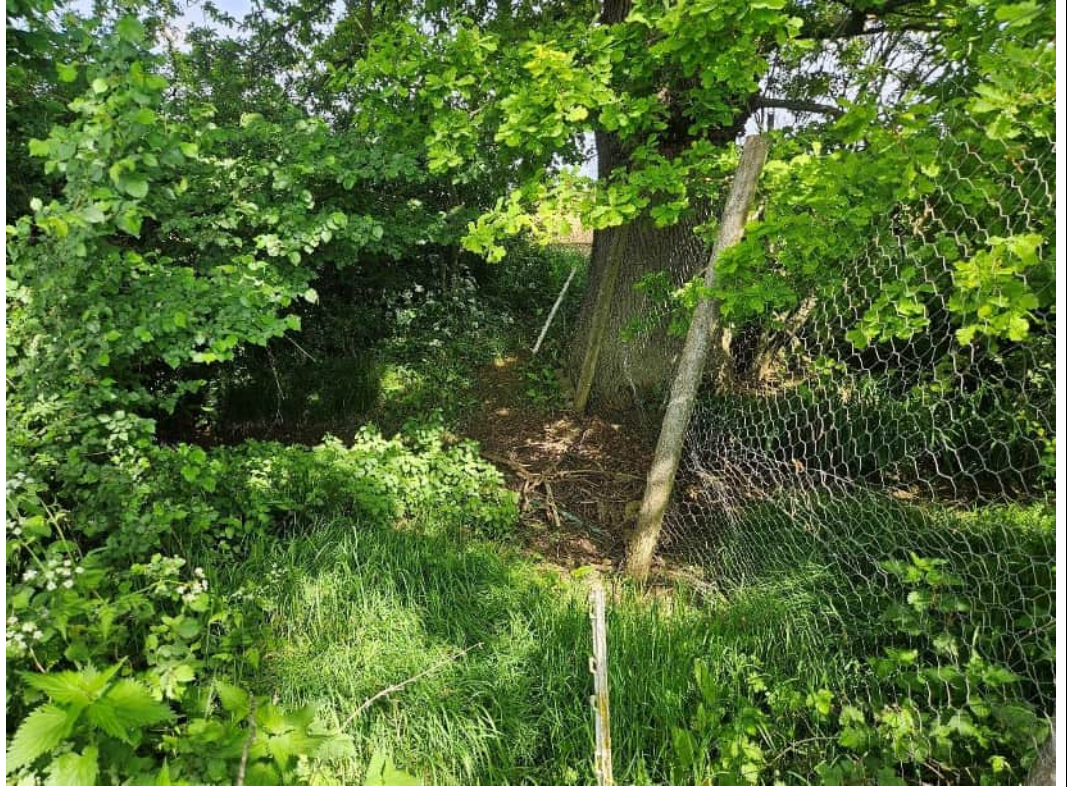
**Comments:** Dry ditch in northern boundary of D1, shared with D22.

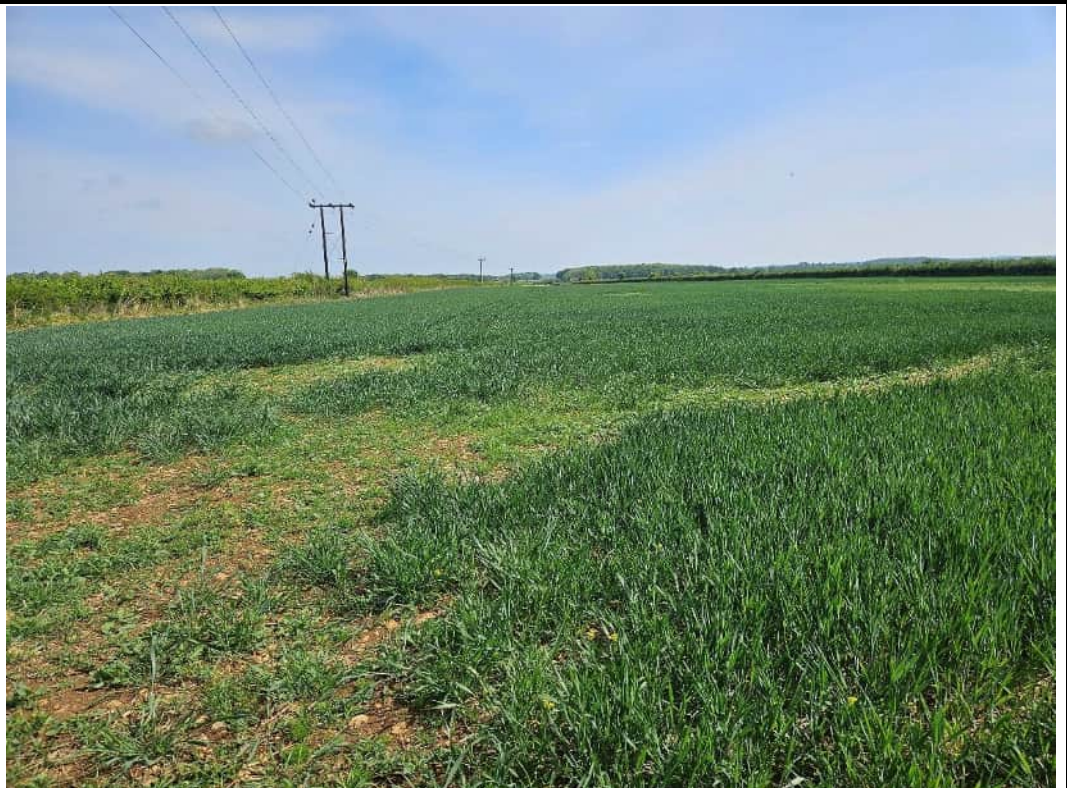
**Photograph 6**

**Comments:** Overhead powerline in D1 running east to west along the eastern boundary shared with D2.

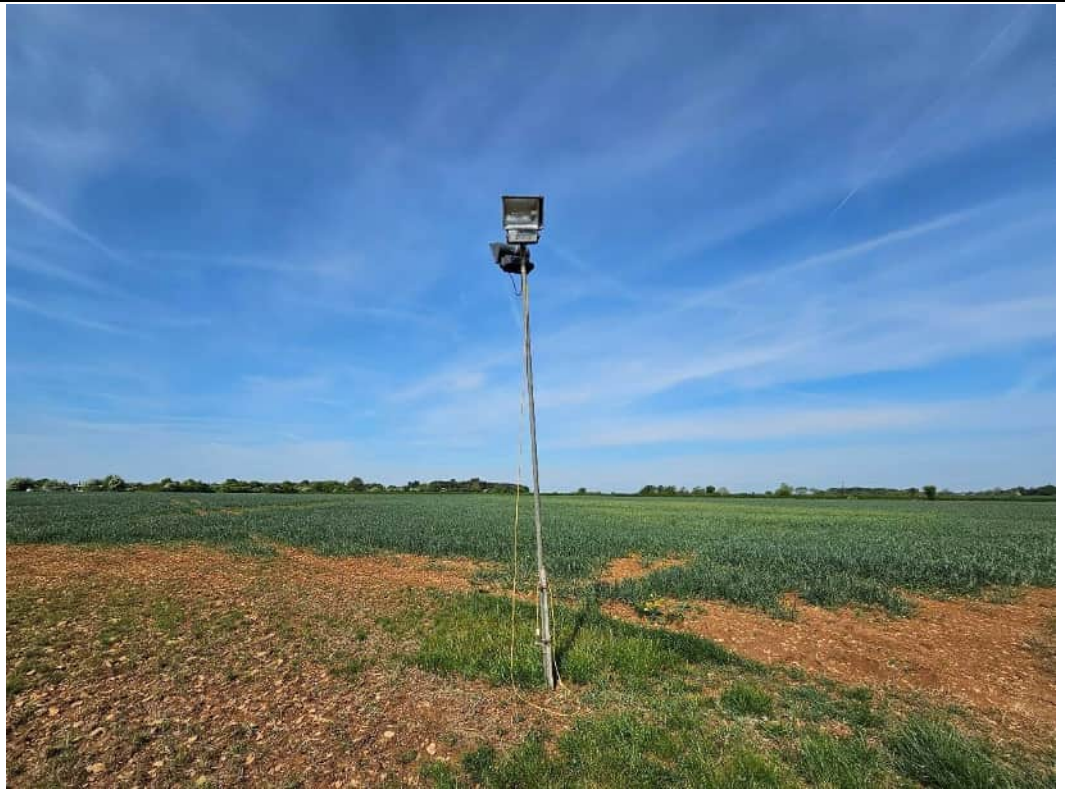
- 1.2.21 D3 contains a flood light attached to scaffolding pole towards southeast of the field. A pile of festival equipment including gazebo frames, scaffold poles, pallets, an empty IBC, rope, tent poles and pegs, and a bin containing mouldy burger boxes is present in the western boundary of D3. A footbridge is observed in the south. D4 contains overhead wires crossing northeast to southwest.

**Comments:** D3 contains a flood light attached to scaffolding pole towards southeast of the field.

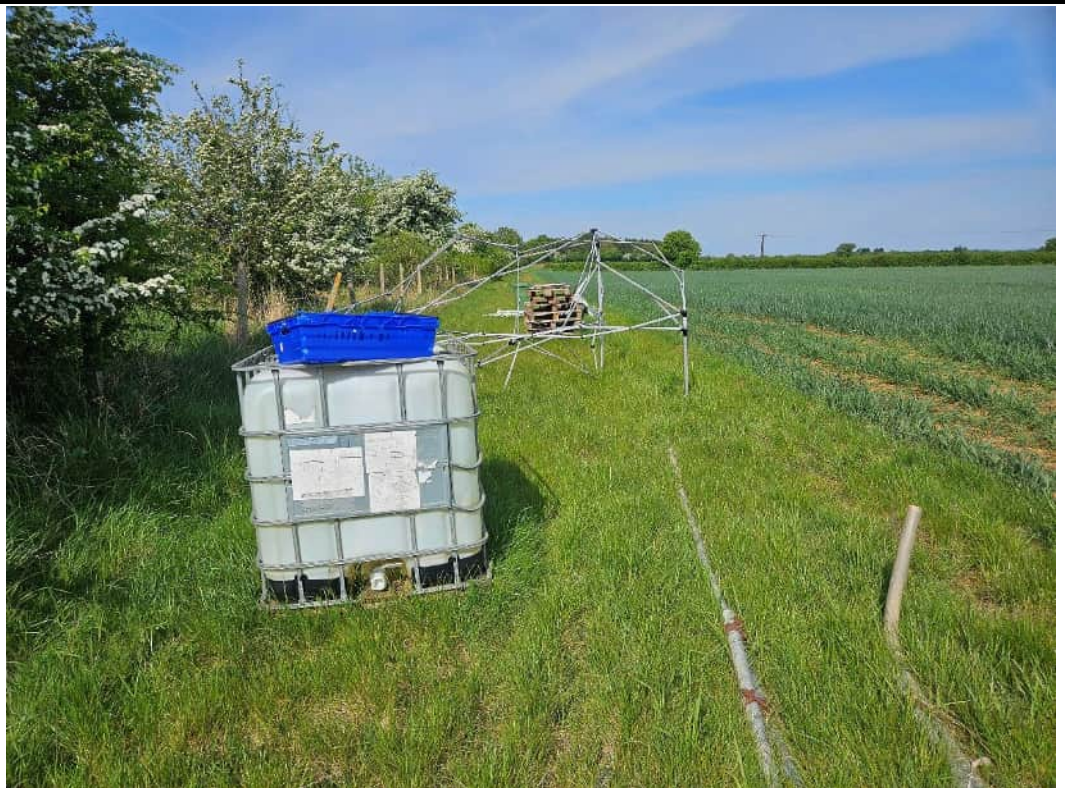
**Photograph 8**

**Comments:** A pile of festival equipment including gazebo frames, scaffold poles, pallets, empty IBC, rope, tent poles and pegs, and a bin containing burger boxes is present in the western boundary of D3.

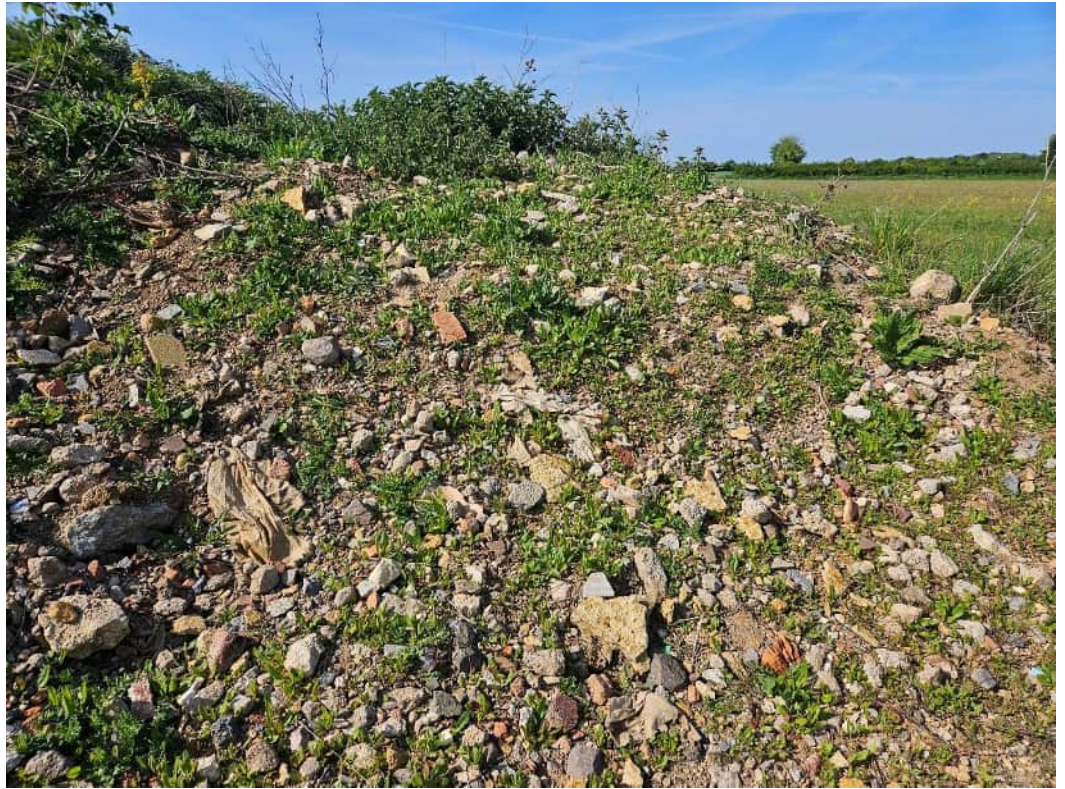
- 1.2.22 The southwestern corner of D5 contains crushed concrete, brick and grey limestone over the track. In the south-central boundary, a stockpile of crushed brick, concrete, asphalt is observed. It is poorly graded. In the southeast corner by the gate, haybales and chopped wood are observed. Vegetated stockpiles of crushed material, a piece of farming equipment and rusted pipes are observed.

**Comments:**  
Southwestern corner of D5 contains crushed concrete stockpile.

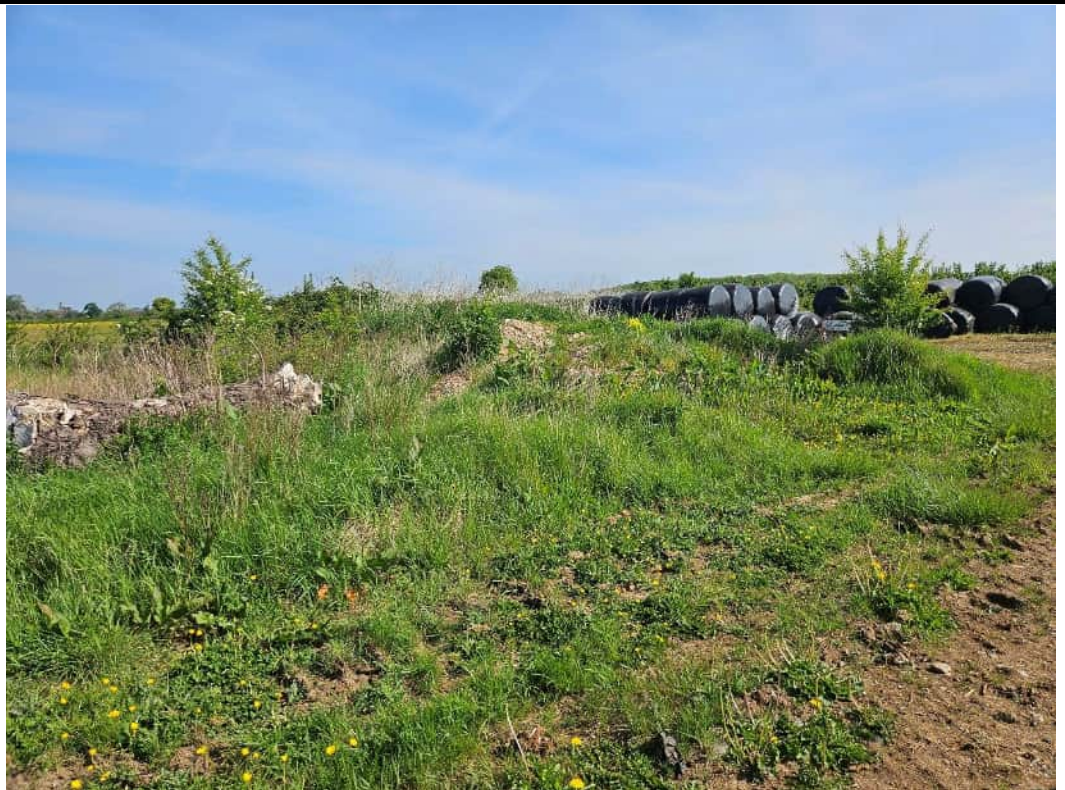
**Photograph 10**

**Comments:** Vegetated stockpiles of crush, piece of farming equipment and rusted pipes are observed in the southwestern corner of D5.

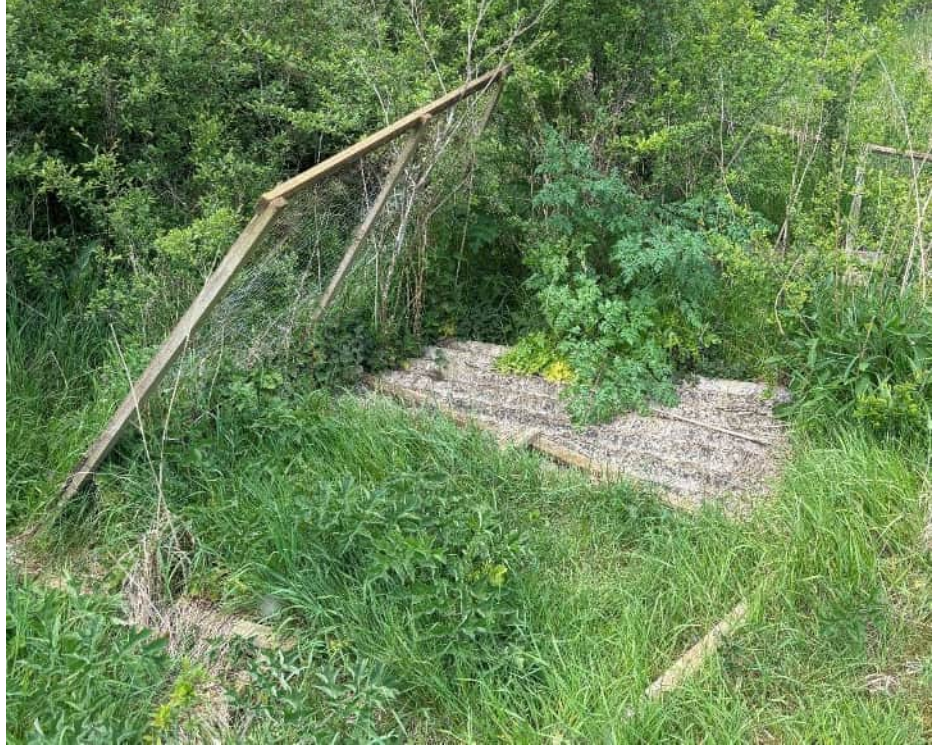
- 1.2.24 D8 contains a barrel covered with asbestos sheeting in southwest corner, and a pile of asbestos cement sheets and wooden structures along the western boundary. A dry ditch on southern banking, a trough with plumbing in the southeast corner. D9 contains two barrels with the same asbestos sheeting covering. A ditch runs between D9 and D10. The boundary also contains two ponds and a public footbridge across the boundary with a sign. A public footpath into the woodland to the north is observed.

**Comments:** D8 contains asbestos sheets and wood structures along the western boundary.

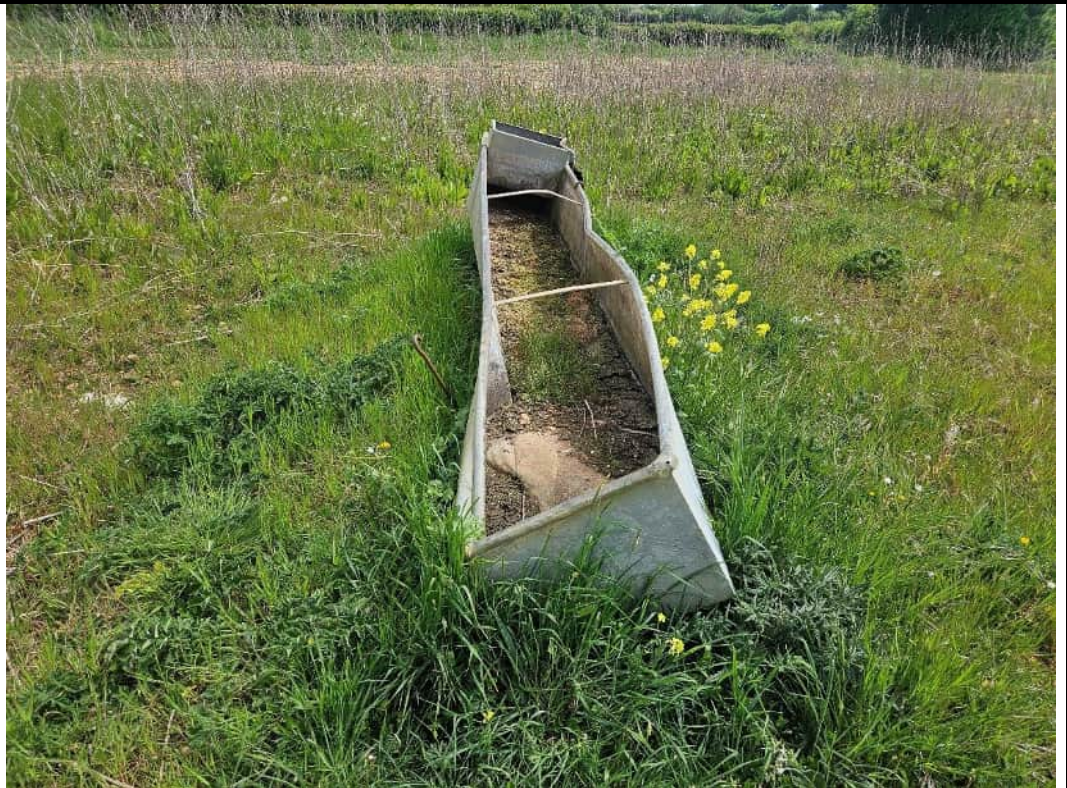
**Photograph 12**

**Comments:** A trough with plumbing in the southeast corner of D8.

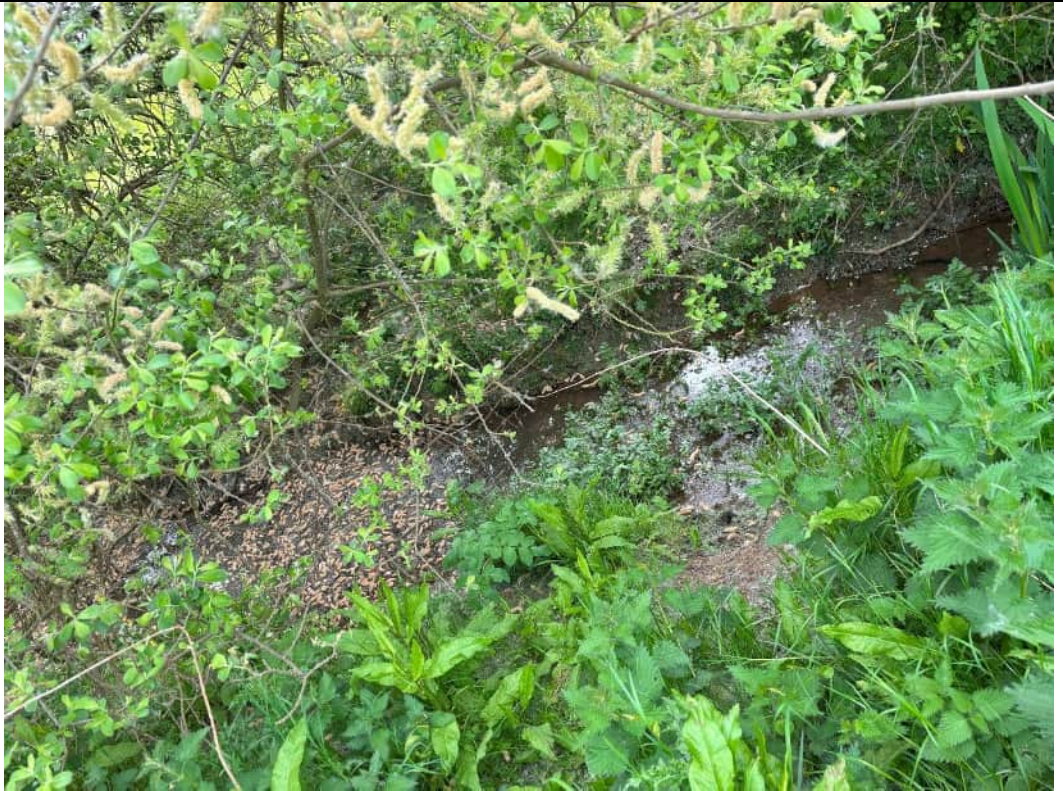
**Comments:** Larger pond between D9 and D10.

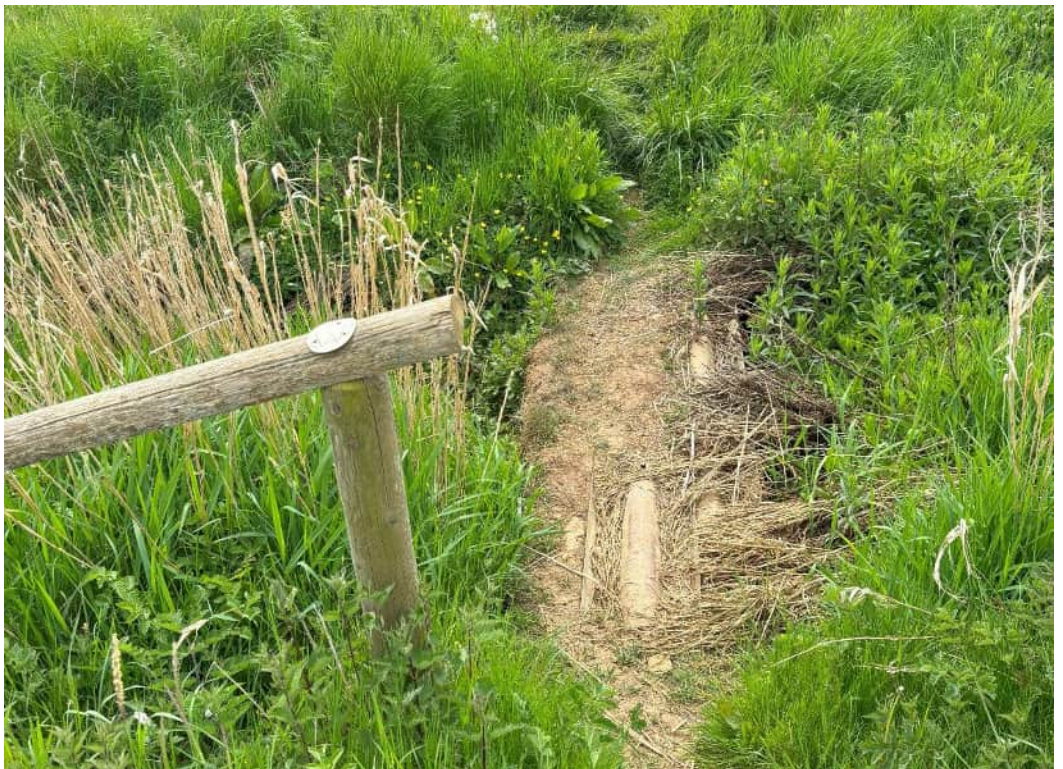
**Photograph 14**

**Comments:** A public footbridge between D9 and D10, with a sign.

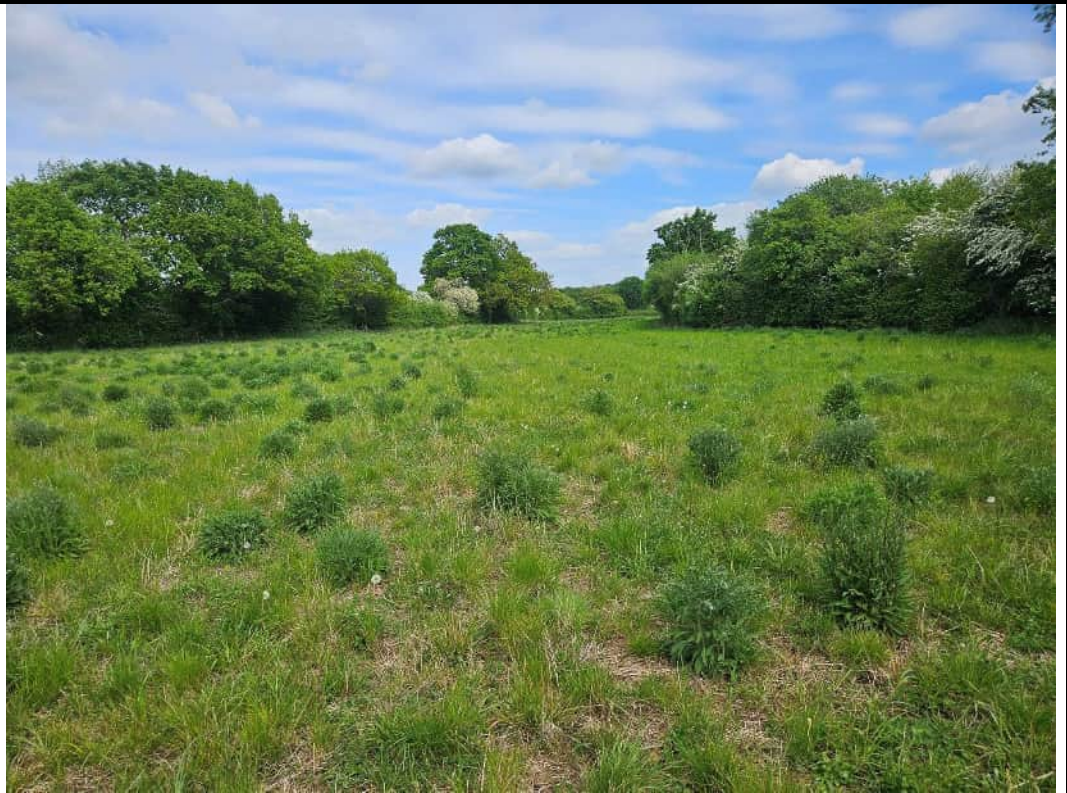
**Comments:** View across the exclusion zone in the east of D12.

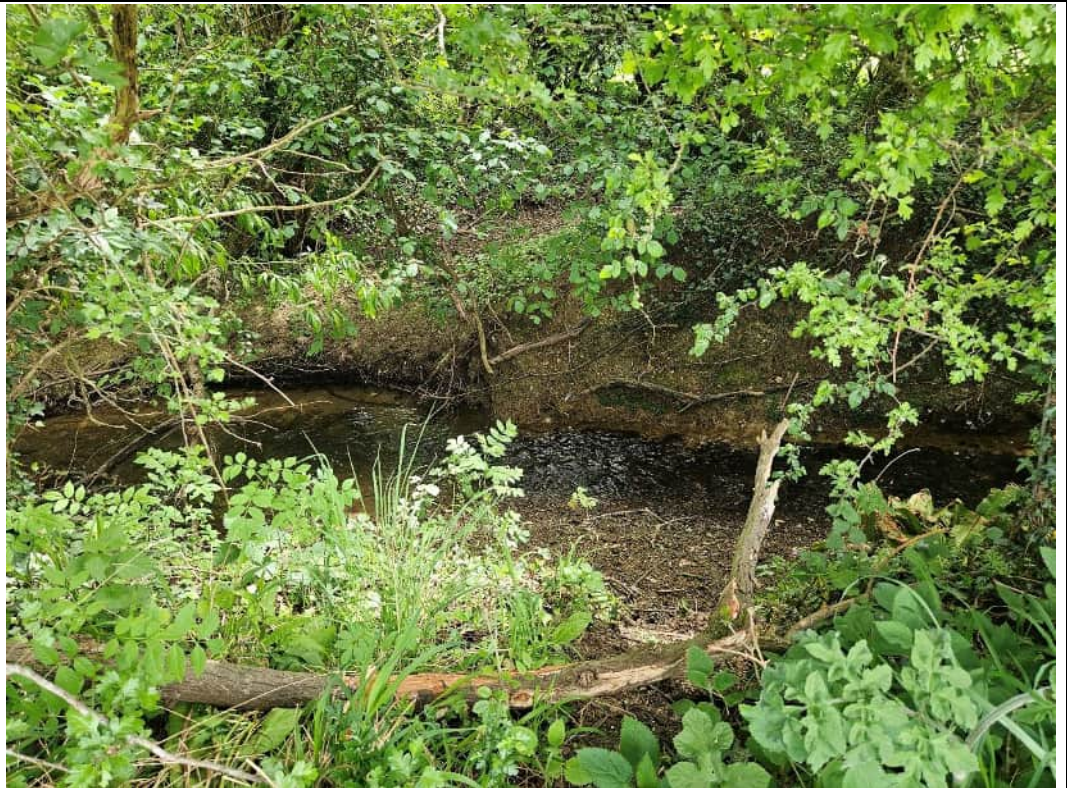
**Photograph 16**

**Comments:** Gauze Brook at south boundary of field D12.

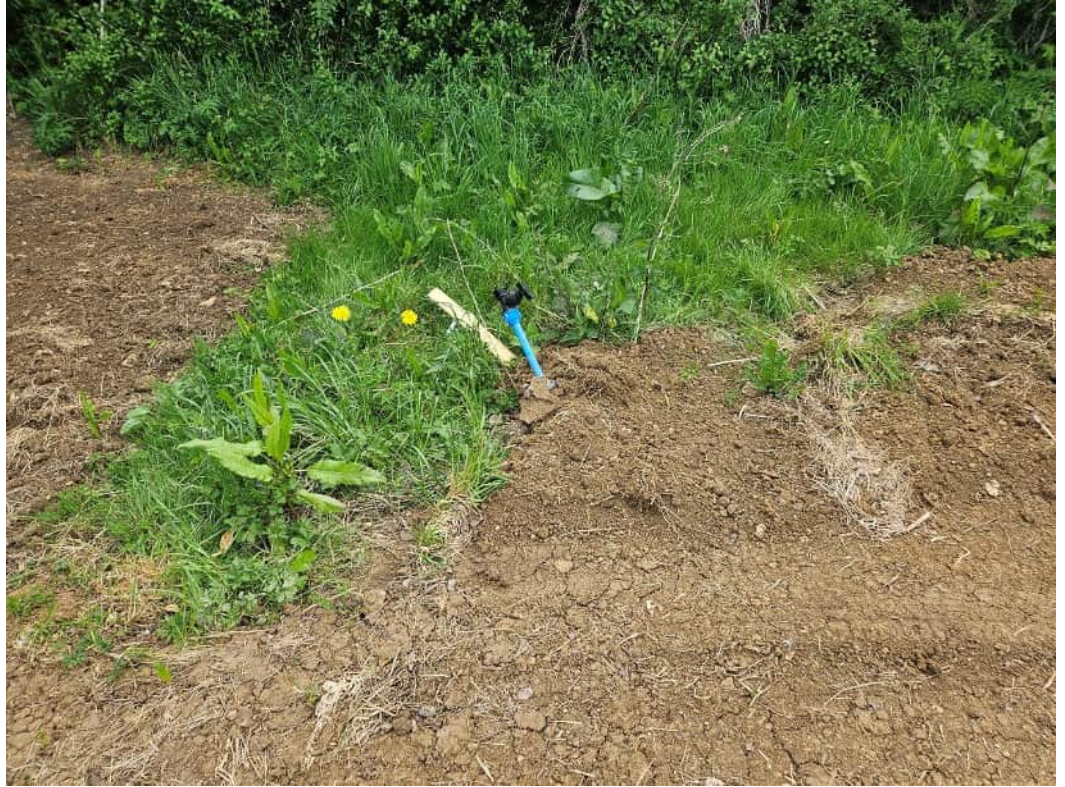
**Comments:** Water tap is observed in the southwestern corner of D17.

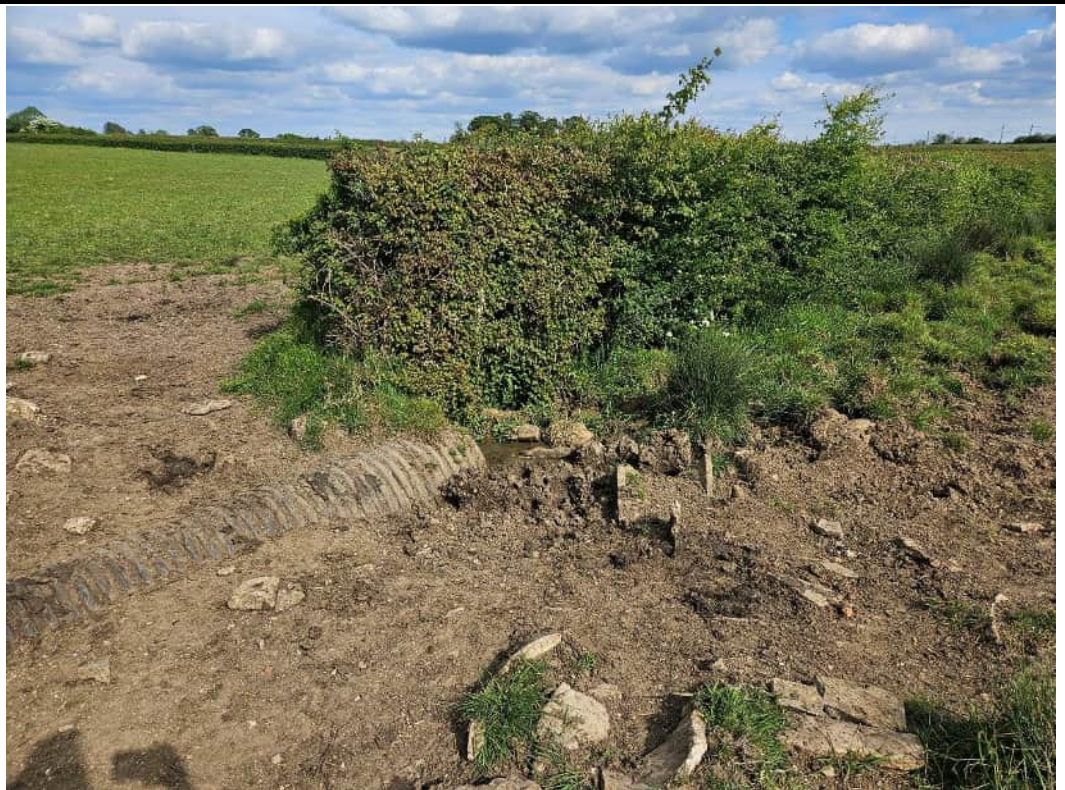
**Photograph 18**

**Comments:** Pipe work in gateway in D18.
