Solar Park

BESS and Substation – Preliminary Geotechnical Risk Register

Planning Inspectorate Reference: EN010168

Document Reference: EXAM/9.12

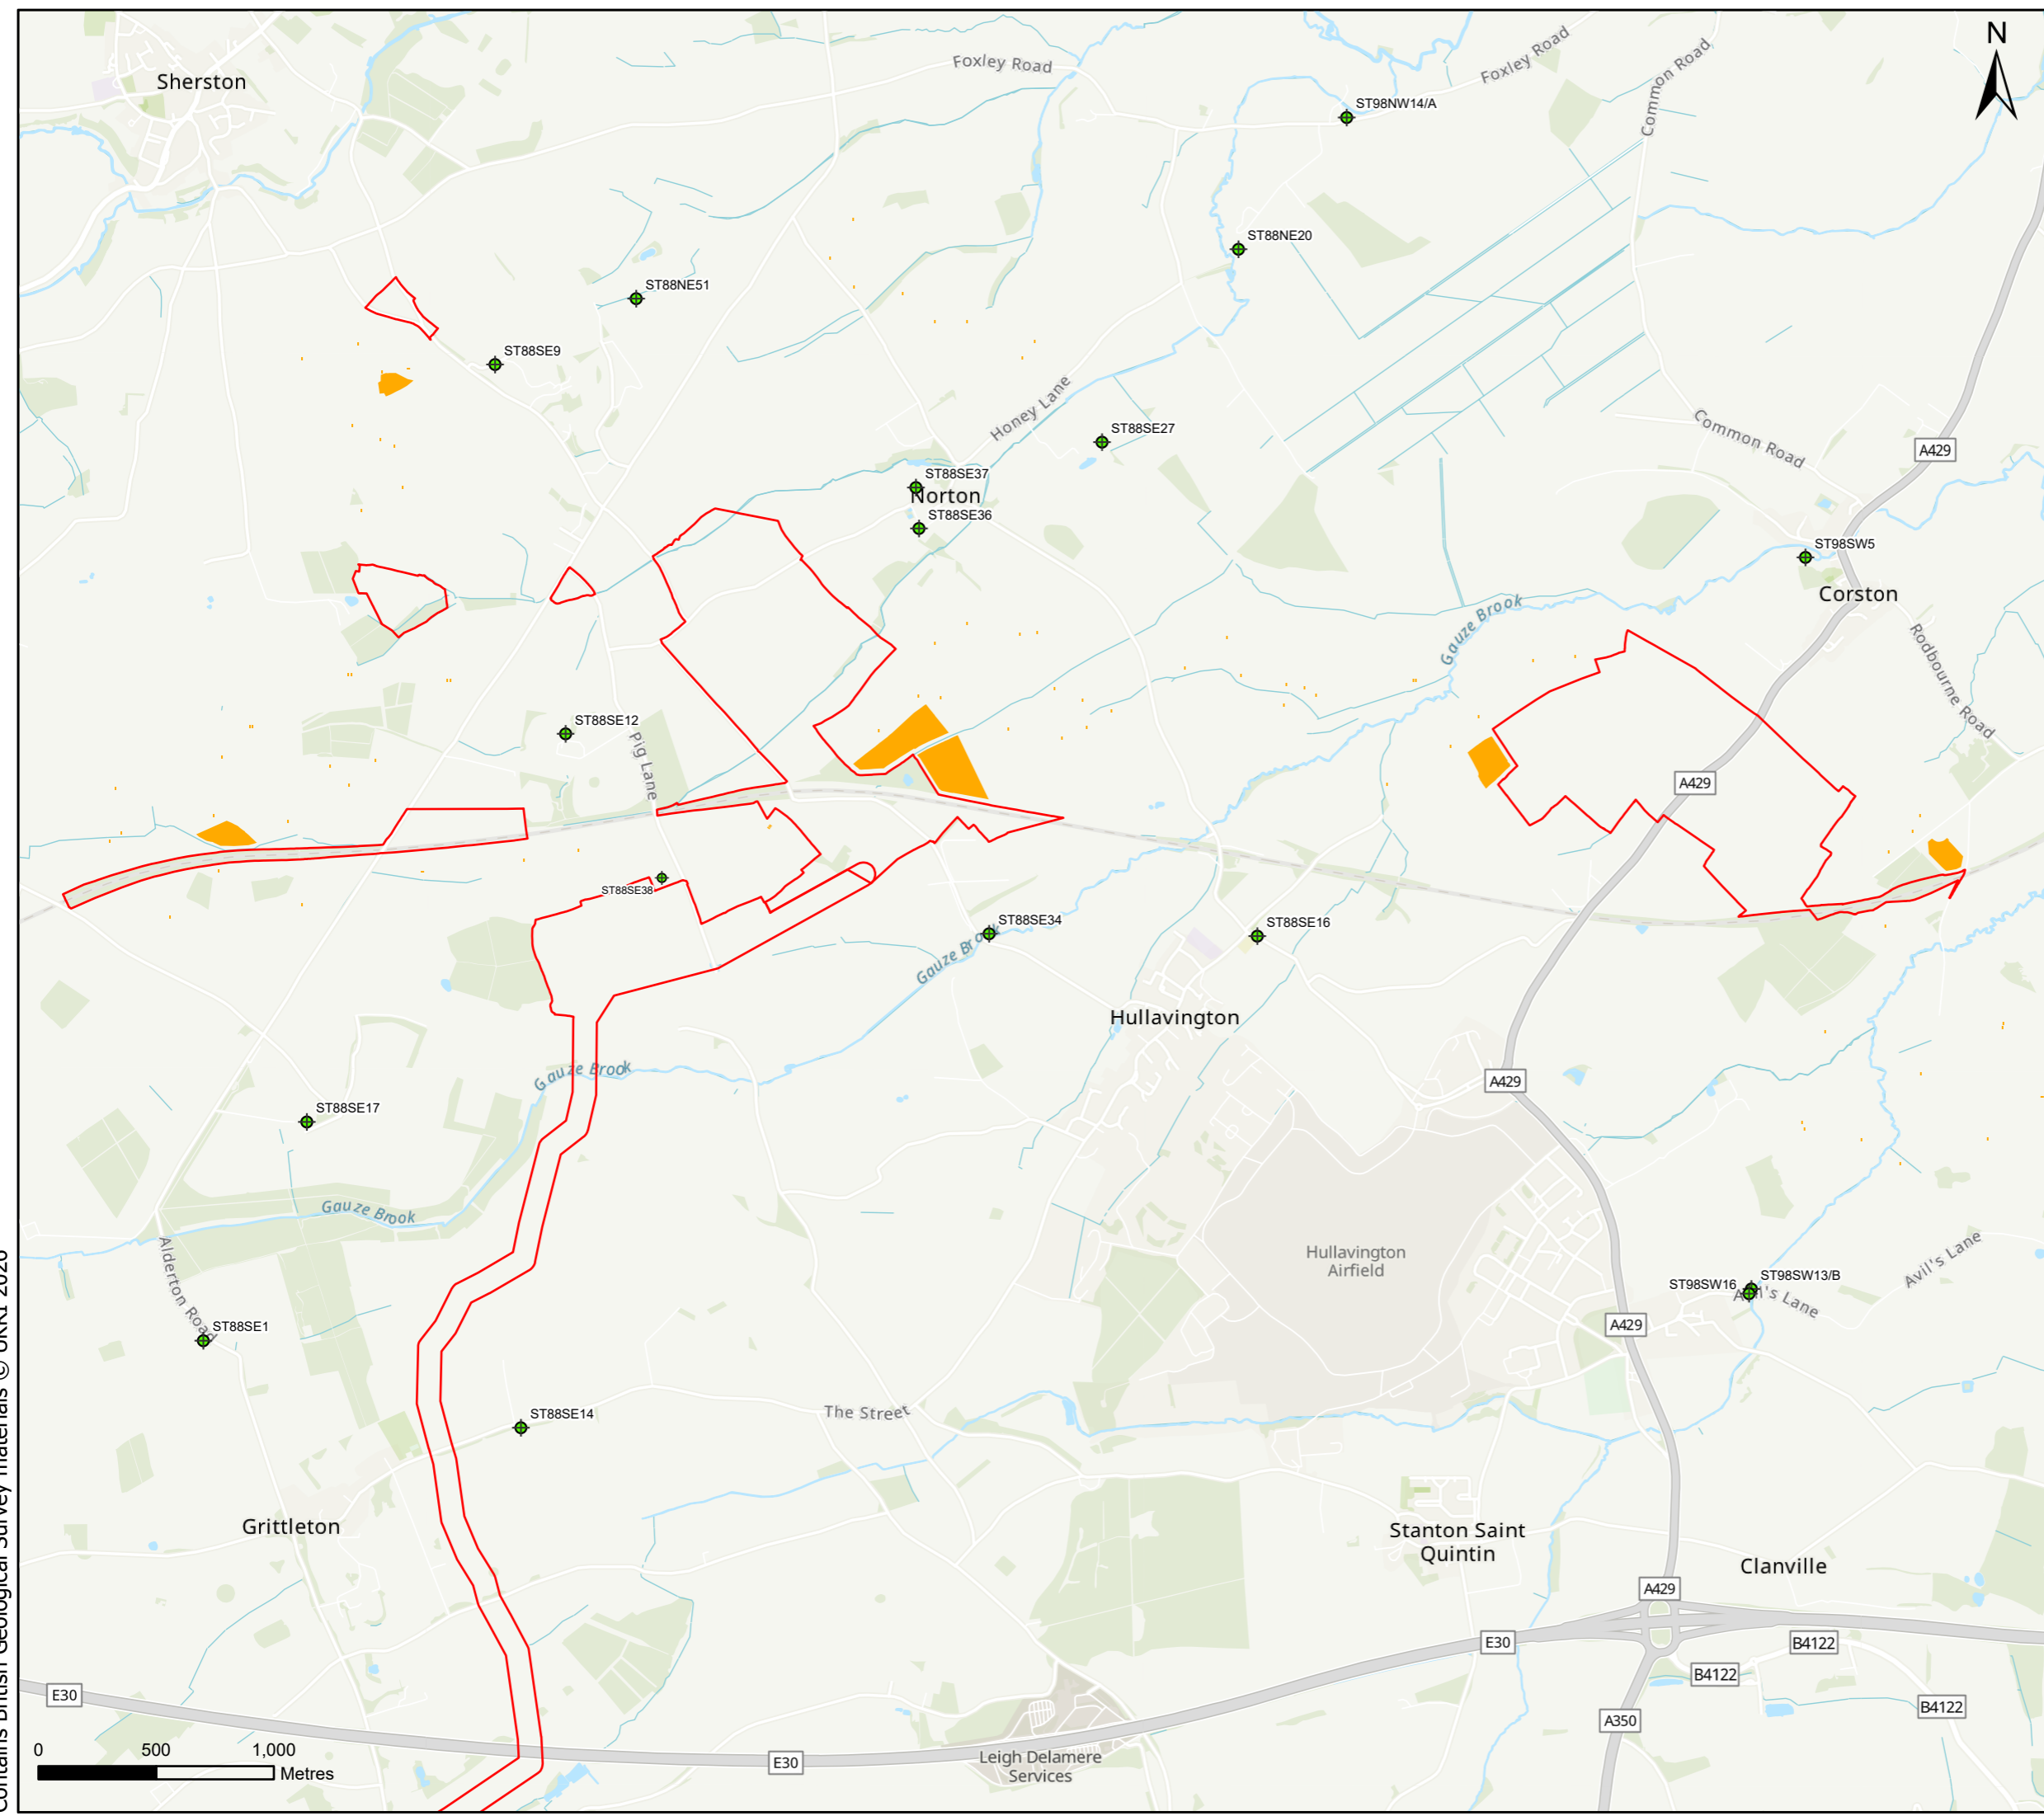
26008710-GEOS-LDSF-BESS-D-G-3001

Exploratory Hole Location Plan

Geosyntec have been commissioned by Lime Down Solar Park Ltd (the “Client”) to prepare a Preliminary Geotechnical Risk Register (PGRR) for the BESS and Substation (the Site) which connect the ‘Cable Route Corridor’ from the Lime Down solar farm to the Existing National Grid Melksham Substation. The purpose of the PGRR is to inform the Client of areas of potential concern with respect to geotechnical hazards beneath or within influencing distance of the Site or hazards influenced by the proposed works. The PGRR will seek to provide an assessment of the impact of geotechnical hazards at the proposed development. The Site location can be found on drawing 26008710-GEOS-LDSF-HDD-D-G-3001 within Appendix A.

Geosyntec have reviewed the publicly available boreholes available on BGS GeoIndex Viewer beneath and within 1.5kmm of the BESS and Substations. Pertinent boreholes are summarised within Table 3.3 and copies of Borehole logs are available online at BGS GeoIndex Viewer. Selected boreholes taken from the available BGS mapping listed above have been included where appropriate. It should be noted that engineering rockhead has been inferred from the logs and is not an accurate representation of the sitewide rockhead. The boreholes used to inform the cross sections are presented on the relevant drawings in Appendix A.

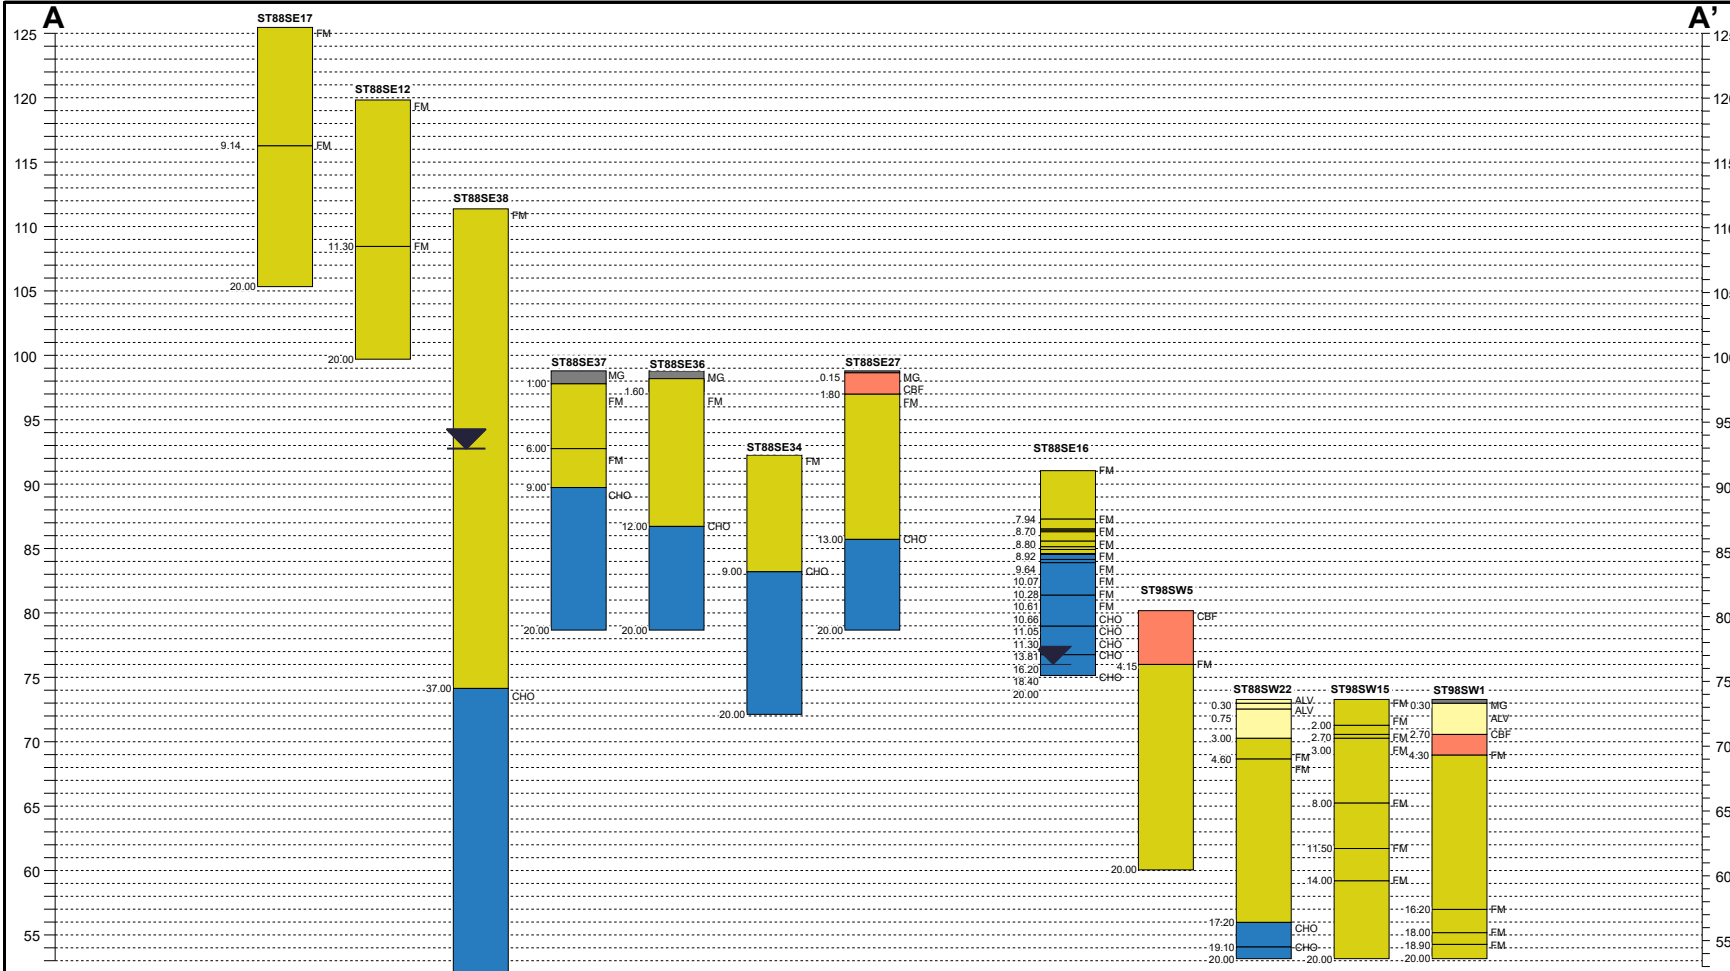
26008710-GEOS-LDSF-BESS-D-G-3002

4. Boreholes presented on the cross-section have been truncated at 50 m BGL for clarity and relevance. Geosyntec accepts no liability for ground conditions occurring below the depth of interpretation shown.

BESS Substation - Section A-A'

The cross sections are presented as Appendix B; the depths are limited to a maximum depth extent of 20m BGL to support the pile risk assessment. The cross sections include boreholes within a 1500m buffer of the BESS and Substation sites on account of poorly available information. Four sections have been produced which encompass the four main areas of development.

Fault Number	Grid Reference	Orientation	Throw Direction	Comment
1 (Corston fault)	391085, 182941	NE/SW	NW	Observed. Runs east of Hullavington to Malmesbury. Crosses section A-A' see appendix B.
2	388863, 181807	ENE/WSW	SSE	Observed, Southwest of Hullavington crosses C-C' see appendix B.
3	393144, 181570	ENE/WSW	NNW	Inferred, East of Lower Stanton St Quintin. Crosses section D-D' see appendix B. (BGS, 2011).

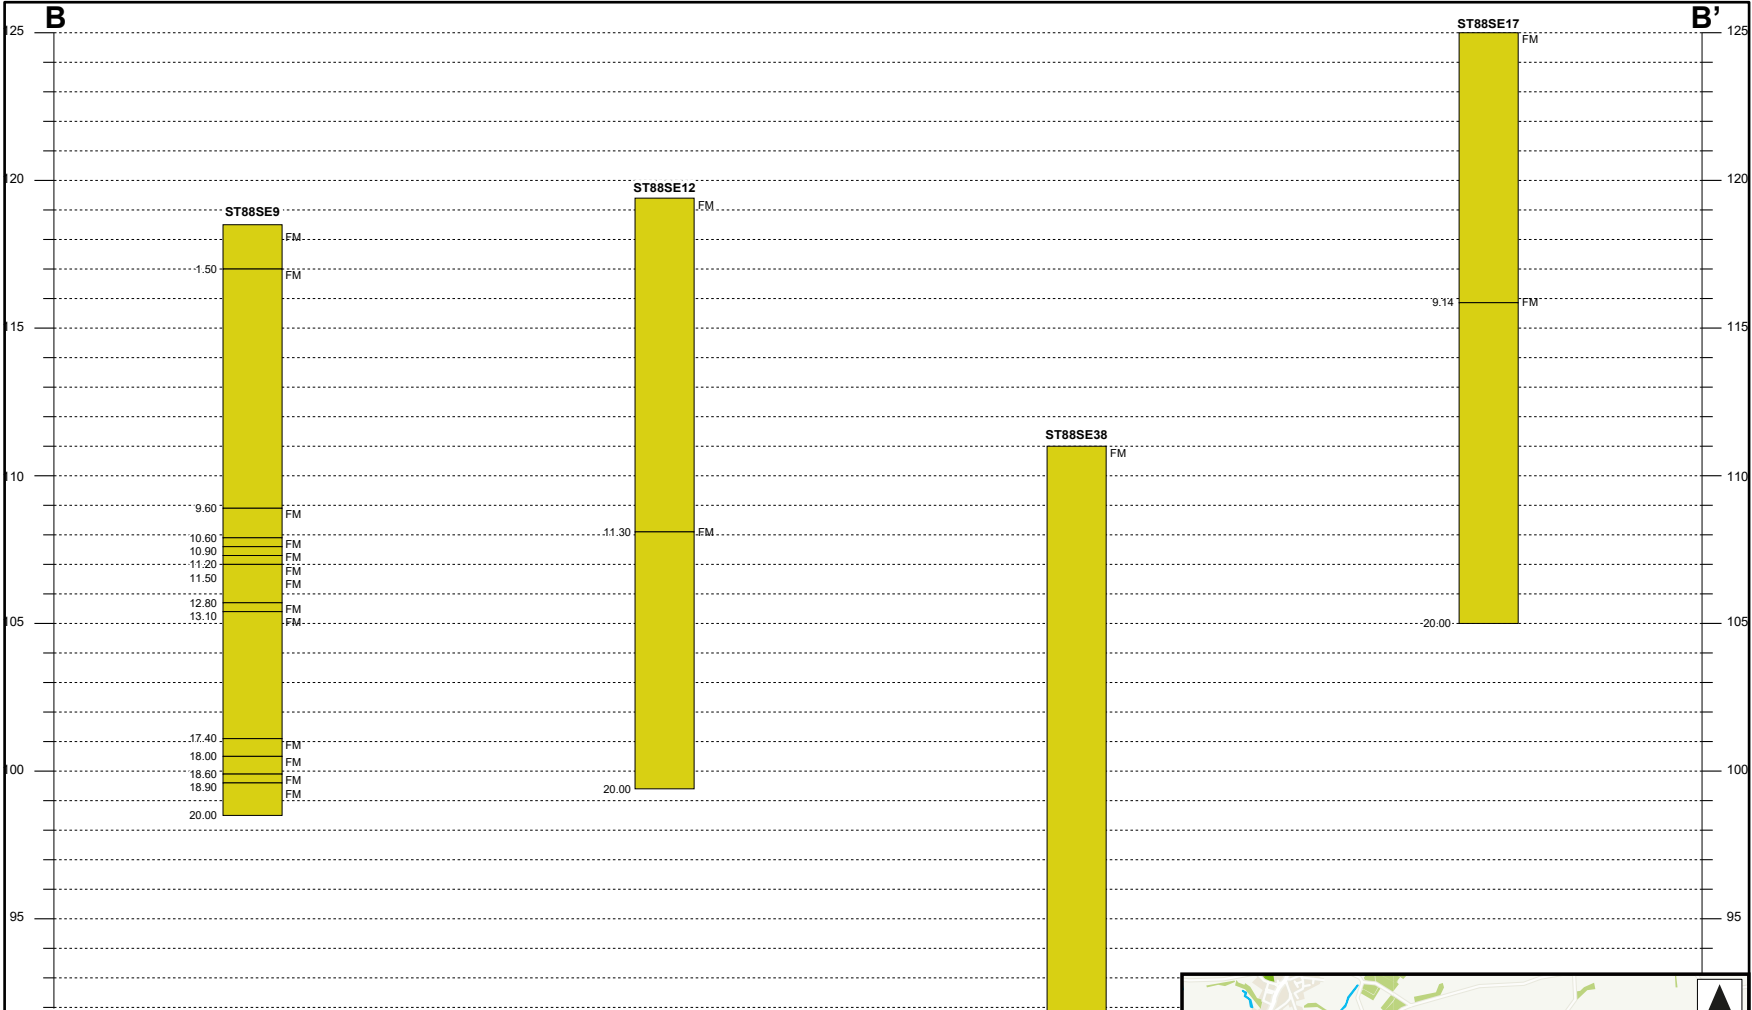
26008710-GEOS-LDSF-BESS-D-G-3003

4. Boreholes presented on the cross-section have been truncated at 50 m BGL for clarity and relevance. Geosyntec accepts no liability for ground conditions occurring below the depth of interpretation shown.

BESS & Substation B-B' Section

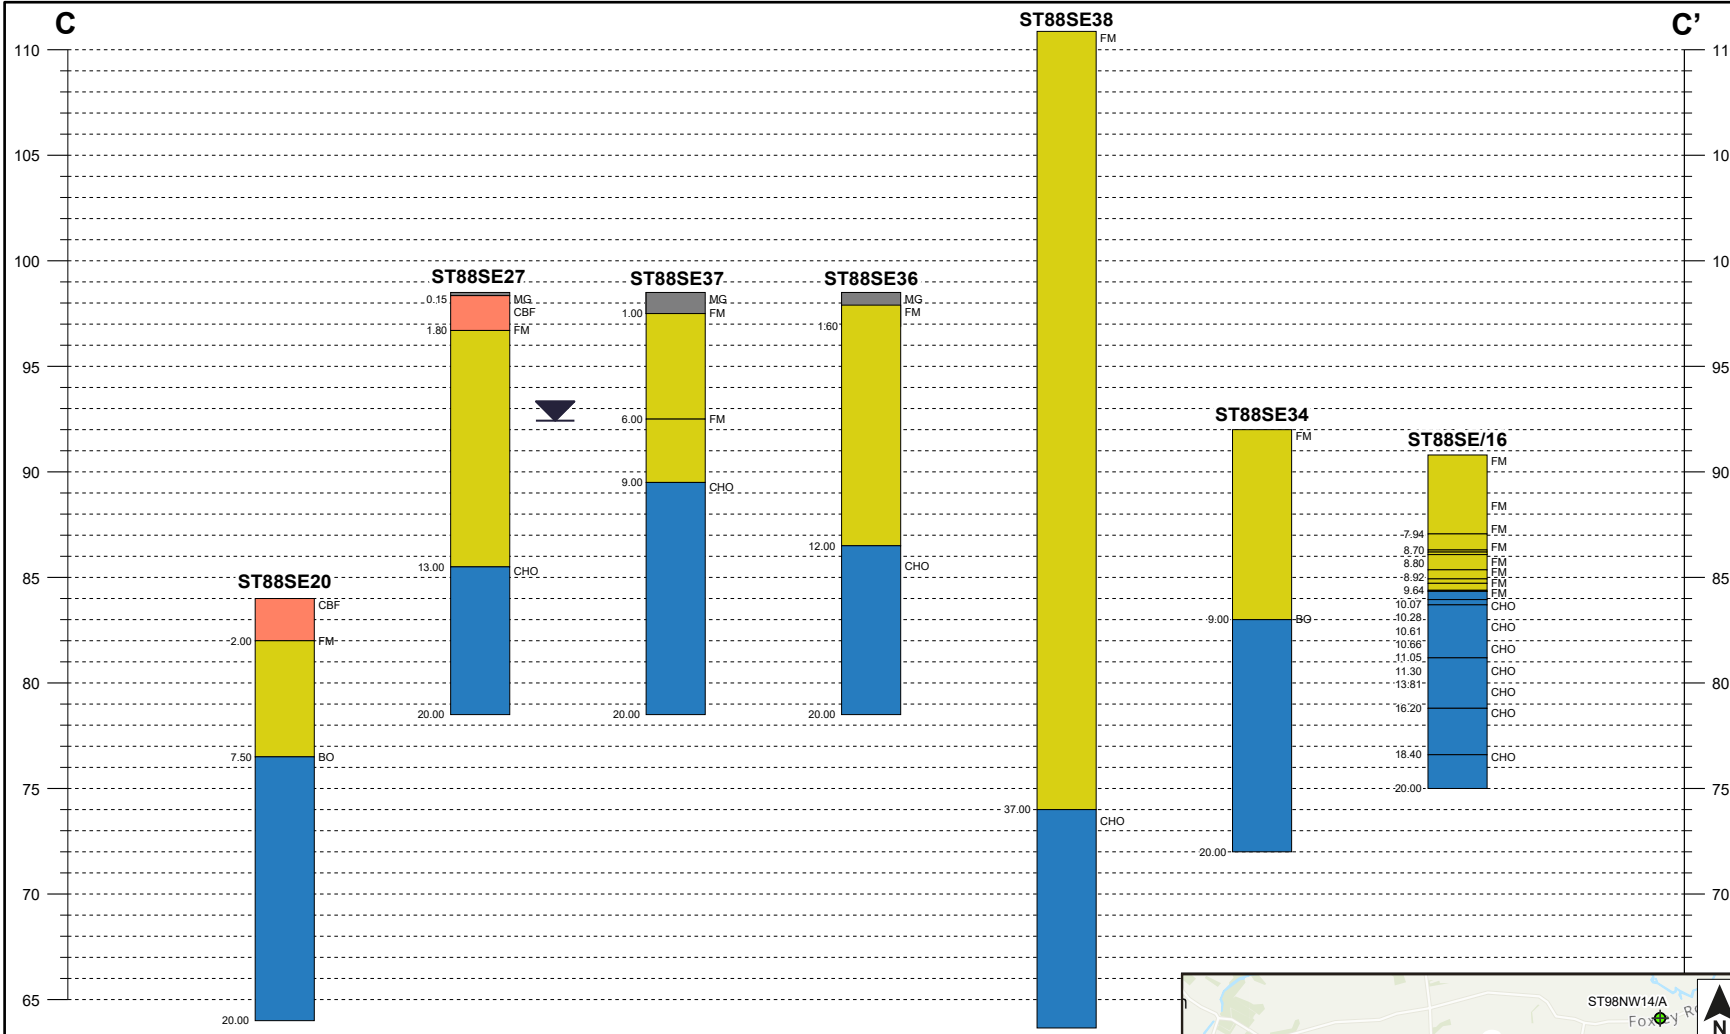
26008710-GEOS-LDSF-BESS-D-G-3004

4. Boreholes presented on the cross-section have been truncated at 50 m BGL for clarity and relevance. Geosyntec accepts no liability for ground conditions occurring below the depth of interpretation shown.

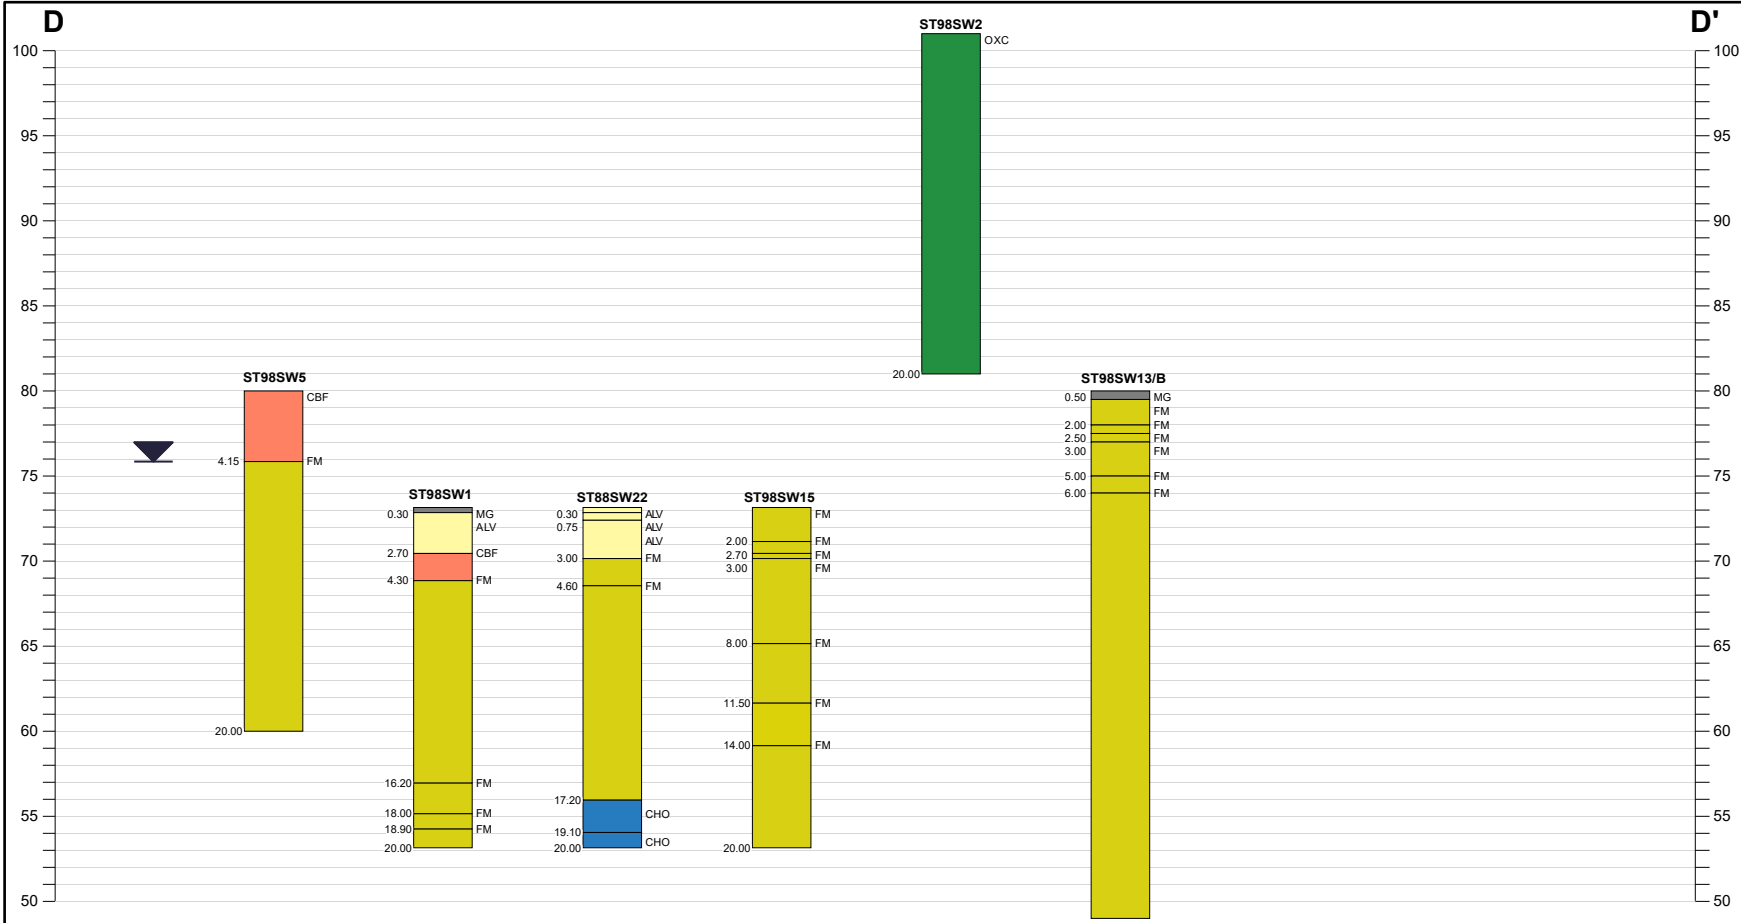
26008710-GEOS-LDSF-BESS-D-G-3005

4. Boreholes presented on the cross-section have been truncated at 50 m BGL for clarity and relevance. Geosyntec accepts no liability for ground conditions occurring below the depth of interpretation shown.
