# M42 Junction 6 Development Consent Order

# 8.11(a) Statement of Common Ground with Warwickshire Wildlife Trust

# **M42 Junction 6 Development Consent Order**

# STATEMENT OF COMMON GROUND WARICKSHIRE WILDLIFE TRUST

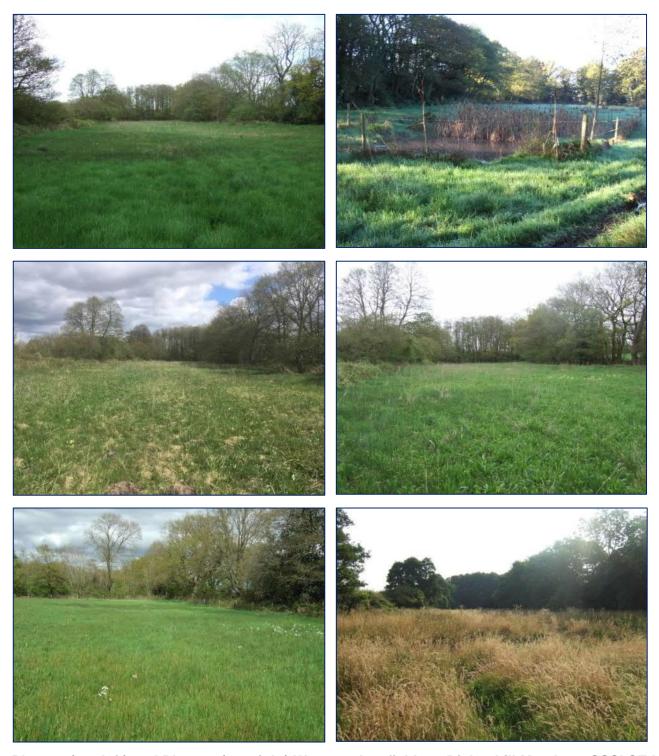
Photo 1 (top left) and Photo 2 (top right) Wet meadow fields at Bickenhill Meadows SSSI SE Unit / Shadowbrook Meadows LNR in cold/wet conditions; Photo 3 (middle left) Wet meadow fields at

Bickenhill Meadows SSSI SE Unit in warm/dry conditions; Photo 4 (middle right) and Photo 5 (bottom left) Bickenhill Meadows SSSI SE Unit in warm/dry conditions; Photo 6 (bottom right) Bickenhill Meadows SSSI unit southern field after a prolonged period of hot weather.

There is a small pond towards the centre of the southern field of the LNR site (but not within the SSSI) with emergent reed vegetation and which is surrounded by a stock proof fence (see Photo 2). The origins of the pond are not known, but when observed in very wet conditions a 'trickle' of water flowed from the pond and overland to the north to ultimately meet the tributary of Shadow Brook, possibly as a result of any undersoil drainage being blocked.

In the northeastern (wet) field of the SE SSSI unit, the ridge and furrow topography gives rise to diverse ecological communities. The furrows tend to be saturated and support grassland species designated as MG4 under the National Vegetation Classification (NVC). MG4 represents a nationally rare flood meadow community. Characteristic species include greater burnet (*Sanguisobra officinalis*) and meadowsweet (*Filipendula ulmaria*). The ridges are drier and support MG5 neutral grassland species with assemblages of English crested dog's tail (*Cynosurus cristatus*) and common knapweed (*Centaurea nigra*), amongst others. Subtle changes in colour across the wet meadow, shown in Photo 1, indicate the changes in vegetation across the site.

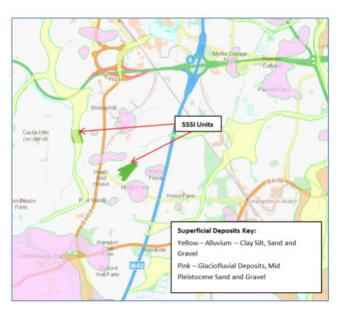
Figure 5. Superficial deposits in the area around Bickenhill Meadows SSSI (source: British Geological Survey Geoindex website, http://www.bgs.ac.uk/geoindex).

According to the British Geological Survey's Geology of Britain website (http://mapapps.bgs.ac.uk/geologyofbritain3d/) the bedrock geology beneath both SSSI units is Sidmouth Mudstone Formation (Mercia Mudstone) (Figure 4). No superficial deposits are recorded below the SE SSSI unit, while alluvium (clay, silt, sand and gravel) is mapped around the stream through the NW SSSI unit (Figure 5).

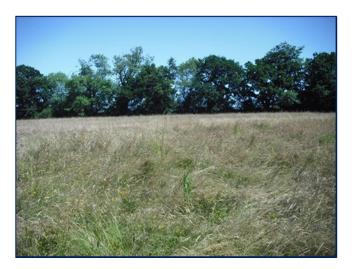
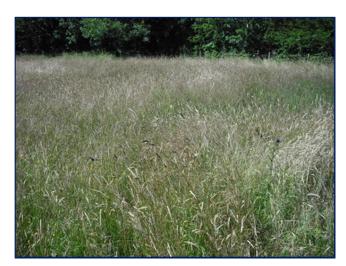
Photo 20 (left) and Photo 21 (right), typical vegetation in the SE SSSI unit eastern fields.

The two fields on the eastern side slope down to the watercourse and the vegetation on the day of the survey was grass dominated (tall and lodging in places) and dry (Photo 20 and 21). Yorkshire fog (Holcus lanatus) was abundant with other grasses such as cock's foot (Dactylis glomerata), common bent (Agrostis capillaris), red fescue (Festuca rubra), crested dog's tail (Cynosurus cristatus) and meadow fescue (Schedonorus pratensis). A range of generally common forbs were recorded and included ribwort plantain (Plantago lanceolata), common knapweed (Centaurea nigra), bird's foot trefoil (Lotus corniculatus) and red clover (Trifolium pratense). Less common species included yellow rattle (Rhinanthus minor) and tormentil (Potentilla erecta).

Seven quadrats were recorded in the two fields, as they were uniform in appearance and structure. The data obtained was run through TABLEFIT and the goodness of fit to the NVC community type MG5; Cynosurus cristatus - Centaurea nigra was around 83% and classed as very good fit. The second best fit was to the MG5a Lathyrus pratensis sub-community type.

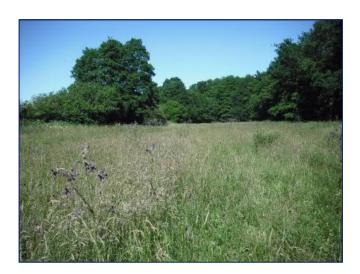
Photo 22 (left) and Photo 23 (right), typical vegetation in the SE SSSI unit wet meadow field.

The field within the SE SSSI unit on the western side of the watercourse was generally flat but with an apparent rise towards the northern boundary; the grasses did not dominate to the degree they did in the dry fields and there were patches of meadowsweet (*Filipendula ulmaria*) and great burnet (*Sanguisorba officinalis*) (Photo 22 and 23). Meadowsweet and other wetland species such as wild angelica (*Angelica sylvestris*) seemed to be more frequent towards the watercourse where the vegetation was taller and coarser. Interesting species recorded here were betony (*Stachys officinalis*) and tormentil (*Potentilla erecta*). It has been reported that meadow thistle (*Cirsium dissectum*) is also present but this was not found during the current survey.

Five quadrats were recorded in this western field and along with the data collected from similar vegetation recorded in the NW section of the SSSI (described below) were run through TABLEFIT. The goodness-of-fit to the NVC community type MG4; *Alopecurus pratensis* – *Sanguisorba officinalis* was around 63% and classed as a fair fit. Any variation in the vegetation from topographical variation was masked by the tall growth and a better understanding of this would be obtained once the field has been cut. This will provide information on the relationship of the community boundaries to topography, depth to water and ditch levels, and enable the communities to be tied with soils information to determine the mechanism whereby any vegetation changes are driven.

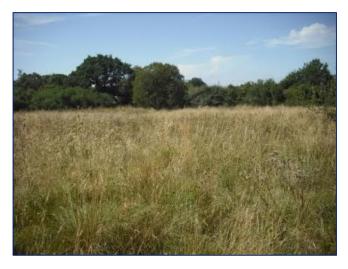
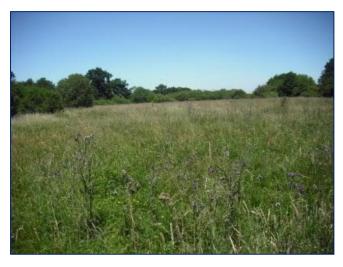
Photo 24 (left) and Photo 25 (right), typical vegetation in the NW SSSI unit western field.

The NW SSSI unit comprises two fields separated by a small, ephemeral watercourse, which was dry on the day of the survey. The western field appeared to be uniform in structure and was generally a mix of patches of larger forbs such as great burnet (Sanguisorba officinalis) and meadowsweet (Filipendula ulmaria), and grasses with a range of smaller forbs including several legumes scrambling through the vegetation (Photo 24 and Photo 25). This field appeared to be more diverse than the corresponding field in the SI SSSI unit and here saw-wort (Serratula tinctoria), quaking grass (Briza media) and devil's bit scabious (Succisa pratensis) were recorded in addition to the more typical and commoner forb species. When visited in August 2018, tufted hair grass (Deschampsia cespitosa) was the dominant species in this field.

Five quadrats were recorded in the field and along with the data collected from similar vegetation recorded in the SE SSSI unit were run through TABLEFIT. The goodness-of-fit to the NVC community type MG4; *Alopecurus pratensis* – *Sanguisorba officinalis* was around 63% and classed as a fair fit.

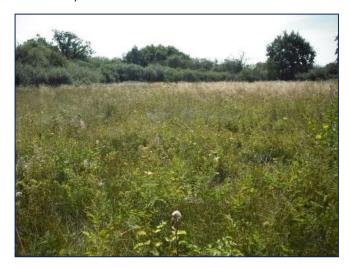
Photo 26 (left) and Photo 27 (right), typical vegetation in the NW SSSI unit eastern field.

The eastern field of the NW SSSI unit was only visited in August and had much coarser vegetation and the dominant grass across large areas was tufted hair grass (*Deschampsia cespitosa*) but with meadowsweet and great burnet also frequent throughout the field. Sedges appeared to be more common in this field and included hairy sedge (*Carex hirta*), false fox sedge (*Carex otrubae*), common sedge (*Carex nigra*) and tufted sedge (*Carex acuta*). Otherwise it was very similar to the western field (Photos 26 and 27).

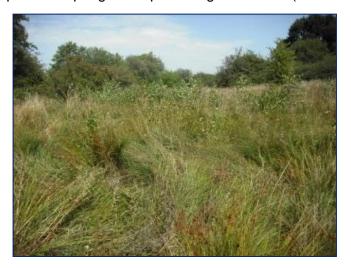
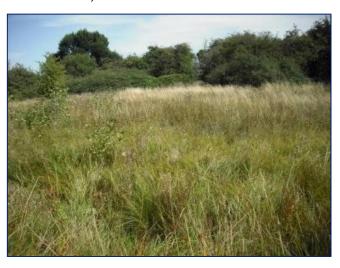
Photo 27 (left) and Photo 28 (right), typical vegetation in the distinct wetter area within the NW SSSI unit eastern field.

Part way along the western boundary of the field, there was a distinctive change in vegetation and whilst this will have to be shown by survey, it appeared to be delineated by a low spot, possibly linked to the ditch and was demarked by young alders (*Alnus glutinosa*). The vegetation here was dominated by tall rushes including soft rush (*Juncus effusus*), hard rush (*Juncus inflexus*) and sharp flowered rush (*Juncus acutiflorus*), along with sedges with abundant great hairy willowherb (*Epilobium hirsutum*) and in the wettest areas patches of fool's watercress (*Apium nodiflorum*). This is the area considered to be a potential spring in the preceding discussion (Photo 27 and Photo 28).

Five quadrats were recorded in this area and the data was run through TABLEFIT. The goodness-of-fit to the NVC community type OV26; *Epilobium hirsutum* community was around 58% and classed as a fair fit. A similar fit was obtained from the MG9 community; *Holcus lanatus-Deschampsia cespitosa* grassland. This community is found in area where the ground is seasonally waterlogged and can be found in association with MG4 grassland but is not usually as species diverse and is tolerant of less free draining soils.

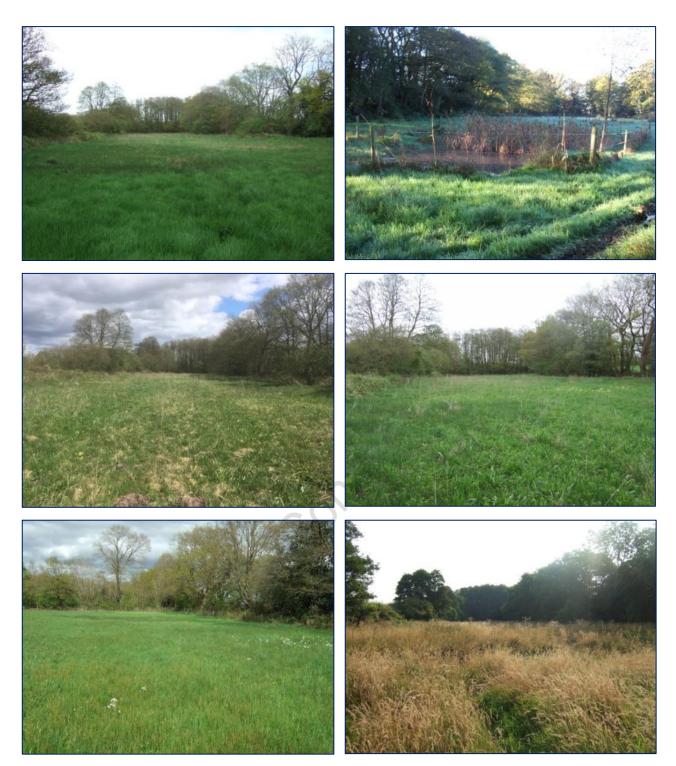
- There is a small pond towards the centre of the southern field of the LNR site (but not within the SSSI) with emergent reed vegetation and which is surrounded by a stock proof fence (see Photo 2). The origins of the pond are not known, but when observed in very wet conditions a 'trickle' of water flowed from the pond and overland to the north to ultimately meet the tributary of Shadow Brook, possibly as a result of any undersoil drainage being blocked. During the late summer of 2018 this pond was completely dry.

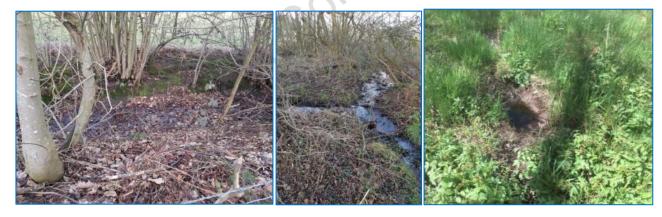
Photo 7 (left) Ponded water in agricultural drainage ditch at NW border of SE Unit; Photo 8 (right) confluence of the tributary of Shadow Brook and the drainage ditch within the alder woodland; Photo 9. Furrows and depressions saturated with water following rainfall in meadow field of SE Unit.

- There is also an ephemeral drainage ditch bordering the northwest of the site (Photo 7), which varies between 1m and 1.5m wide. This was largely dry on the majority of site visits, with some ponded water in places of 1-2cm depth adjacent to the upper wet meadow. However, when observed after heavy rain there was obvious flow in the ditch, which presumably was sourced from runoff from the adjacent arable field which slopes significantly down to the SSSI. As the ditch enters the alder woodland at the northern extent of the SSSI there was a small amount of flow even during the drier site visits, which drains into the tributary of Shadow Brook (approximate NGR SP 18950 81743), see Photo 8.

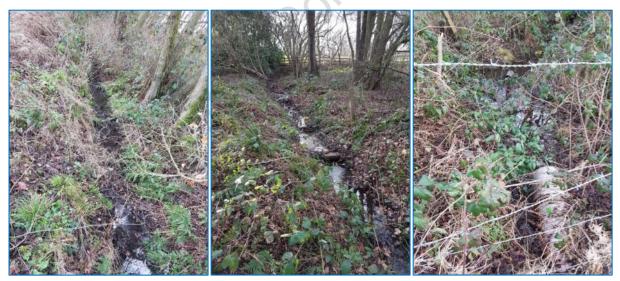
Photo 10 (left) and Photo 11 (centre): Tributary of Shadow Brook within the wet woodland. Photo 12: (right) Culvert exit downstream of the grassed land bridge.

Towards the centre of the SE SSSI Unit the brook is culverted under a grassed land bridge through a plastic pipe of around 400 mm diameter (Photo 12). Upstream the culvert is partially buried, and there is potential for impoundment of flow during extreme rainfall events, which may result in occasional flooding of the immediate grasslands, although there was no evidence of this. Several blockages across the stream from woody debris and accumulations of leaves were observed during the site visits, which again could cause localised impoundment of flows and encourage local out of bank events. Connectivity to the surrounding floodplain is good in some sections, particularly on the left bank in the northern field. However, the stream is not considered significant enough in size to cause widespread out of bank events across the grasslands and woodland, and Natural England and WWT are not aware of any widespread flooding at the site resulting from out of bank stream flows. However, the brook may locally support groundwater levels in the close vicinity of the channel, and it is possible that soil on either side has been compacted in places due to the past placing of dredgings, and this may influence soil hydrology on the upslope side by helping to maintain wetter ground conditions.

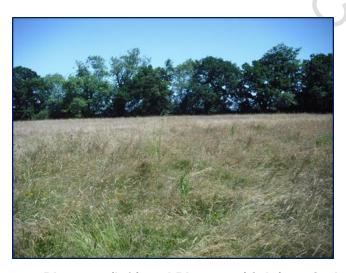
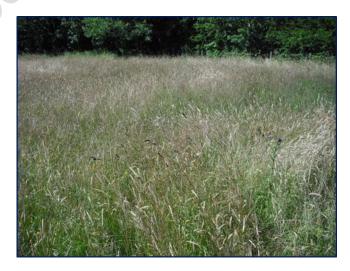
Photo 20 (left) and Photo 21 (right), typical vegetation in the SE SSSI unit eastern fields.

- 11.4 The two fields on the eastern side slope down to the watercourse and the vegetation on the day of the survey was grass dominated (tall and lodging in places) and dry (Photo 20 and 21). Yorkshire fog (Holcus lanatus) was abundant with other grasses such as cock's foot (Dactylis glomerata), common bent (Agrostis capillaris), red fescue (Festuca rubra), crested dog's tail (Cynosurus cristatus) and meadow fescue (Schedonorus pratensis). A range of generally common forbs were recorded and included ribwort plantain (Plantago lanceolata), common knapweed (Centaurea nigra), bird's foot trefoil (Lotus corniculatus) and red clover (Trifolium pratense). Less common species included yellow rattle (Rhinanthus minor) and tormentil (Potentilla erecta).

- 11.5 Seven quadrats were recorded in the two fields, as they were uniform in appearance and structure. The data obtained was run through TABLEFIT and the goodness of fit to the NVC community type MG5; *Cynosurus cristatus Centaurea nigra* was around 83% and classed as very good fit. The second best fit was to the MG5a *Lathyrus pratensis* sub-community type.
- 11.6 The field within the SE Unit on the western side of the watercourse was generally flat but with an apparent rise towards the northern boundary; the grasses did not dominate to the degree they did

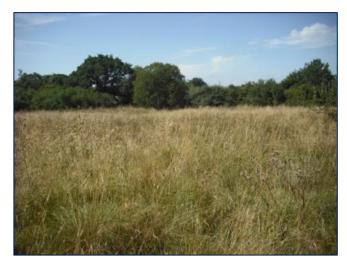
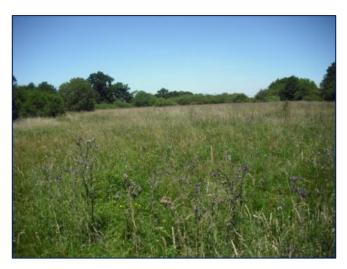
Photo 24 (left) and Photo 25 (right), typical vegetation in the NW SSSI unit western field.

- 11.8 The NW Unit comprises two fields separated by a small, ephemeral watercourse, which was dry on the day of the survey. The western field appeared to be uniform in structure and was generally a mix of patches of larger forbs such as great burnet (*Sanguisorba officinalis*) and meadowsweet (*Filipendula ulmaria*), and grasses with a range of smaller forbs including several legumes scrambling through the vegetation (Photo 24 and Photo 25). This field appeared to be more diverse than the corresponding field in the SE Unit and here saw-wort (*Serratula tinctoria*), quaking grass (*Briza media*) and devil's bit scabious (*Succisa pratensis*) were recorded in addition to the more typical and commoner forb species. When visited in August 2018, tufted hair grass (*Deschampsia cespitosa*) was the dominant species in this field.

- 11.9 Five quadrats were recorded in the field and along with the data collected from similar vegetation recorded in the SE SSI unit were run through TABLEFIT. The goodness-of-fit to the NVC community type MG4; *Alopecurus pratensis Sanguisorba officinalis* was around 63% and classed as a fair fit.
- 11.10 The eastern field of the NW Unit was only visited in August 2018 and had much coarser vegetation and the dominant grass across large areas was tufted hair grass (*Deschampsia cespitosa*) but with meadowsweet and great burnet also frequent throughout the field. Sedges appeared to be more common in this field and included hairy sedge (*Carex hirta*), false fox sedge (*Carex otrubae*), common sedge (*Carex nigra*) and tufted sedge (*Carex acuta*). Otherwise it was very similar to the western field (Photos 26 and 27).

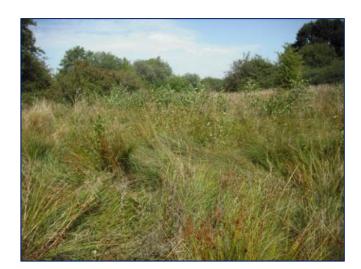
Photo 27 (left) and Photo 28 (right), typical vegetation in the distinct wetter area within the NW SSSI unit eastern field.

11.11 Part way along the western boundary of the field, there was a distinctive change in vegetation and whilst this will have to be shown by survey, it appeared to be delineated by a low spot, possibly linked to the ditch and was demarked by young alders (*Alnus glutinosa*). The vegetation here was dominated by tall rushes including soft rush (*Juncus effusus*), hard rush (*Juncus inflexus*) and sharp flowered rush (*Juncus acutiflorus*), along with sedges with abundant great hairy willowherb (*Epilobium hirsutum*) and in the wettest areas patches of fool's watercress (*Apium nodiflorum*). This is the area considered to be a potential spring in the preceding discussion (Photo 27 and Photo 28).

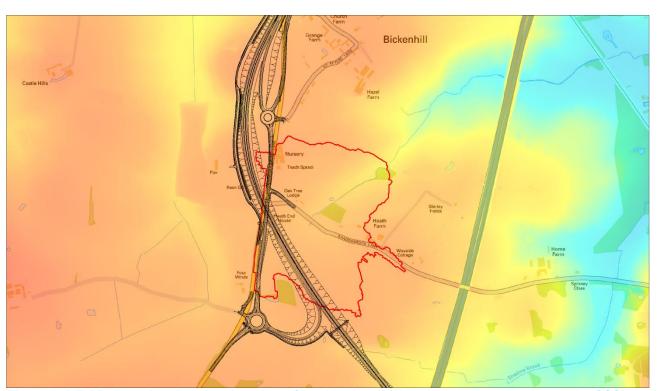
Figure 2: LiDAR data showing the elevation of land in the catchment area contributing to the SSSI

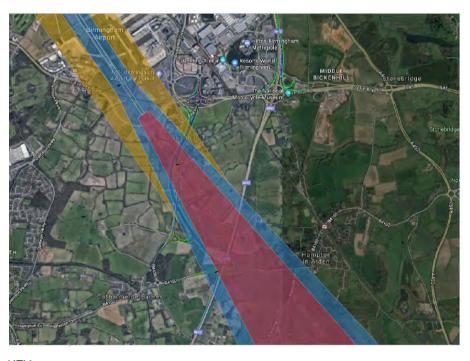
- Key Environmental Constraints
  - Meridan Gap Green Belt
  - Aspbury's Copse and Barbers Coppice Scheduled Ancient Woodland
  - Bickenhill Meadows SSSI
  - River Blythe SSSI
- Airport Constrains
  - CAA Safeguarding Surfaces
  - Influencing the wider scheme design and mitigation strategy
  - Limits on infrastructure heights during and post construction
  - Bird management-open water restrictions subject on going discussions with airport and EA.
