# **A585 Windy Harbour to Skippool Improvement Scheme**

**TR010035**

## **7.30 Draft Archaeological Mitigation Strategy and Preliminary WSI**

# **Interim Report 1: A585 Windy Harbour to Skippool Improvement Scheme Archaeological Evaluation**

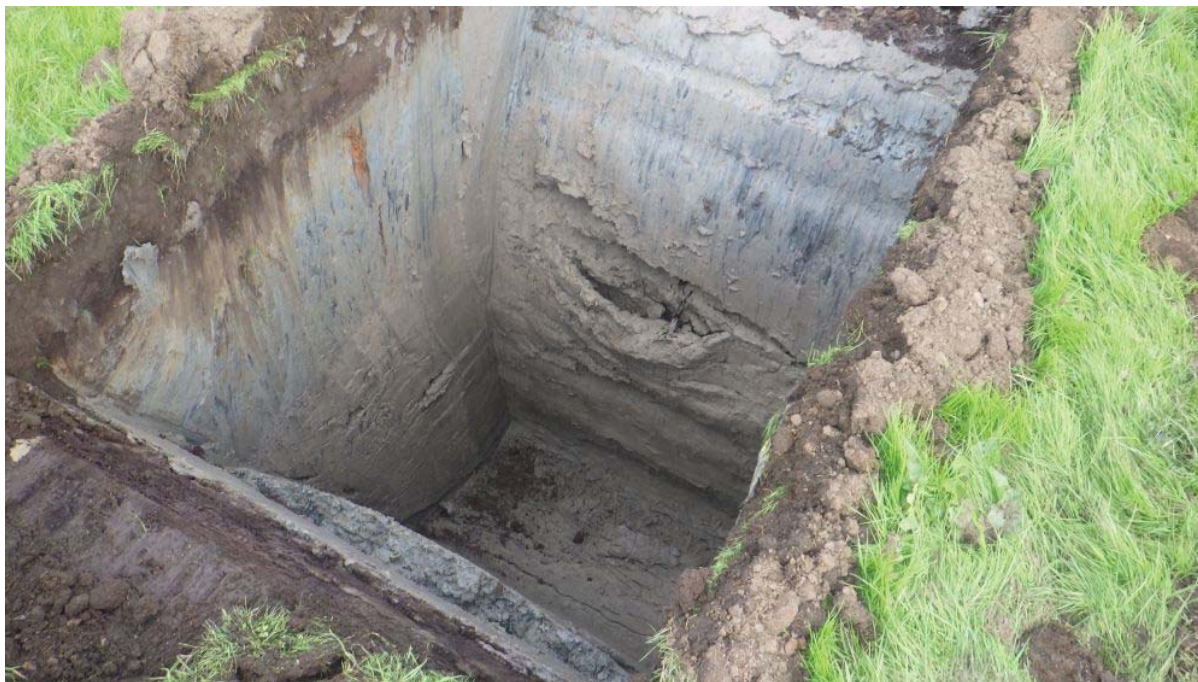
Plate 1: Topsoil over a thin layer of peat, sealing alluvium and tidal-flat deposits

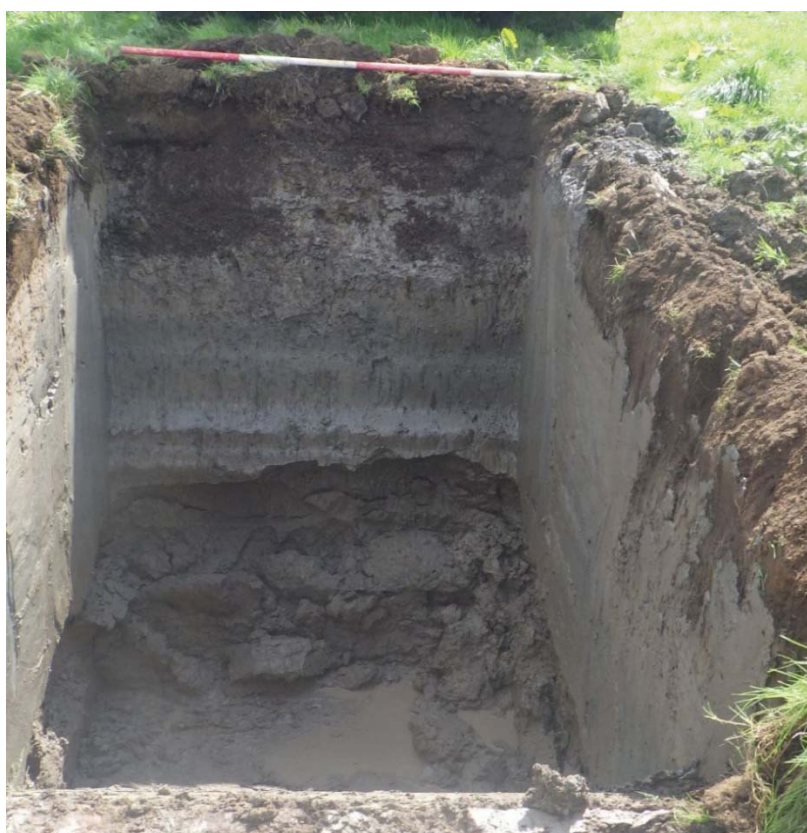
Plate 2: Topsoil over a thin layer of peat, sealing laminated alluvial and tidal-flat deposits (2m scale)

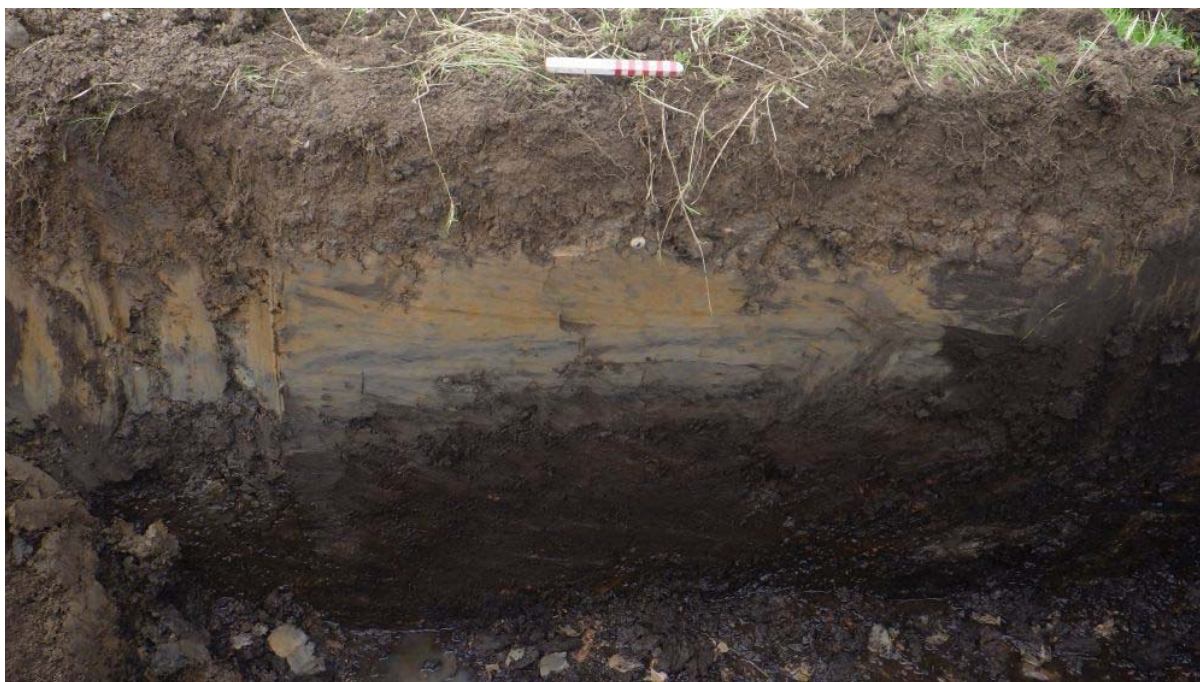
Plate 3: Trench 33: topsoil over a thin layer of alluvium, sealing peat deposits (200mm scale)

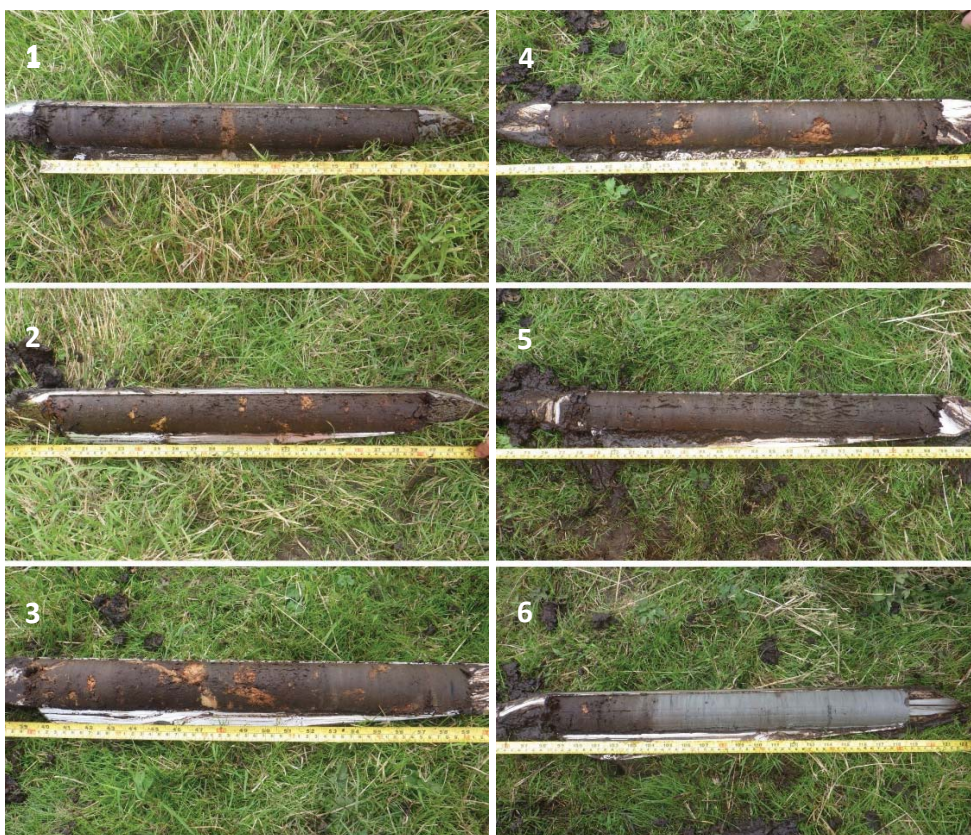
Plate 4: Trench 33: 200mm cores of peat (1-6) sealing tidal-flat deposits (6)

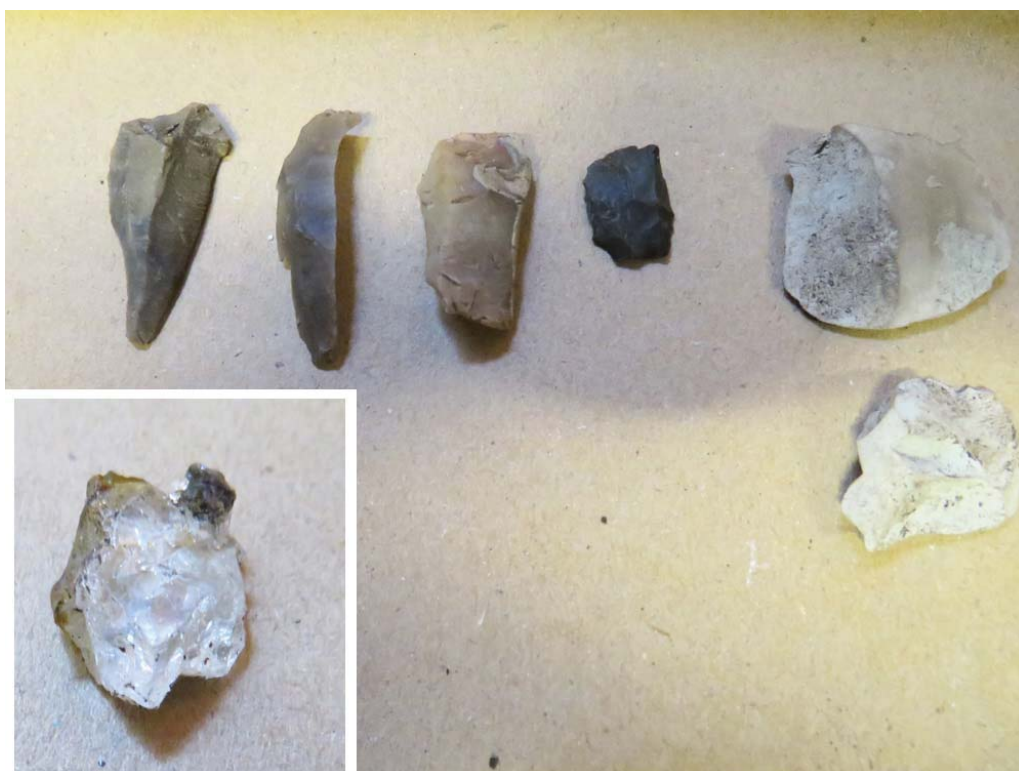
Plate 6: Flaked lithics: three flint blades (Test Pit 5; top left) and a chert flake (Trench 24; top centre); two Langdale tuff axe reduction flakes (Trench 24; right); rock crystal (Trench 24; bottom left)

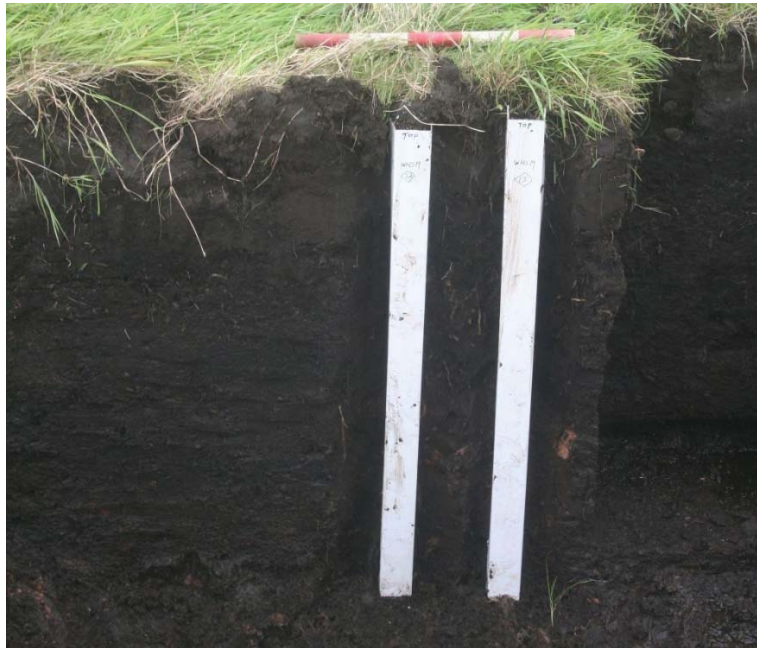
Plate 7: Peat in Trench 24 (scale 0.5m); the axe reduction flakes were from 0.6m below ground, 0.5m to the right of the monoliths

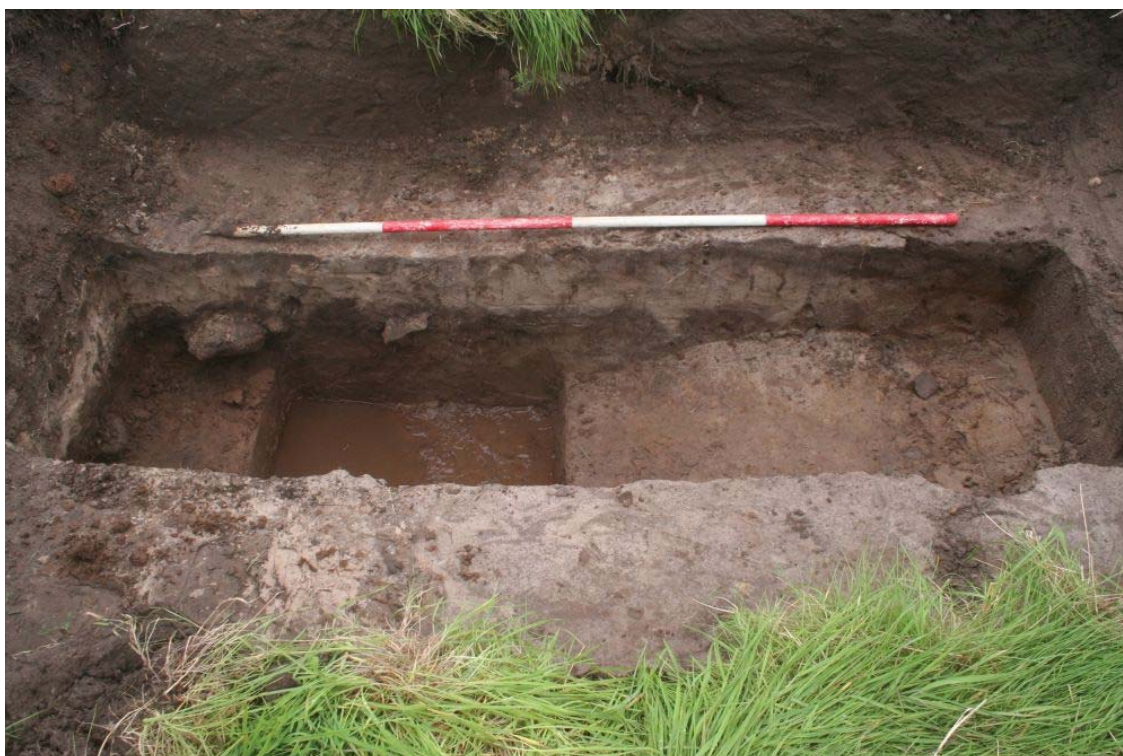
Plate 9: Test Pit 5: sands sealing silts – both buried soils (possible *polissoir* has been removed, from just below point of 2m scale)

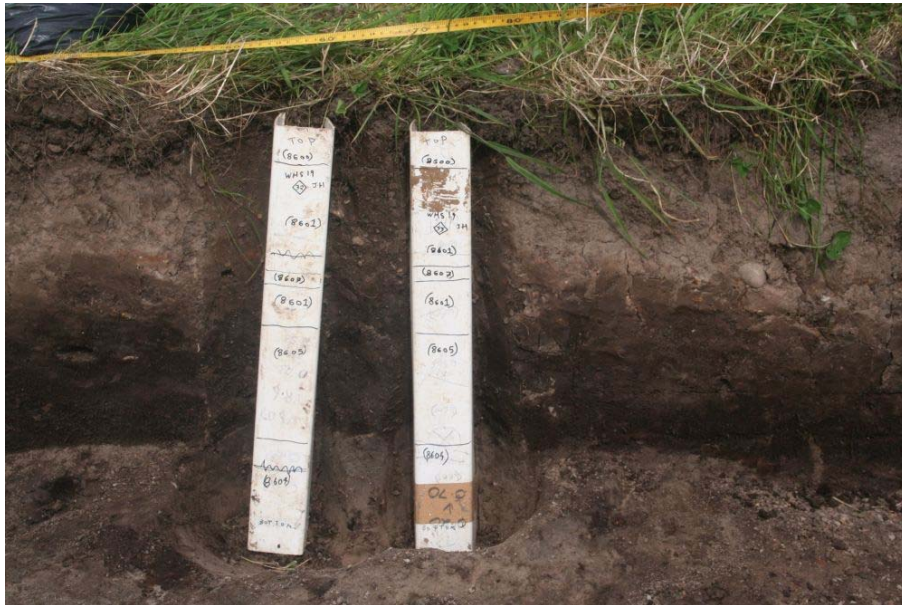
Plate 11: Monolith samples (0.5m) placed through the sand and charcoal-rich silts (both buried soils) in Test Pit 5

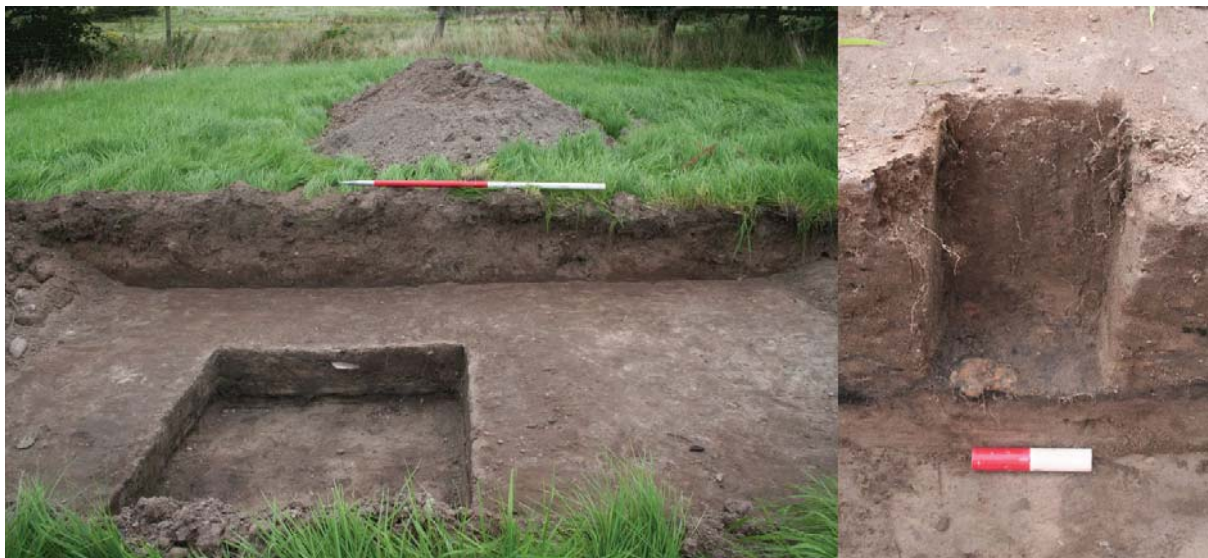
Plate 12: Test Pit 13: charcoal-rich buried soils revealed in test pit (left, 1m scale); pottery *in-situ* within charcoal rich layer (right, 100mm scale)

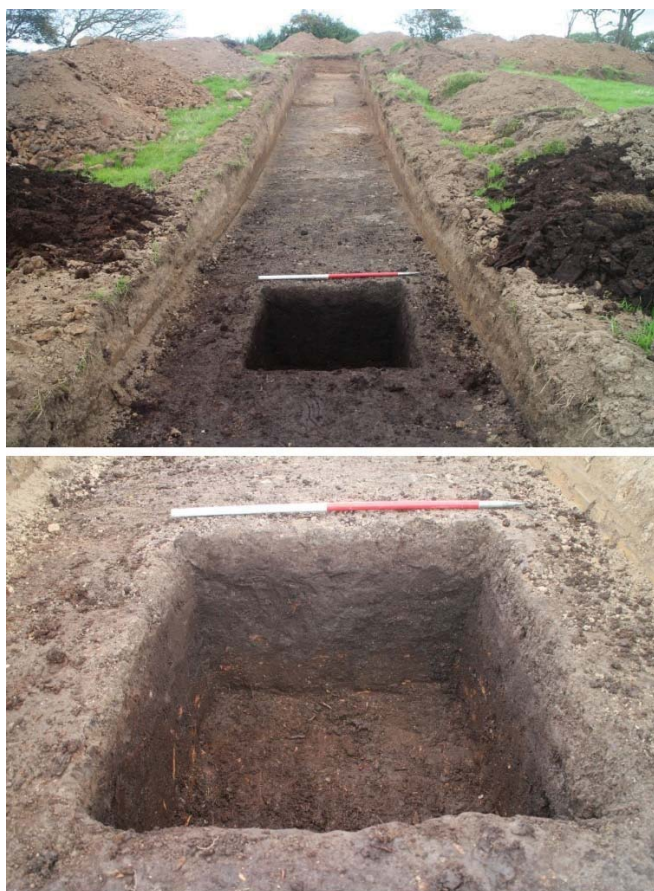
Plate 13: Trench 58: test pit excavated in the peats at the foot of the raised area, grey silty buried soils visible under redeposited material, with orange glacial till at top of slope (looking north; 1m scale)

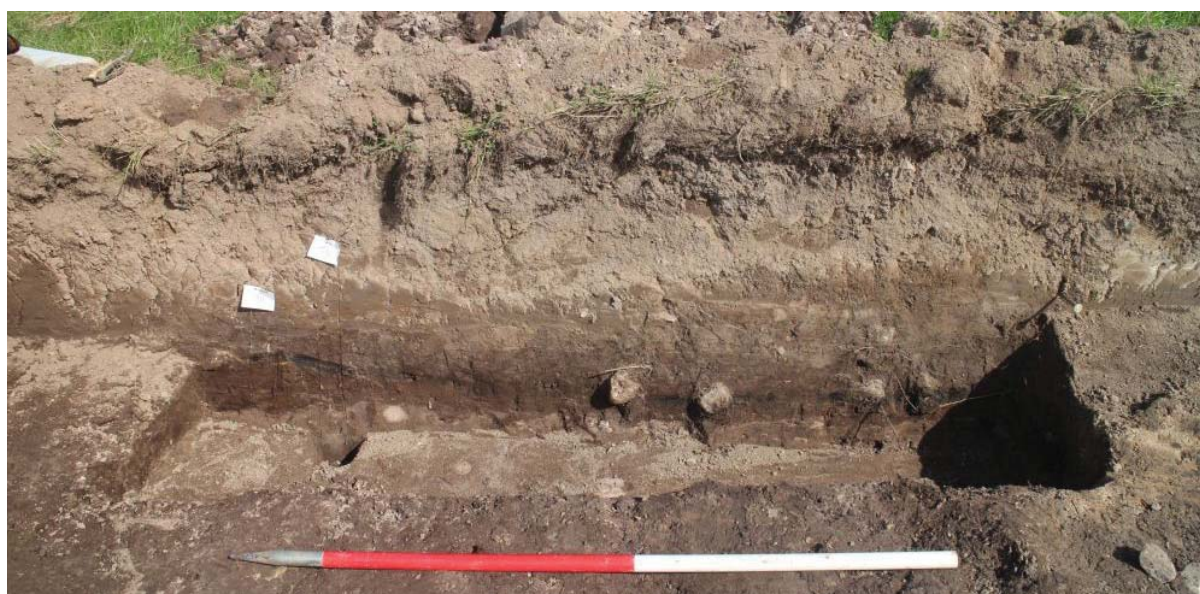
Plate 14: Trench 58 (western arm): shallow, concave feature with charcoal rich fills (1m scale)

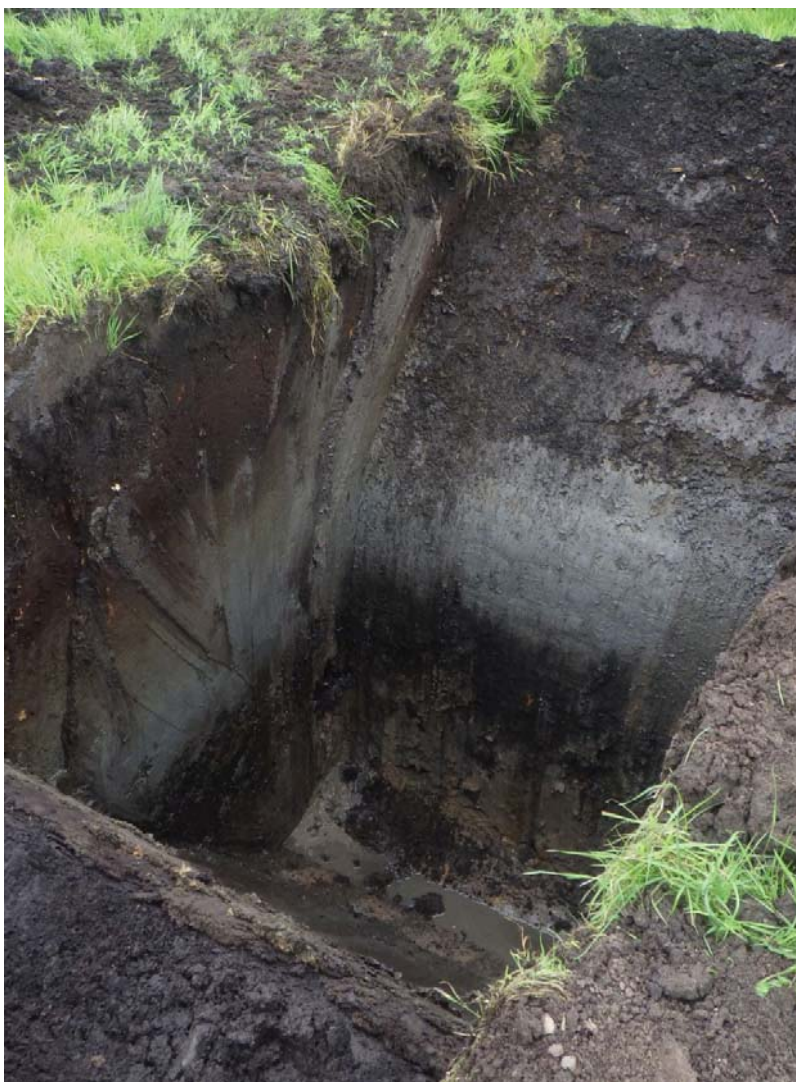
Plate 15: Trench 31: peat layers separated by a layer of alluvial/tidal-flat deposits
