PORTISHEAD BRANCH LINE (METROWEST PHASE 1)
DCO SCHEME

Tree Survey Report

North Somerset Council

July 2018

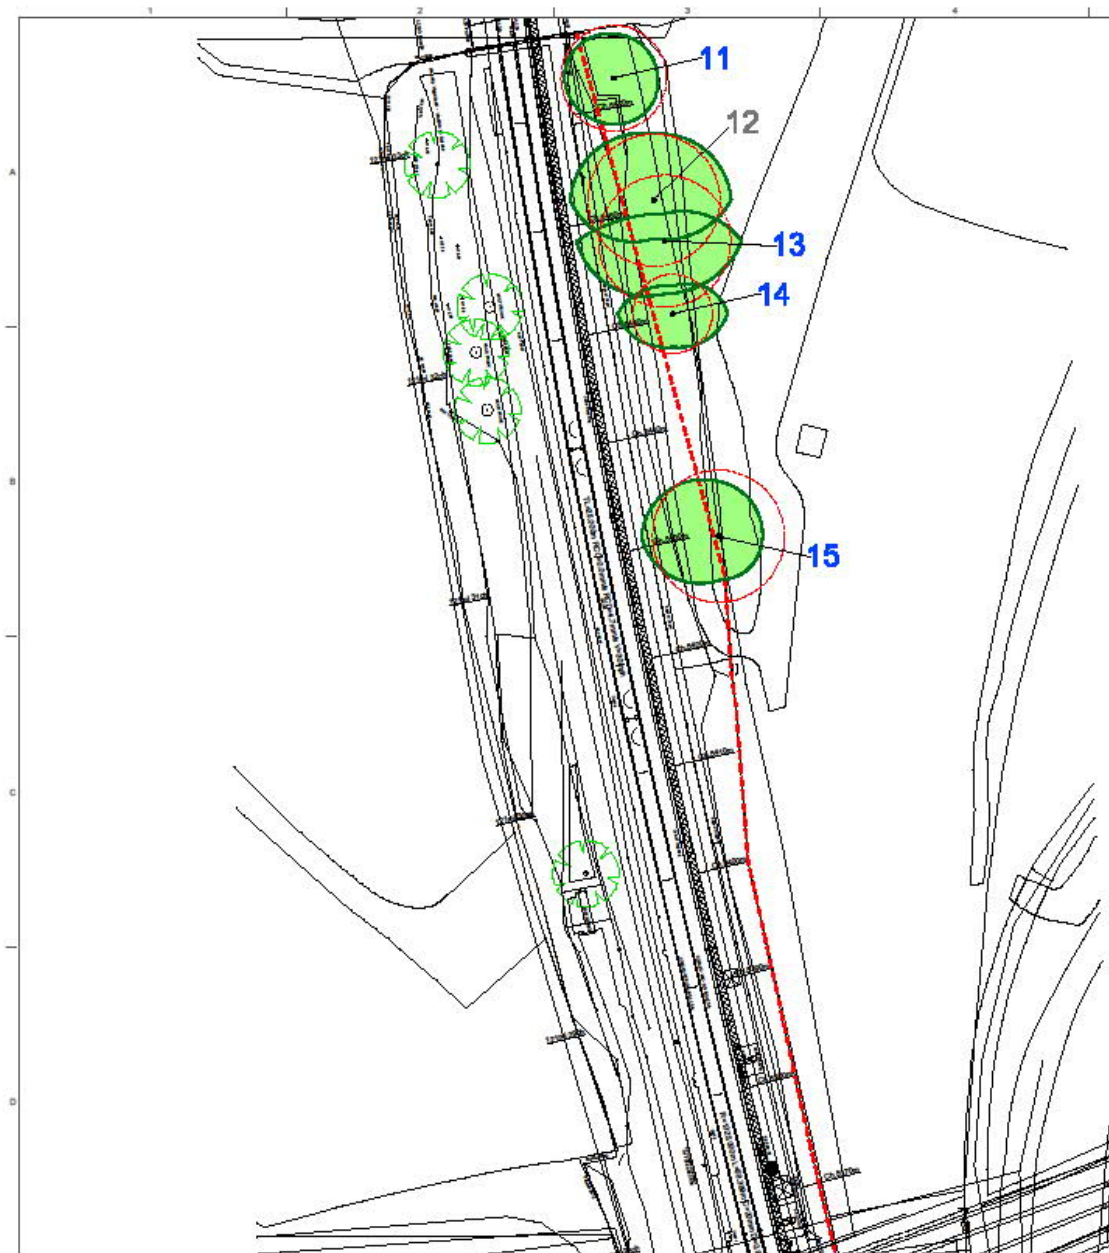
Drawing No:	FIGURE 4
Drawing Scale:	1:250 @ A1

- 1.1.5 This report details the methodology of the survey and provides plans showing tree locations, canopy sizes, indicative Root Protection Areas (RPA) and classification with an accompanying tree schedule for the site.

Drawing
**TREE SURVEY PLAN
AUGUST 2020
SHEET 1 OF 4**

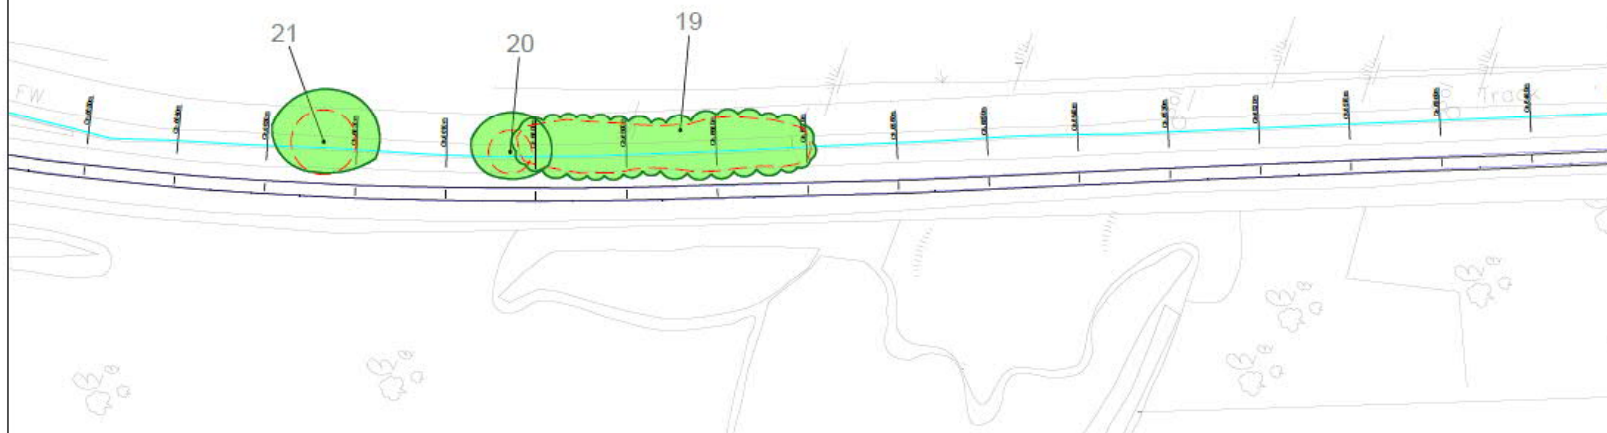
Drawn by: MBAS	Date: 19/09/2020
Checked by: AL	Date: 21/09/2020
Approved by: CF	Date: 21/09/2020
Drawing No:	FIGURE 5
Revision:	-

Drawing
TREE SURVEY PLAN
AUGUST 2020
SHEET 2 OF 4
