# MetroWest+

## Portishead Branch Line (MetroWest Phase 1)

**6.25, Environmental Statement, Volume 4, Appendix 9.11, Avon Gorge Vegetation Management Plan**

**Author: CH2M**

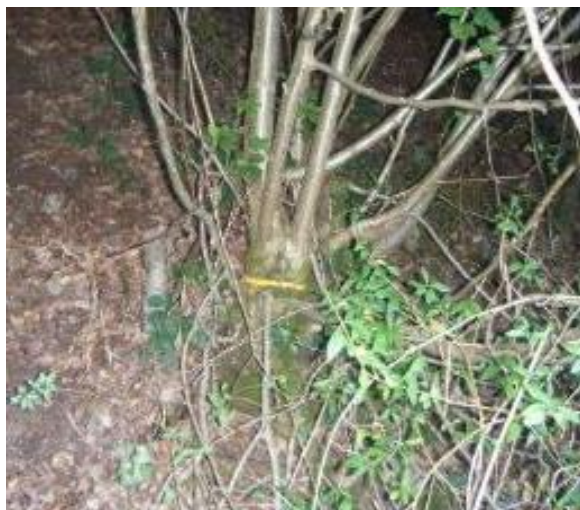
*Plastic yellow collars installed to facilitate the identification of sensitive species during works along the freight line. A number of these collars are now constricting the plant which they demarcate and should be removed to prevent growth restriction and death of the tree.*

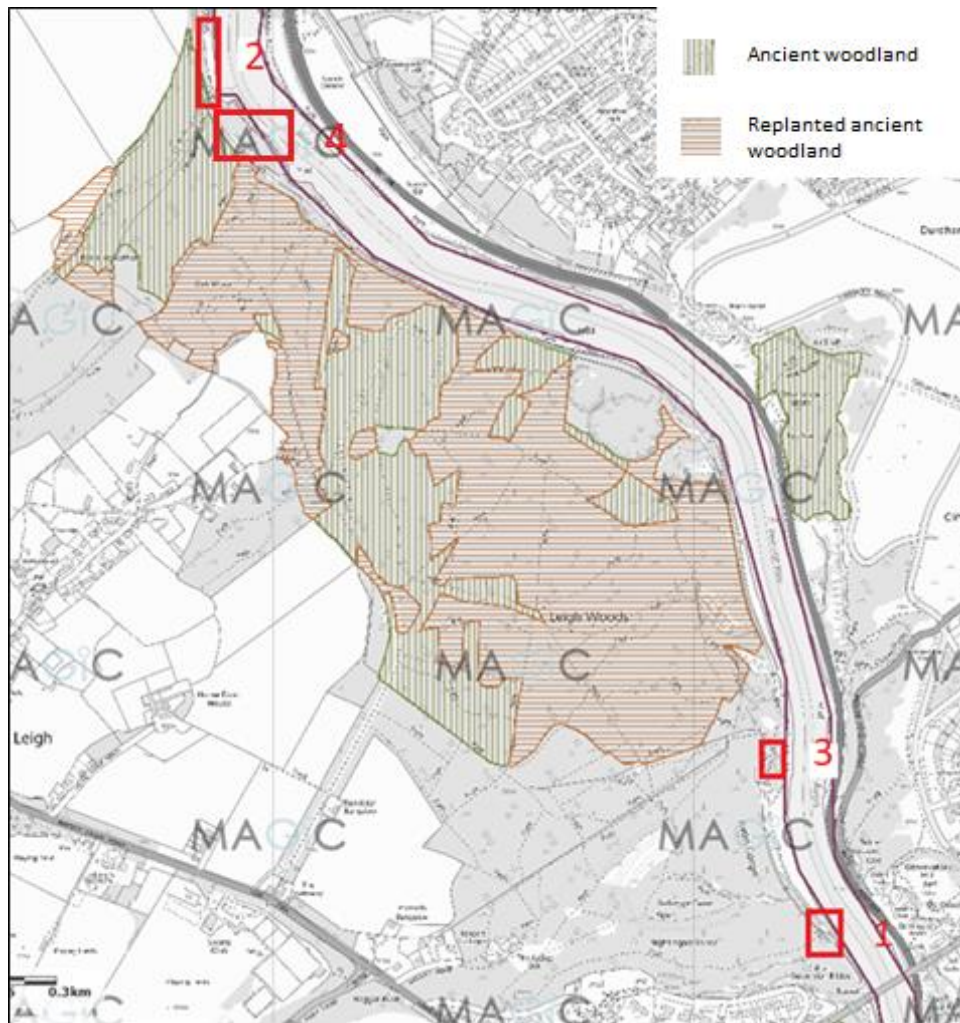
**Figure 1. Map showing Ancient Woodland Inventory for Leigh Woods (accessed 18 June 2019) and the four planting sites.**

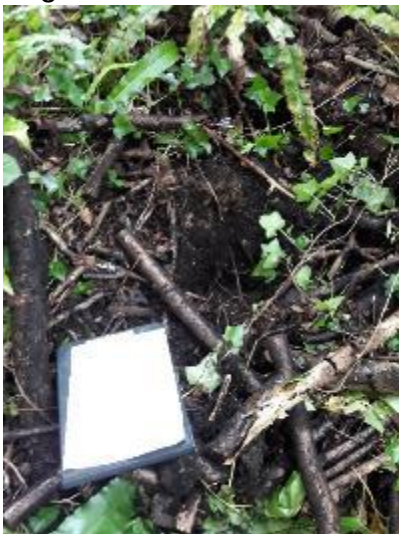
| Soil pit | Grid reference | Assessment | Soil profile | Suitable for planting |
|---|---|---|---|---|
| 4 | ST56272.73<br>255 | North-east facing man-made embankment | <p>Surface: Leaf mould/ivy, lots of cut decaying tree trunks</p> <p>0-40+ cm: deep brown earthy loam with roots and some clinker, with larger stones 20 cm across at base.</p> | yes |

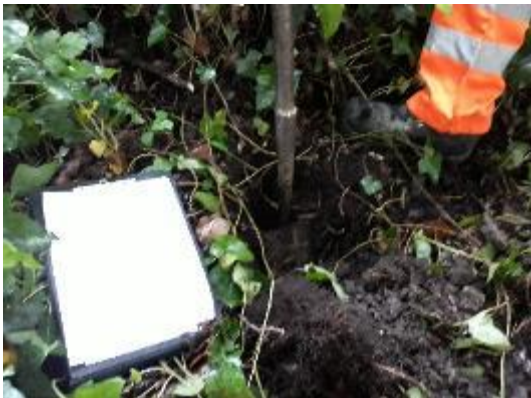
| Soil pit | Grid reference | Assessment | Soil profile | Suitable for planting |
|---|---|---|---|---|
| 5 | ST56284.73<br>241 | North-east facing man-made embankment | <p>Surface: Leaf mould/ivy.</p> <p>0-10 cm: brown loamy earth with a little clay with roots and small clinker/stones, possibly material discarded from railway bed.</p> <p>10-20 cm: larger ballast stones mixed with brown earth.</p> <p>20 cm+: larger stones and some earth</p> | yes |

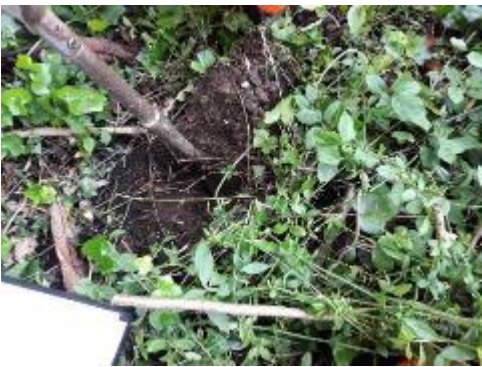
| <b>Soil pit</b> | <b>Grid reference</b> | <b>Assessment</b> | <b>Soil profile</b> | <b>Suitable for planting</b> |
|---|---|---|---|---|
| 7 | ST54841.75258 | East facing man-made embankment | <p>Surface: Leaf mould/ivy, lots of cut decaying tree trunks</p> <p>0-7.5 cm: blackish stony earth with grit and small stones</p> <p>7.5-40 + cm: light brown stony earth</p> | yes |

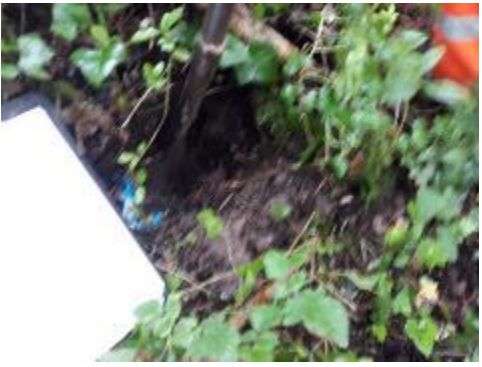
| <b>Soil pit</b> | <b>Grid reference</b> | <b>Assessment</b> | <b>Soil profile</b> | <b>Suitable for planting</b> |
|---|---|---|---|---|
| 8 | ST54848.75230 | East facing man-made embankment | <p>Surface: Leaf mould/ivy.</p> <p>0-40+ cm: brown clayey earth with little clinker/stones</p> | yes |

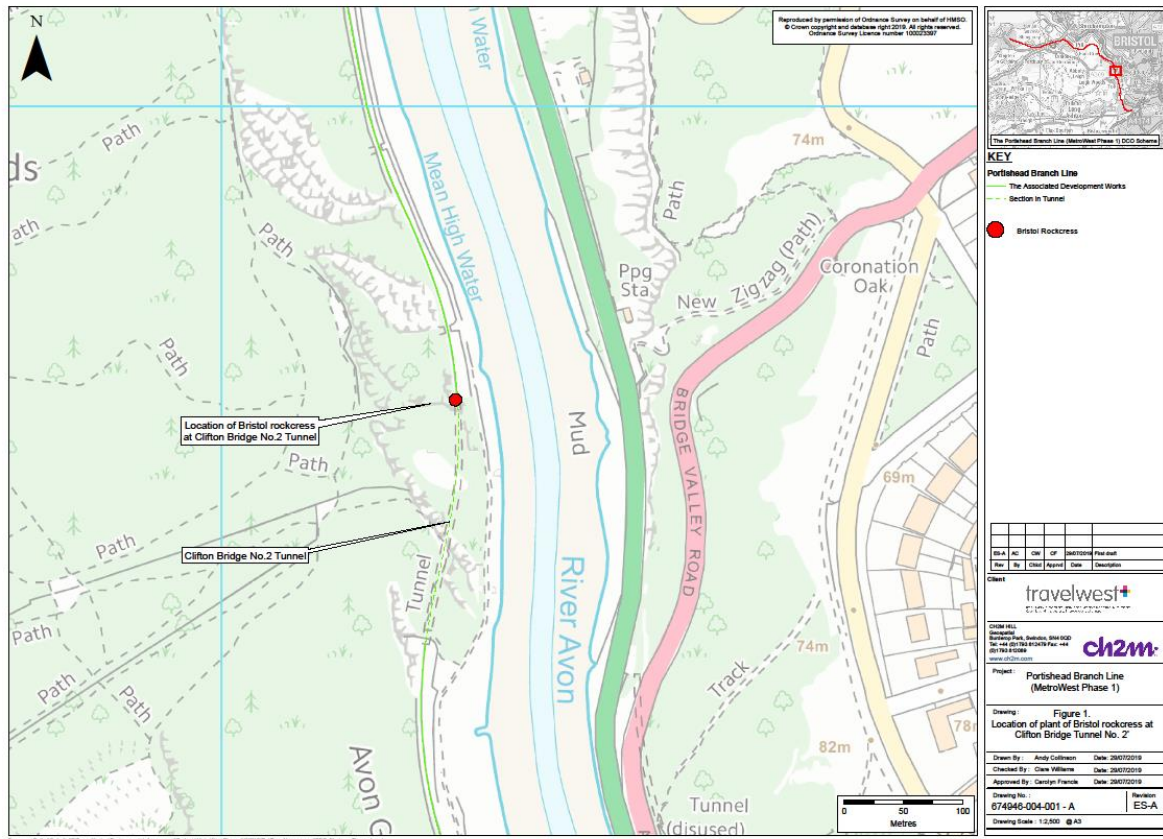
**Figure 1. Location of plant of Bristol rockcress at Clifton Bridge Tunnel No. 2**

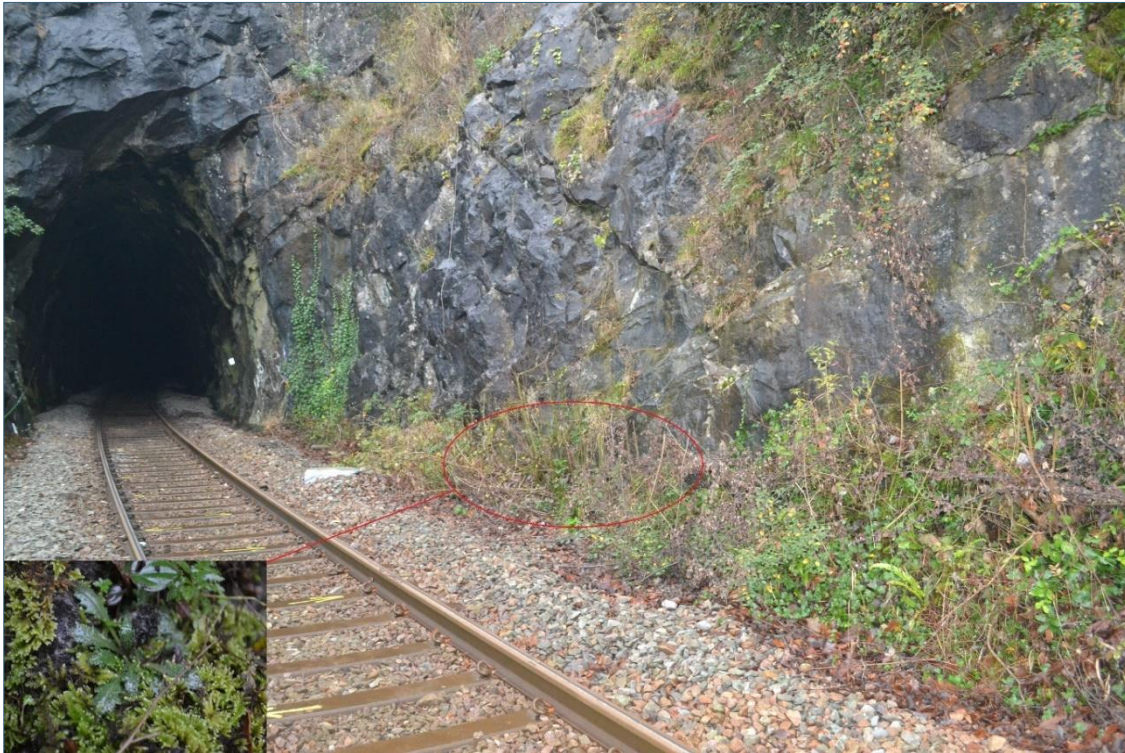
**Figure 2. Approximate location of Bristol rockcress on ledge just outside the Portishead portal of Clifton Bridge Tunnel 2. Inset bottom left: the Bristol rockcress plant in moss.**

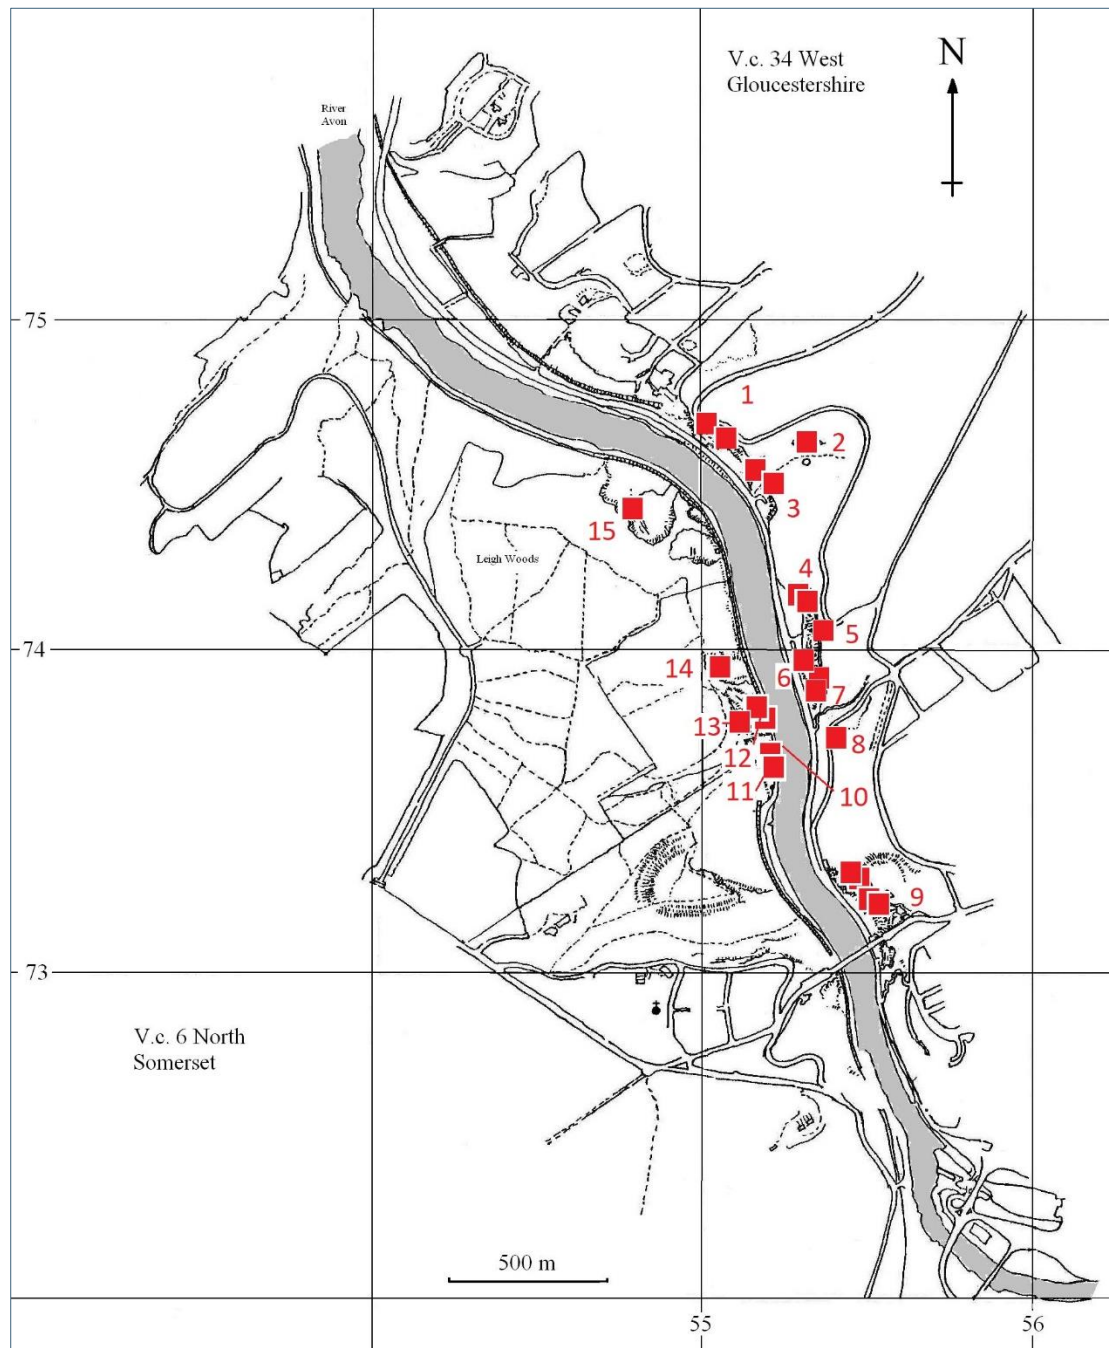
**Figure 3. Distribution of Bristol rockcress in the Avon Gorge.** Site numbering follows Table 1.

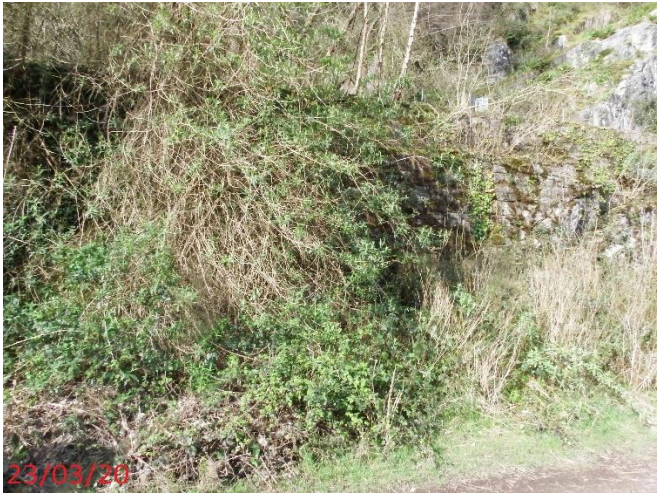
| <b>Arisings location number and temporary storage and/or deadwood provision</b> | <b>Nearest positive management areas (Figure 1)</b> | <b>Proposed number of felled trees to be left for deadwood provision</b> | <b>Location Description</b> | <b>Photograph</b> |
|---|---|---|---|---|
| 1. Temporary - duration of the tree works in the area plus a maximum of 2 months afterwards. | G1 | n/a | <p>Area (approx. 1.5m x 4m) of bramble and buddleia adjacent to the tow path. Would need to remove buddleia and treat the stumps with herbicide to establish location for arisings. No arisings to be placed on area of patchy brambles to the north. Suitable for temporary storage.</p> <p>Photo taken date: 23 March 2020</p> | |

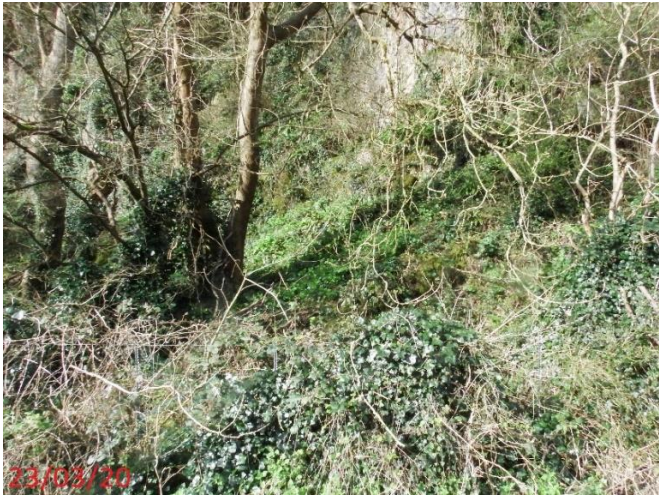
| Arisings location number and temporary storage and/or deadwood provision | Nearest positive management areas (Figure 1) | Proposed number of felled trees to be left for deadwood provision | Location Description | Photograph |
|---|---|---|---|---|
| 2. Temporary (duration of the tree works in the area plus a maximum of 2 months afterwards) and deadwood provision | G1 | 2 | <p>Area (approx. 6m x 4m) at base of quarry in secondary woodland, just behind the rail line fence. Suitable for temporary storage and deadwood provision.</p> <p>Photo taken date: 23 March 2020</p> | |

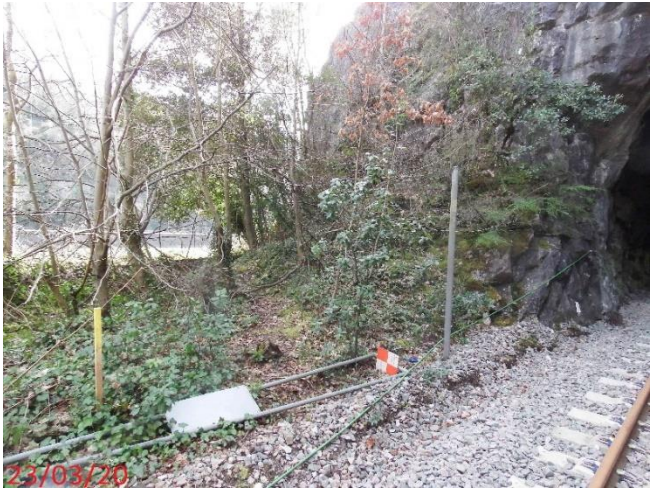
| Arising location number and temporary storage and/or deadwood provision | Nearest positive management areas (Figure 1) | Proposed number of felled trees to be left for deadwood provision | Location Description | Photograph |
|---|---|---|---|---|
| 9. Temporary (duration of the tree works in the area plus a maximum of 2 months afterwards) | G14 | n/a | <p>Area (approx. 2m x 4m) on the tow path side adjacent to Clifton Bridge No. 2 tunnel, below the cliff. The holm oak saplings in this area could be cleared and stumps treated with herbicide to increase the area available for arisings. Suitable for temporary storage.</p> <p>Photo taken date: 23 March 2020</p> | |

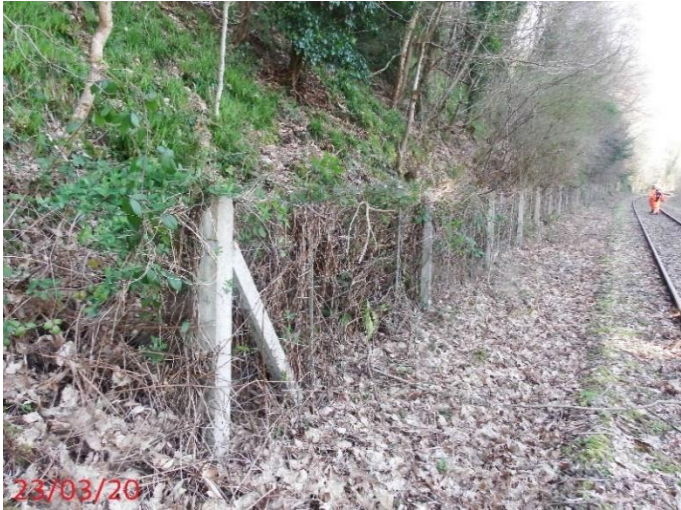
| Arisings location number and temporary storage and/or deadwood provision | Nearest positive management areas (Figure 1) | Proposed number of felled trees to be left for deadwood provision | Location Description | Photograph |
|---|---|---|---|---|
| 18. Temporary - for the duration of the line blockage only | G18 & G19 | n/a | <p>A band approx. 1m x 30m on the edge of the ballast adjacent to a concrete post and wire fence is suitable for temporary storage for the duration of the line blockage only.</p> <p>Photo taken date: 23 March 2020</p> | |

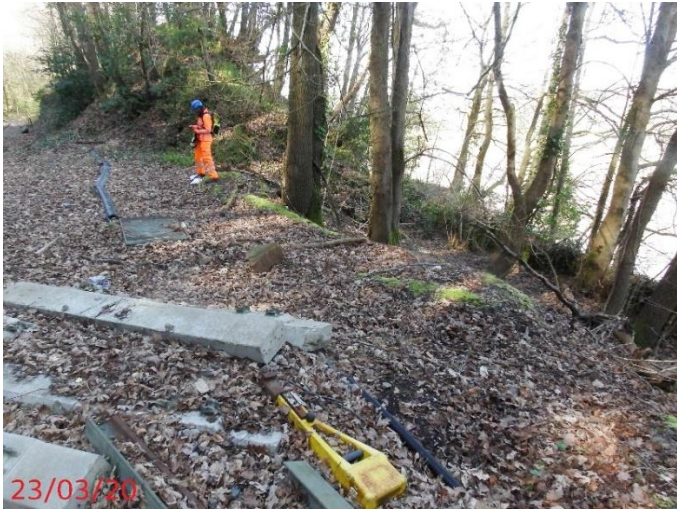
| Arisings location number and temporary storage and/or deadwood provision | Nearest positive management areas (Figure 1) | Proposed number of felled trees to be left for deadwood provision | Location Description | Photograph |
|---|---|---|---|---|
| 20. Temporary (for the duration of the line blockage only) | G20 & G21 | n/a | <p>Broad area of ballast (approx. 10m x 3m in extent) opposite a metal rock fall barrier just to the south of G21. Suitable for temporary storage for the duration of the line blockage only.</p> <p>Photo taken date: 23 March 2020</p> | |
