Hampshire Water Transfer and Water Recycling Project

Environmental Statement – Appendix 19.2 Water Environment Regulations compliance assessment

APPLICATION DOCUMENT REFERENCE: 6.2

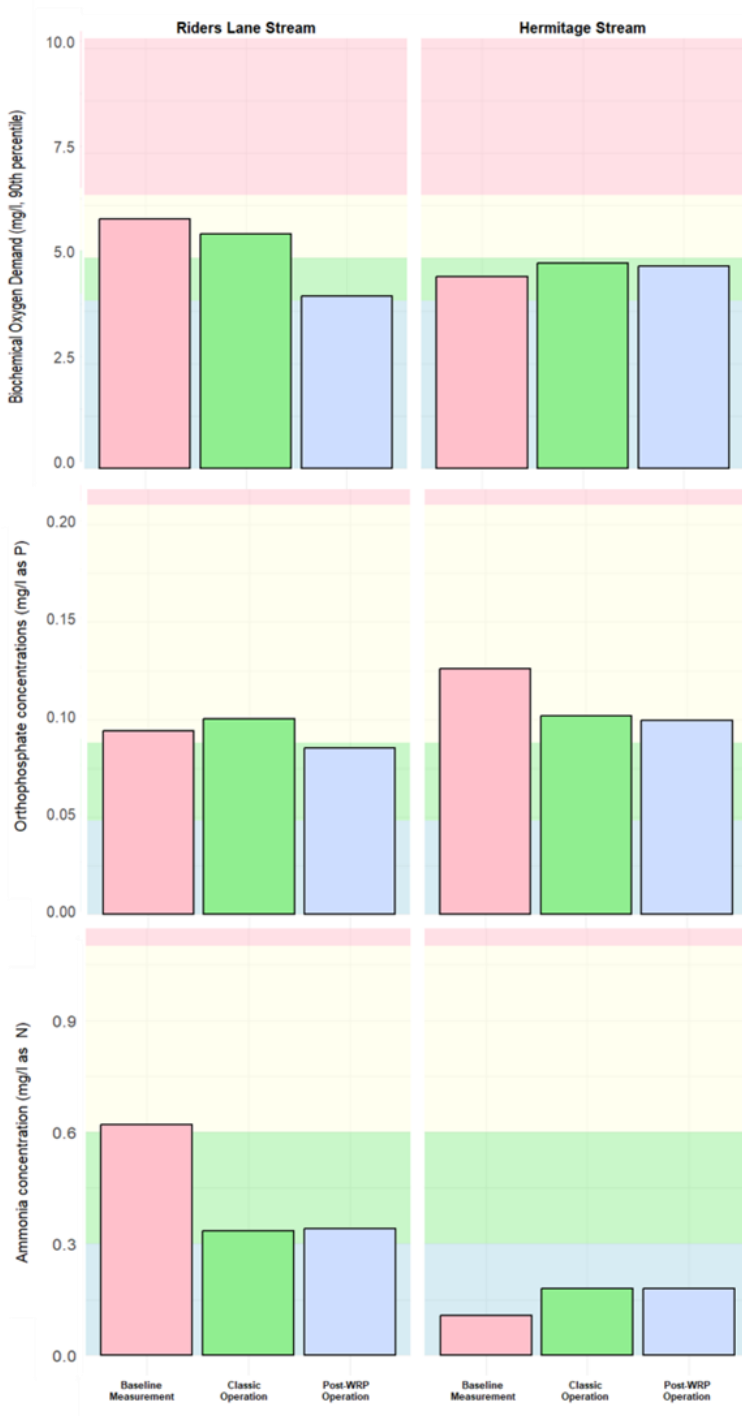
Figure 8-2 Modelled water quality in Riders Lane Stream and Hermitage Stream compared to physico-chemical status thresholds from the WFD Directions 2015: BOD, orthophosphate and ammonia

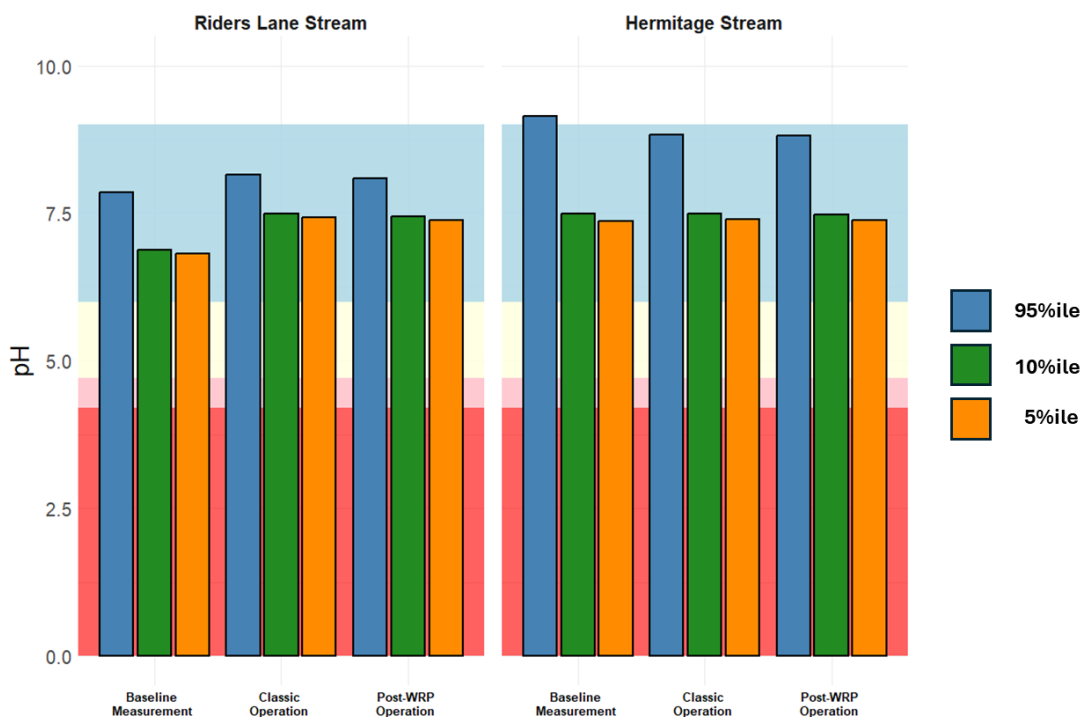
Figure 8-3 Modelled water quality in Riders Lane Stream and Hermitage Stream compared to physico-chemical status thresholds from the WFD Directions 2015: pH
