## Land Parcel C, Site Walkover Photographs

Site Walkover Questionnaire.

Date	30/11/2023
Project Name	Peartree solar farms
Project No.	323165
Site Name	Area D
GPS Location	53° 51' 51.965" N 0° 20' 28.8" W
Site Engineer	Matthew Fenton
Accompanied by	
Site Engineer Arrival Time	30/11/2023, 08:00
Site Engineer Departure Time	30/11/2023, 10:30
Other RSK Staff On Site	
Weather Conditions	<div><div><input type="checkbox"/> Heavy Rain</div><div><input type="checkbox"/> Rain</div><div><input type="checkbox"/> Drizzle</div><div><input type="checkbox"/> Overcast</div><div><input checked="" type="checkbox"/> Cloudy</div><div><input checked="" type="checkbox"/> Sunny Spells</div><div><input type="checkbox"/> Sunny</div><div><input type="checkbox"/> Fog</div><div><input type="checkbox"/> Snow</div><div><input type="checkbox"/> Thunder</div><div><input type="checkbox"/> Hail</div></div>

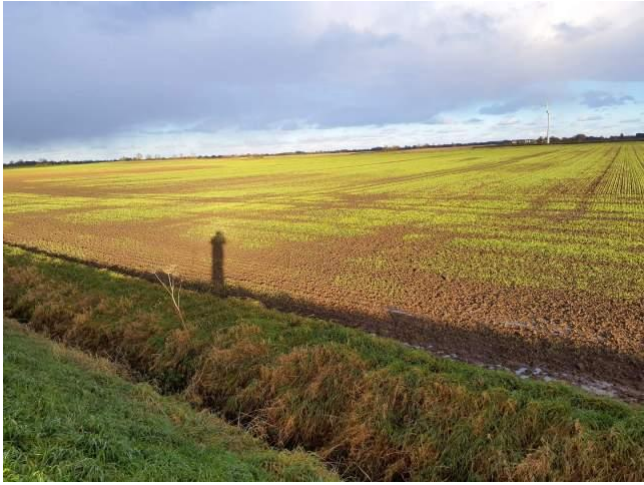
OTHER	C1 from SW corner looking NW. Small drainage ditch in foreground.	NW

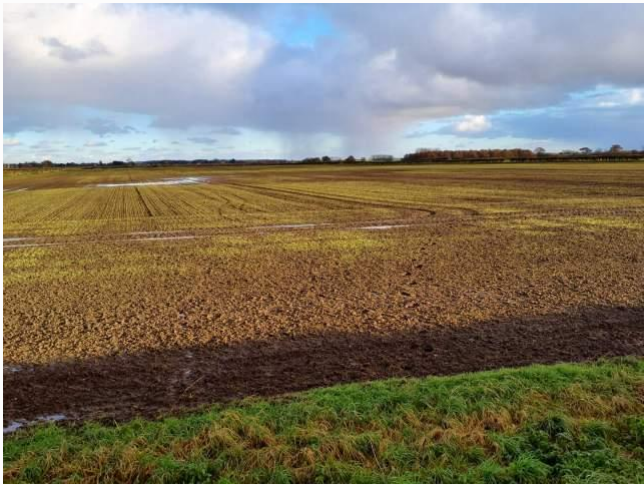
OTHER	C2 from western edge looking east.	E

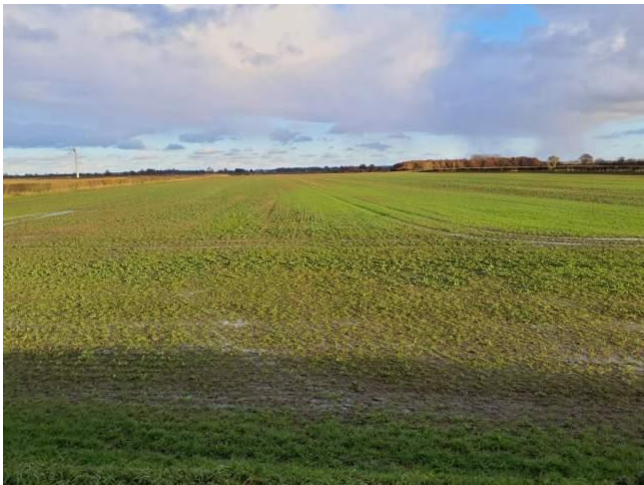
OTHER	C3 from western edge looking east	E

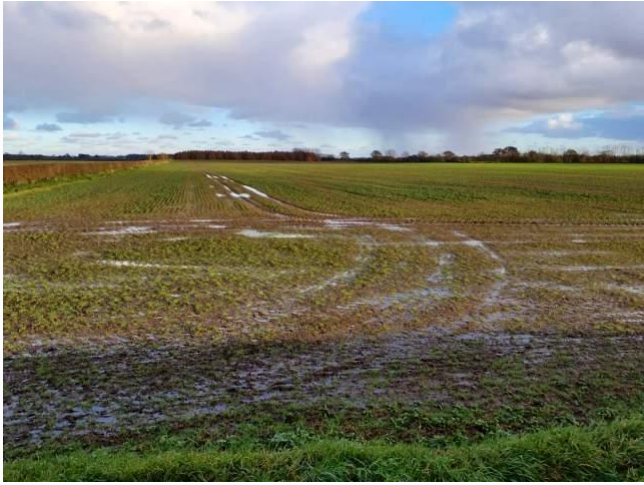
OTHER	C4 from western edge looking east. Trees are borders.	E

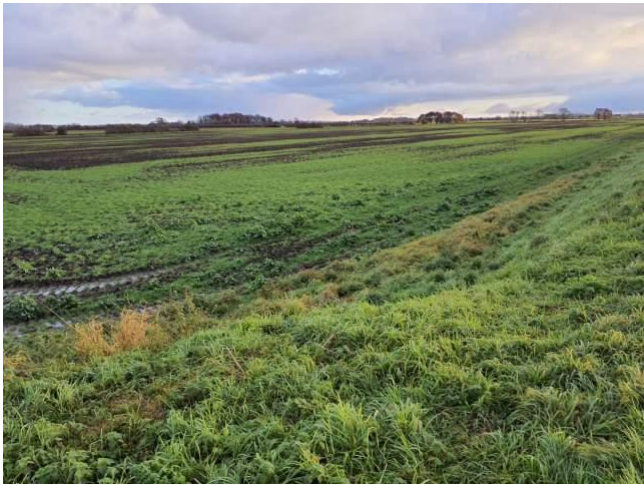
OTHER	C5 from western edge looking SE.	SE

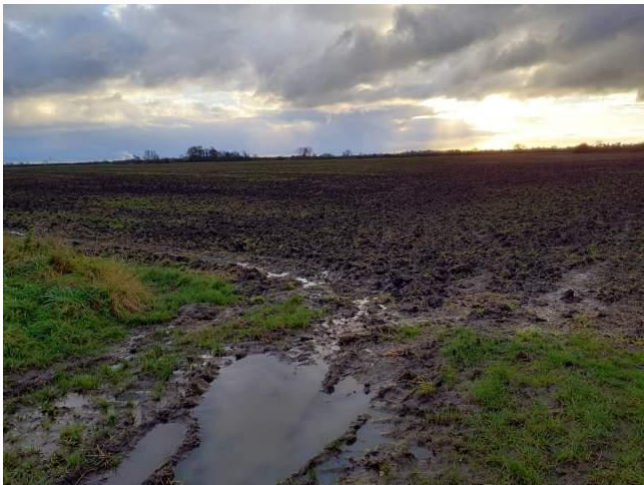
OTHER	C7 from northern border looking SW. Arnold West Carr Drain is eastern boundary.	SW

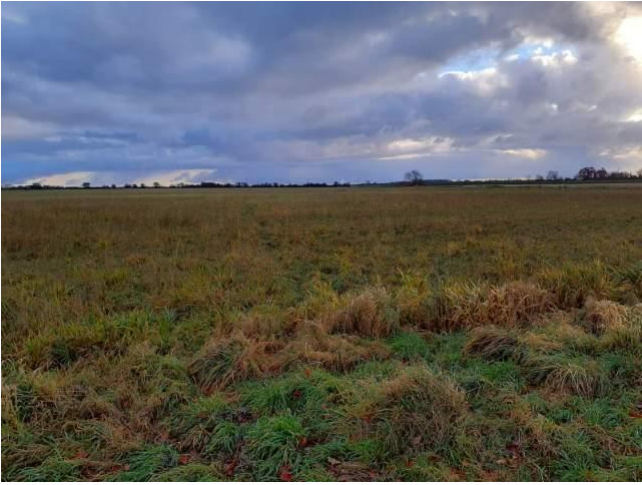
OTHER	C9 from northern border looking SW towards Carr Drain boundary. Hedges mark other boundaries.	SW

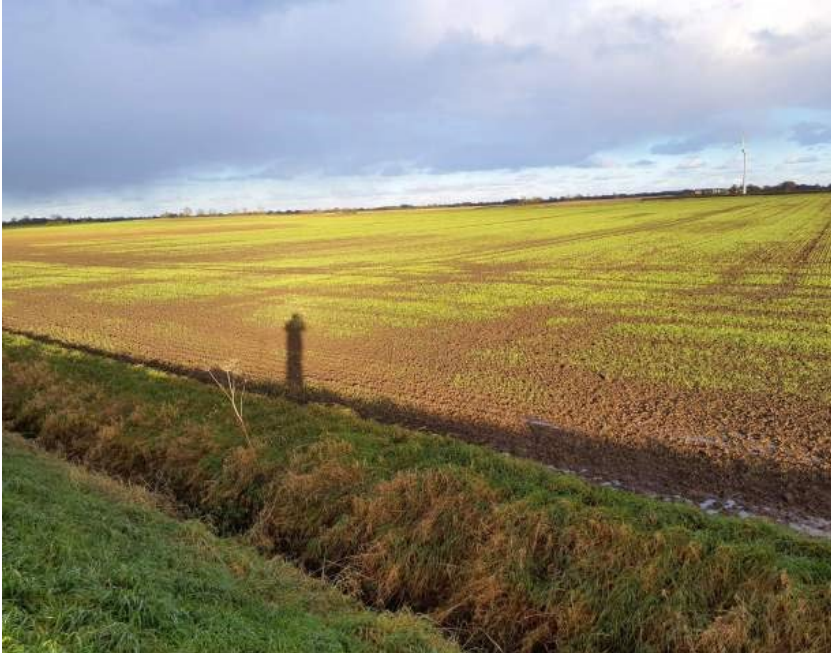
C4	C1 from SW corner looking NW. Small drainage ditch in foreground.	NW

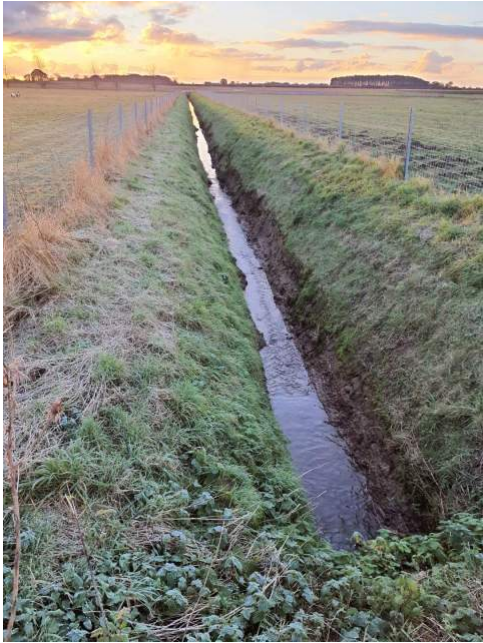
OTHER	Ditch on western border of d6 with outfall at foreground of image. D4 to the right.	S

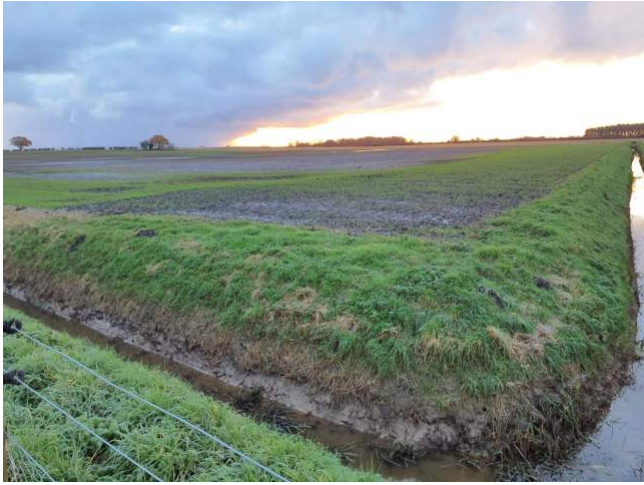
OTHER	NW corner of d5 looking SE. Ditch runs around perimeter.	SE

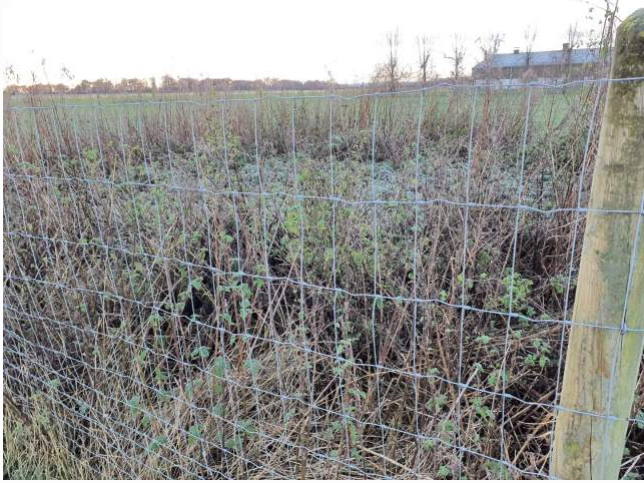
OTHER	Potential infilled pond on Eastern side of d1.	SW

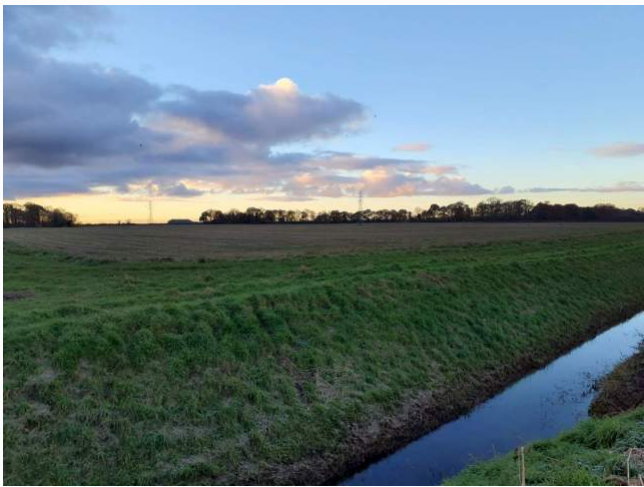
OTHER	Looking onto D14 from SW corner of D2. Trees and hedge line mark Western boundary of D14. Pylon is in D14 SW quadrant. Ditches act as borders between d1/d2 and d14.	SW

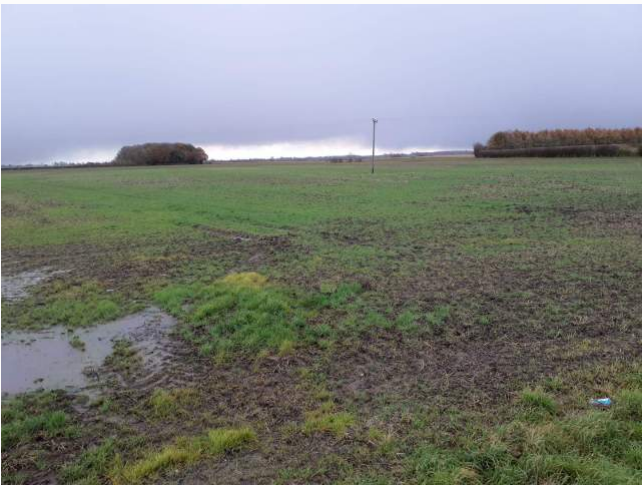
OTHER	Photo of D7 from western access looking to apex of NE bend. Overhead lines run across field.	E

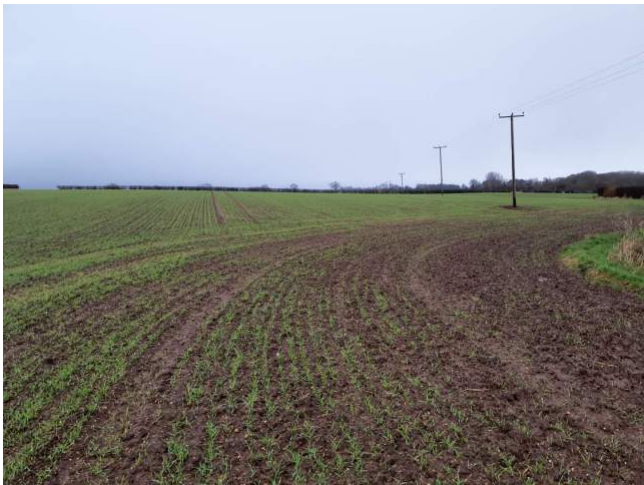
OTHER	Southern half of D9 from the middle of the 2 halves, looking south. Note overhead wires running through field N-S.	S

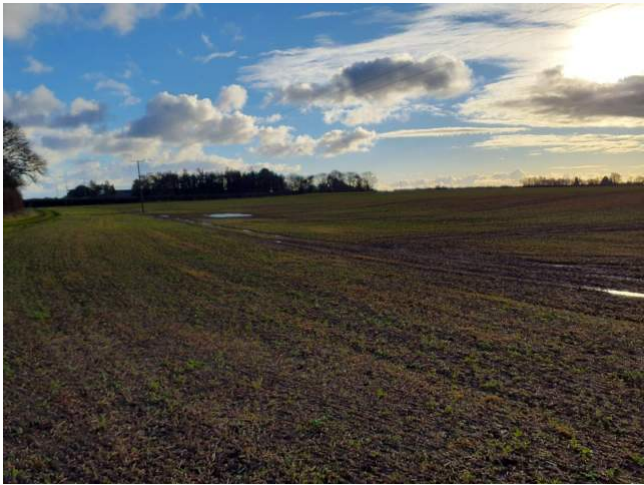
OTHER	D18 from northern field entrance looking east. Hedgeline marks eastern boundary with road. Note powerlines running across field.	E

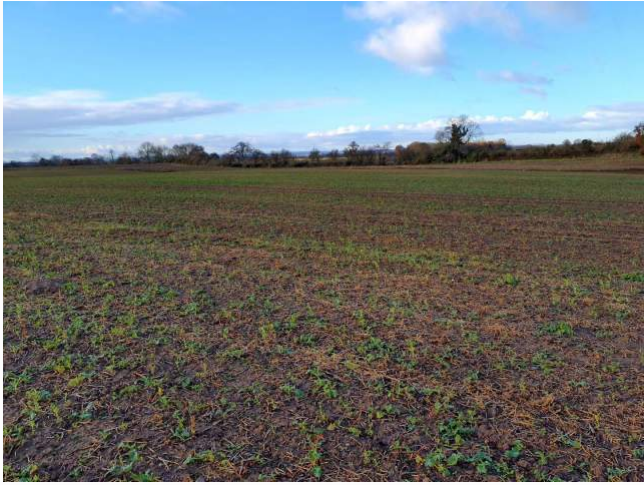
OTHER	Western edge of field of d8 looks boggy than rest of field, not worked and different vegetation.	W

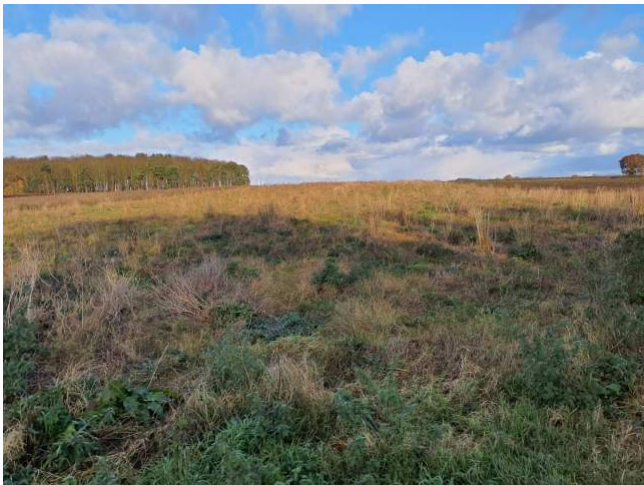
OTHER	Overgrown area between d17 (east) and d15.	N

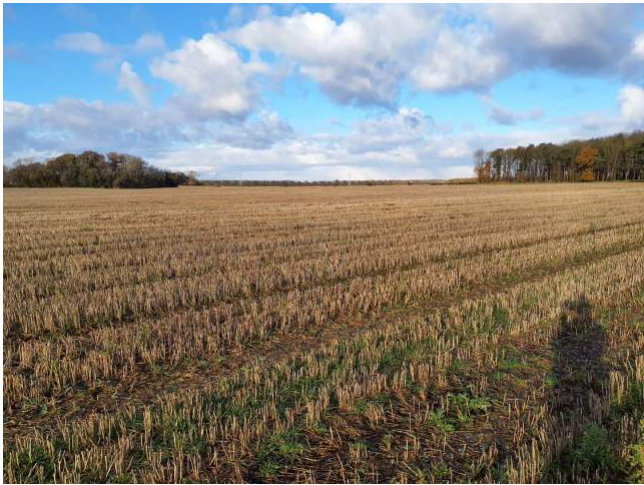
OTHER	SE corner of D15 looking NW. Bounded by electricity pylons to the south. The boundary runs around the edges of the two wooded areas to the hedging of the borders with D13 to the N and D14 to the NW. Large electric pylon in distance is in D14.	NW

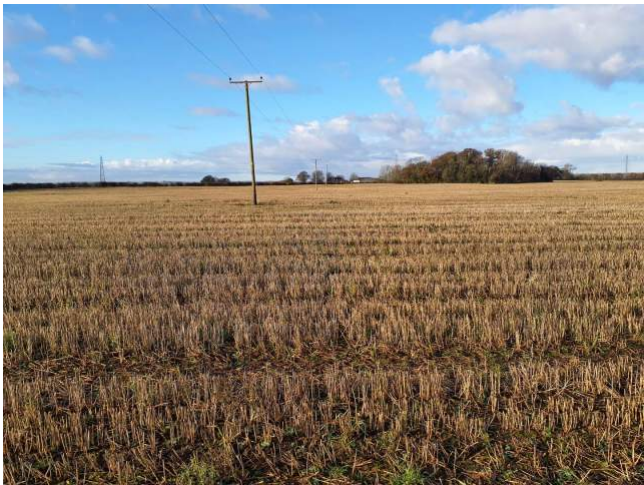
OTHER	Pylons in D15 that continued from D18 heading east-west. They did not go through D17 but a field outside the boundary.	W

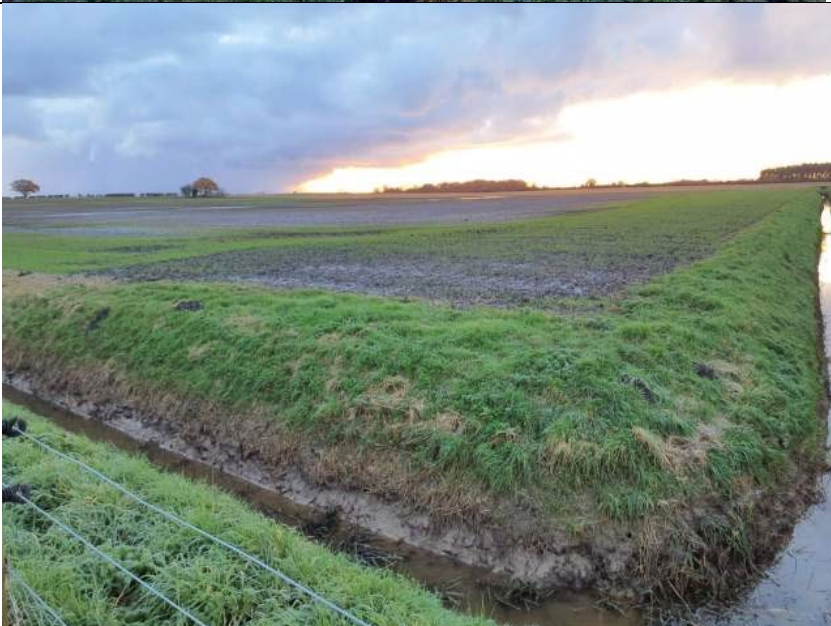
D4	NW corner of D5 looking SE. Ditch runs around perimeter	SE

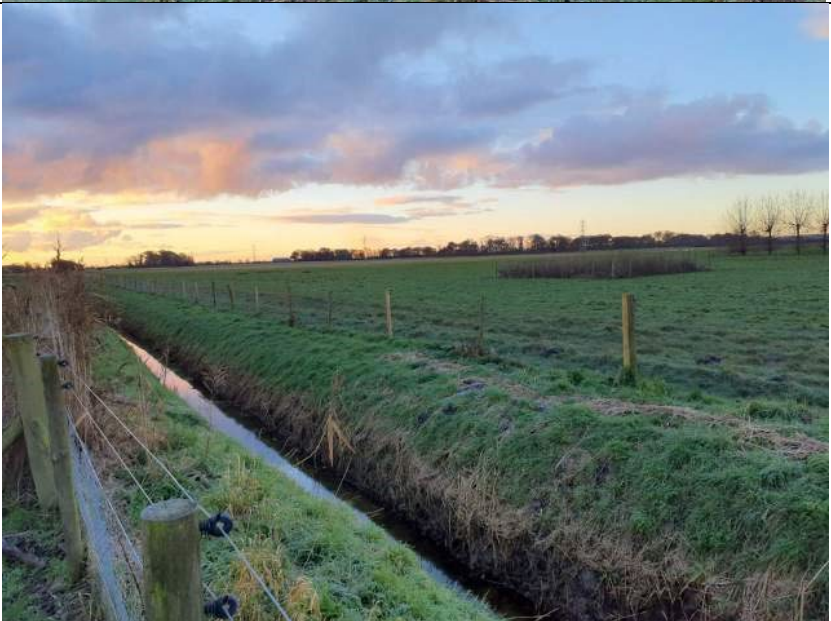
D6	NE corner of D1 looking SW. Ditch in foreground borders D1 and D3. Note pylons are not in area of D1.	SW

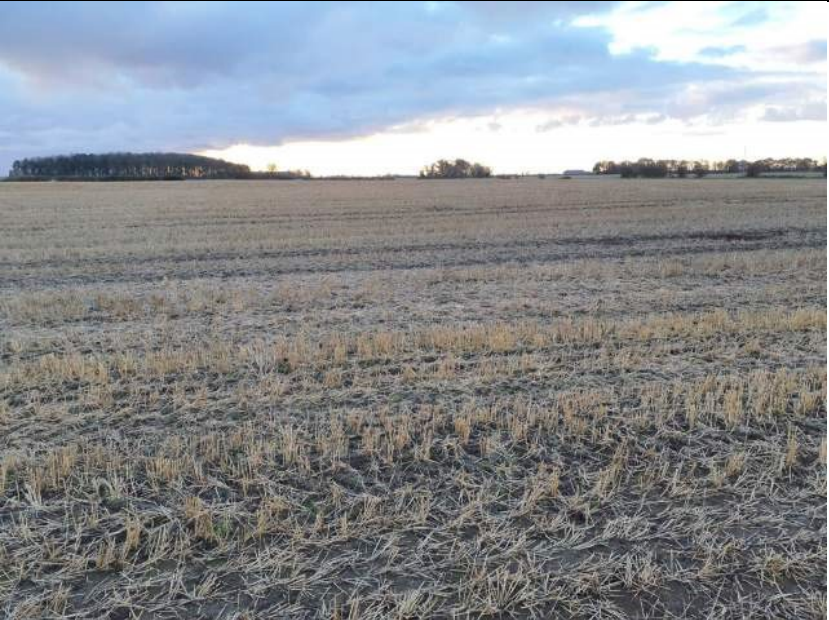
D9	Looking south from approximate NE corner of D2. Left edge of photo marks Eastern edge of area	S

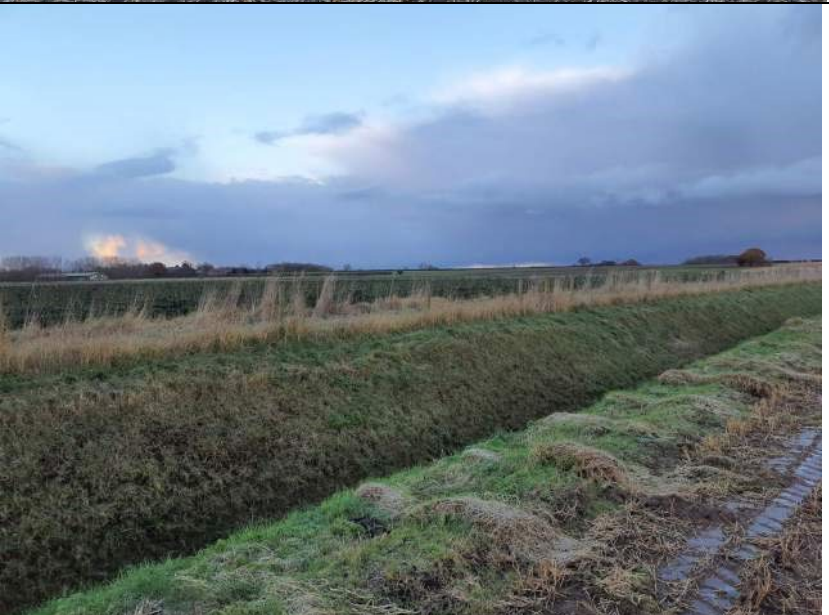
D10	D3 and D5 (background) from above position looking NE	NE

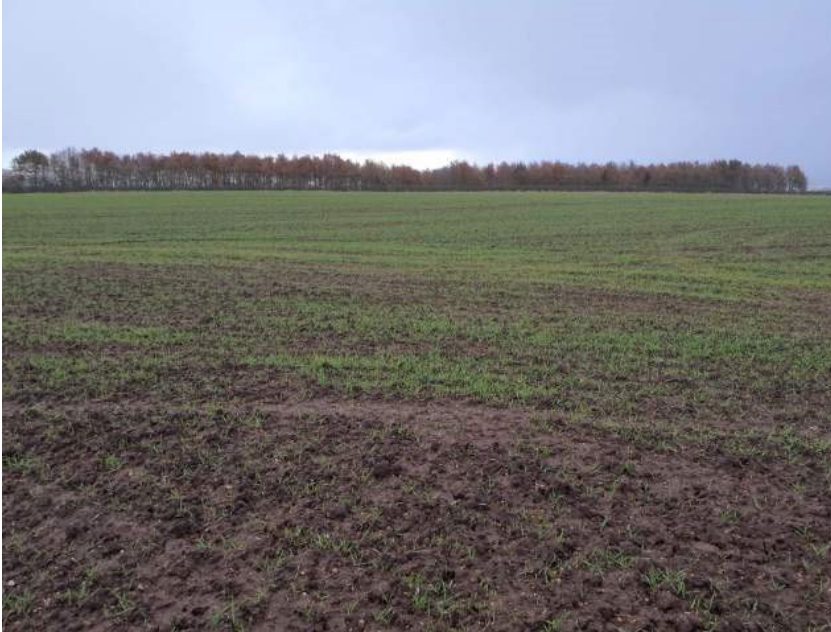
D17	Northern half of D9 from boundary with D8. Looking east	E

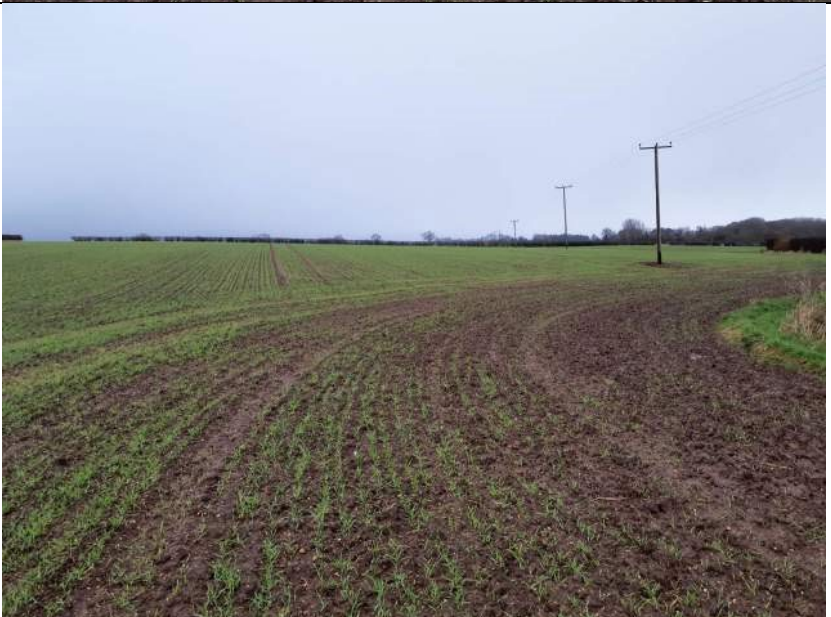
D18	Southern half of D9 from the middle of the two halves, looking south. Note overhead wires running through field N-S	S

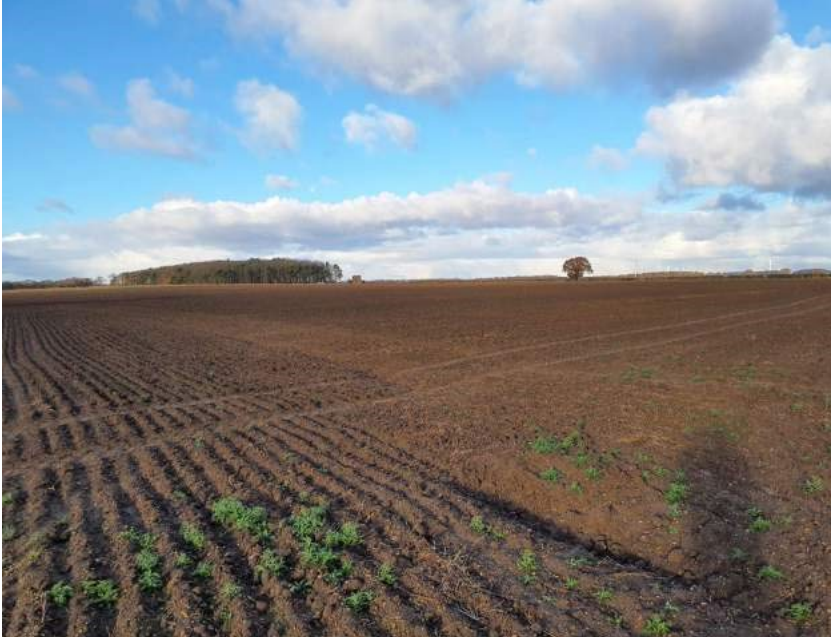
D26	D17 from its SE border looking NW. Trees mark NW border with D12 and D13, and the northern corner of D15.	NW

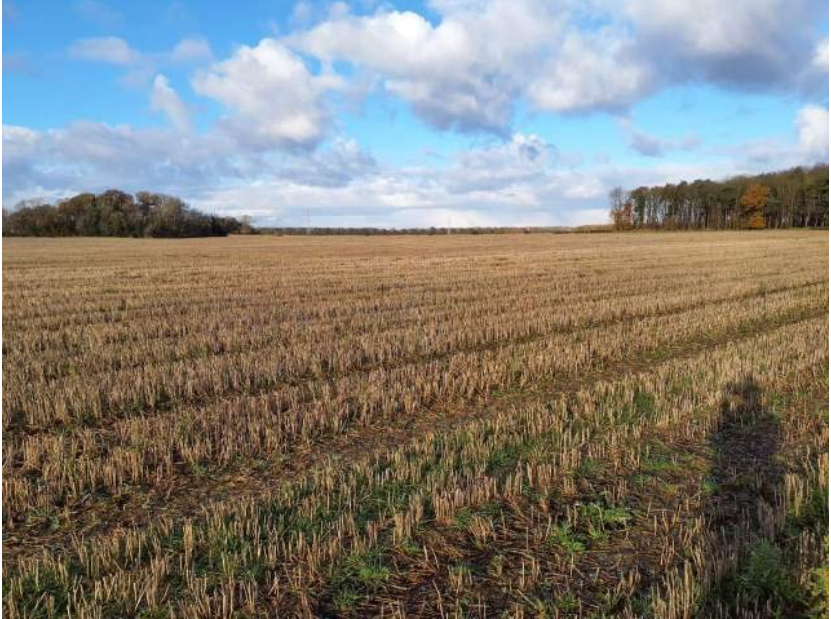
D29	SE corner of D15 looking NW. Bounded by electricity pylons to the south. The boundary runs around the edges of the two wooded areas to the hedging of the borders with D13 to the N and D14 to the NW. Large electric pylon in distance is in D14.	NW

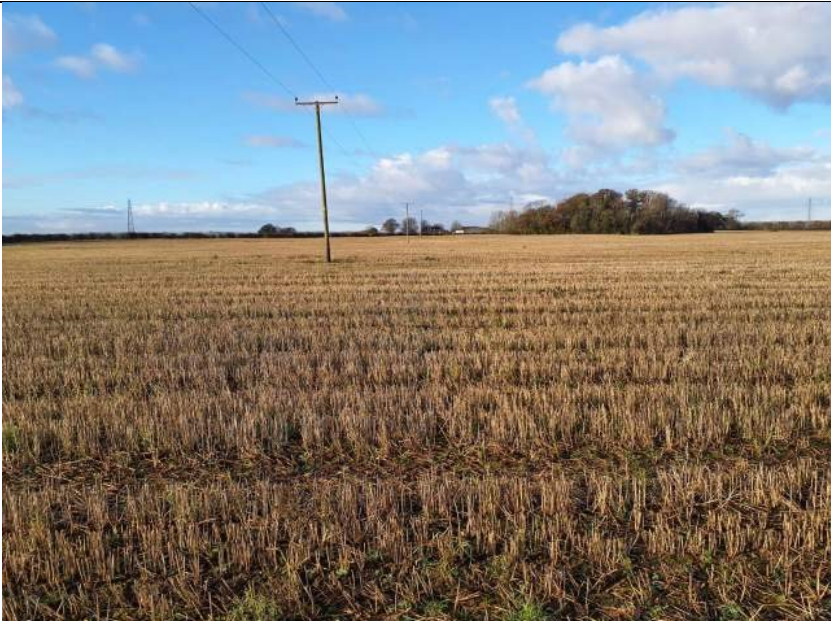
D30	Pylons in D15 that continued from D18 heading east-west. They did not go through D17 but a field outside the boundary.	W

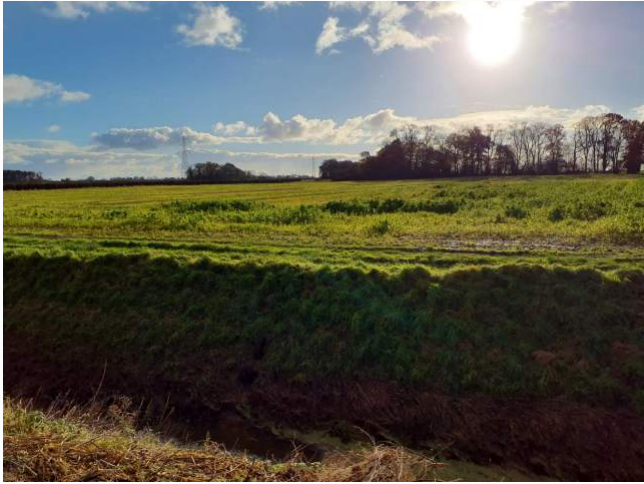
Select Feature	Description	Direction Taken	
OTHER	E2. From NW corner looking south. Treeline is boundary.	S

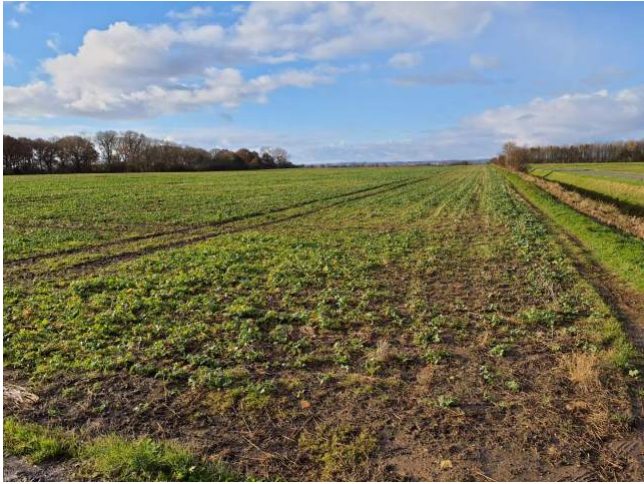
OTHER	E1. Looking west from border with e2 on road to farm. As with e2, treeline is southern boundary. Routh and Meaux drain is northern boundary	W

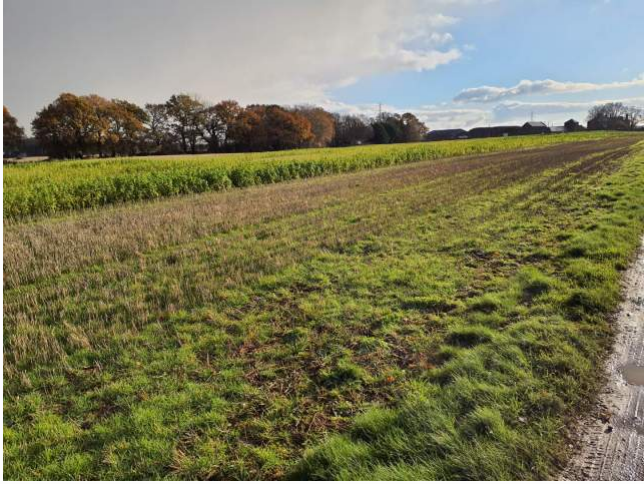
OTHER	E3 from western edge looking south. Treeline marks eastern edge. Farming buildings mark southern edge. Access road is western edge.	S

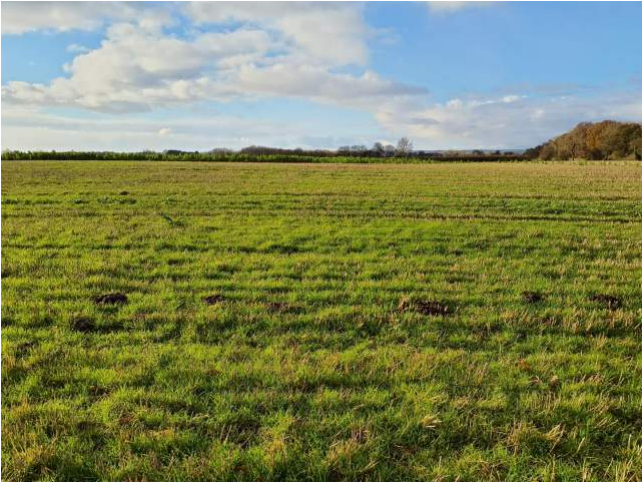
OTHER	<p>E4 from eastern edge looking west towards e5. Hedge in distance marks the boundary. Trees to right mark northern edge. Access road is eastern edge.</p>	W

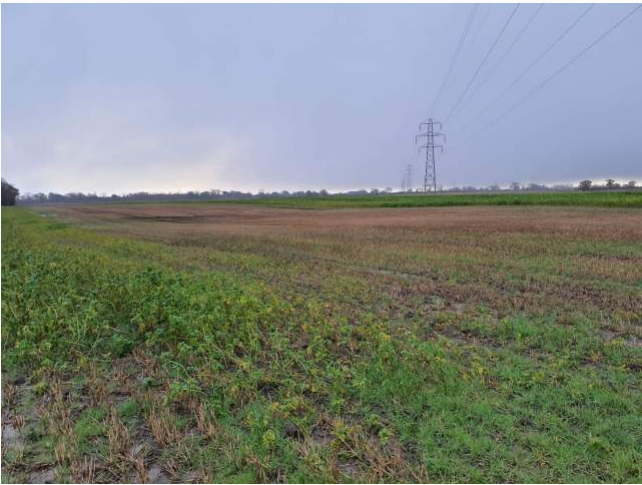
OTHER	<p>E8 from N corner looking south. Power lines run across field N-S.</p>	S

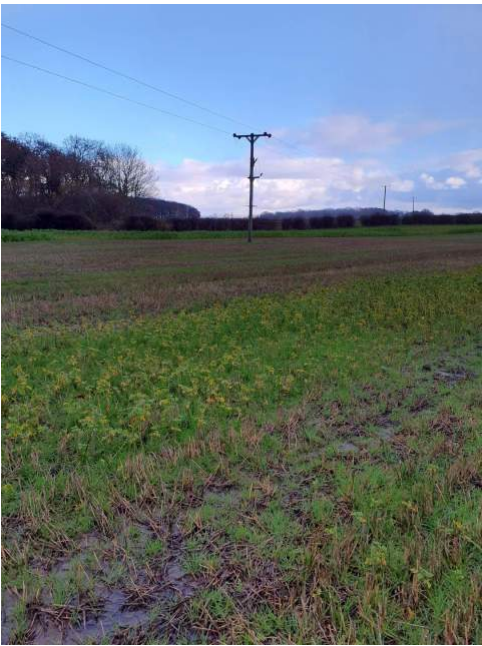
OTHER	<p>Smaller power lines in E8 running to farm house</p>	E

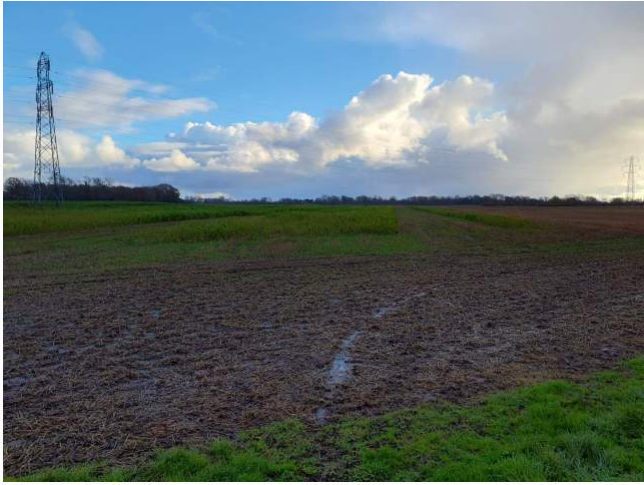
OTHER	E8 from border with e7 looking east.	E

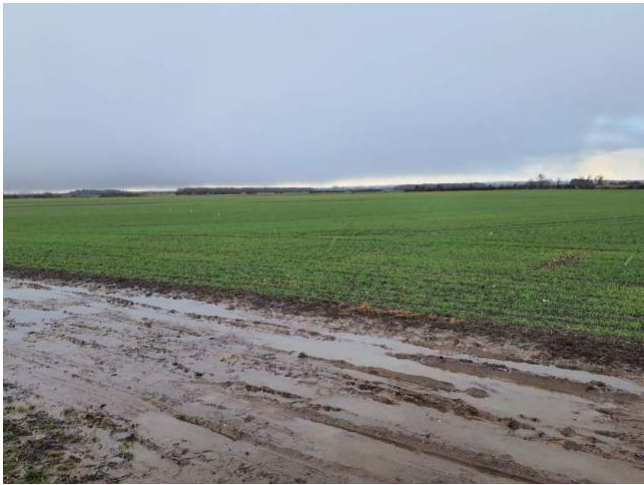
OTHER	E7 from border with E8 looking west	W

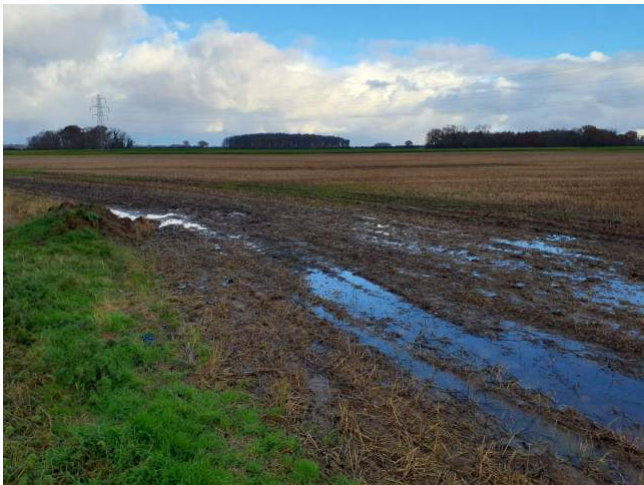
OTHER	E8 from SW corner looking NE. Bounded by hedgeline to NE.	NE

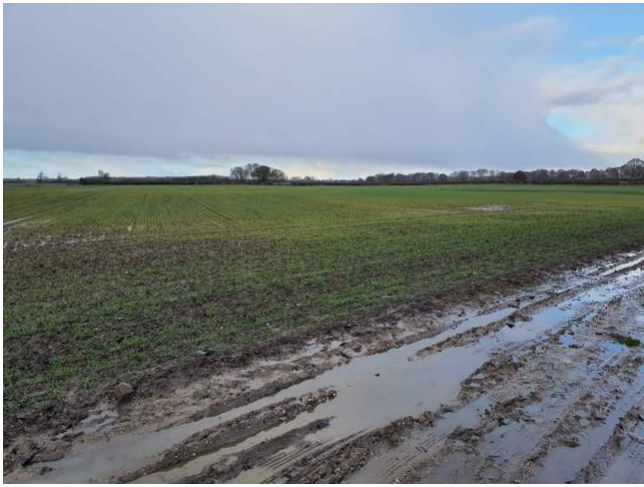
SE corner of E7 looking

OTHER	NW. Hedging marks northern and western borders. Ditches marks eastern and southern boundary.	NW

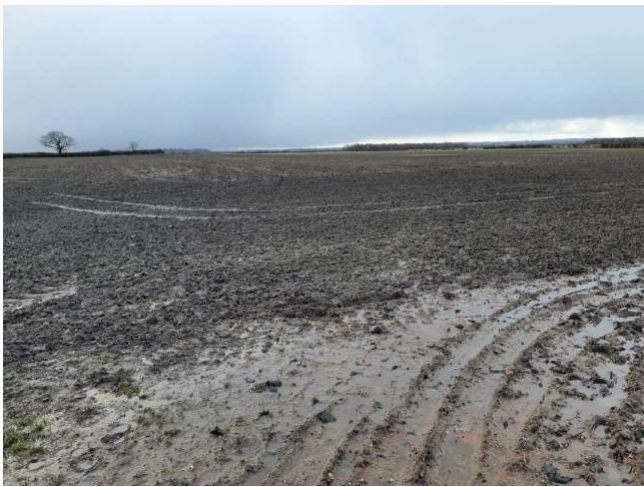
OTHER	View of E11 from western edge with E10 in distance.	E

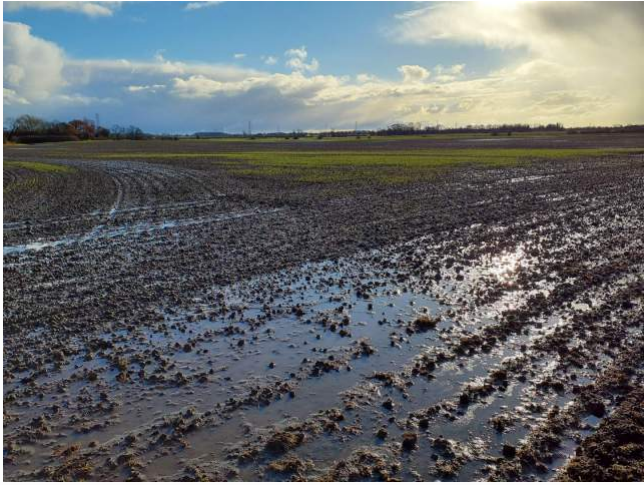
OTHER	with E11 looking east-south-east. Boundary follows hedgeline to the east and then back west.	SE

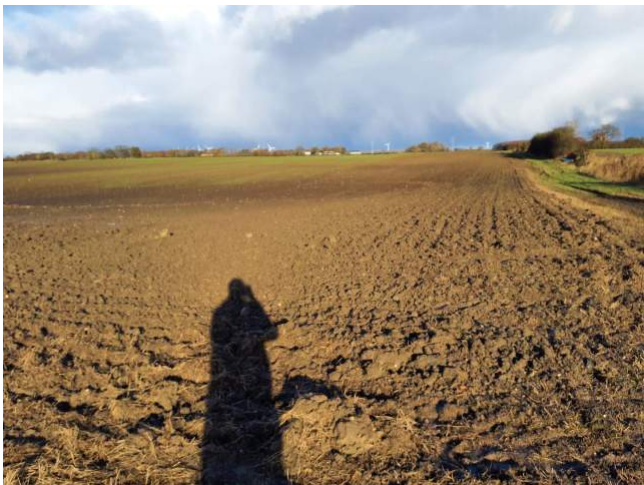
OTHER	E11 from SE corner looking north.	N

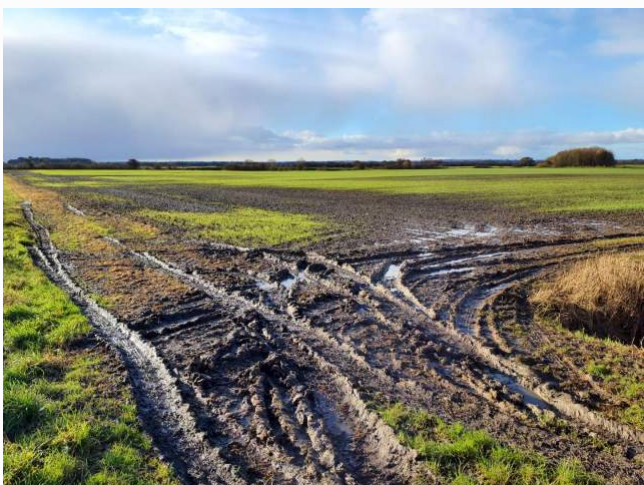
OTHER	E10 from NE corner looking SW. Bordered by bushes to east, south, west and ditch to the north.	SW

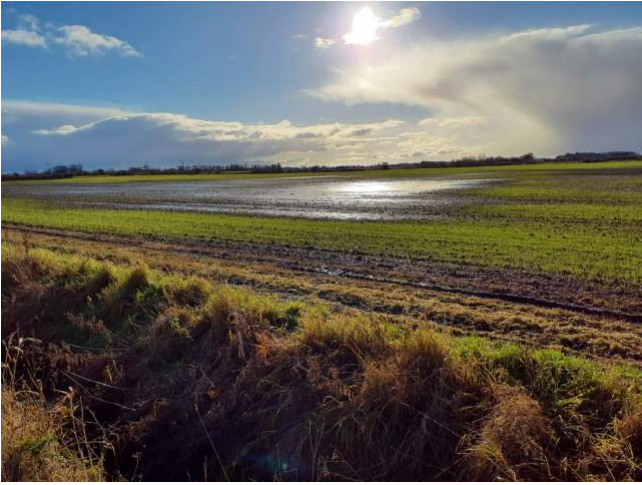
OTHER	Southern portion of E10 from SW corner of E11 looking SE.	SE

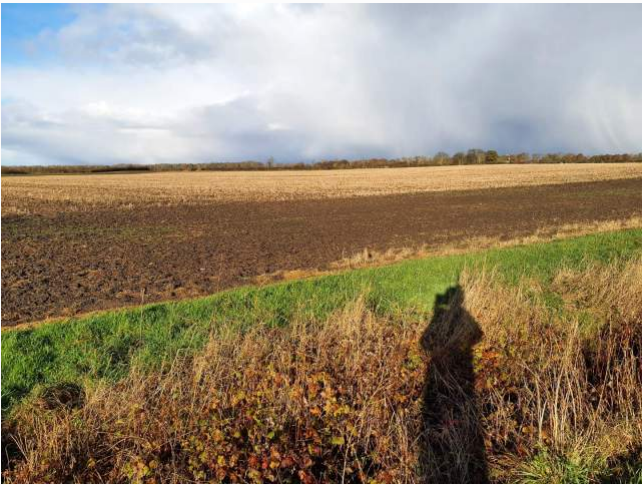
OTHER	Northern portion of e10 from SW corner of e11 looking NW.	NW

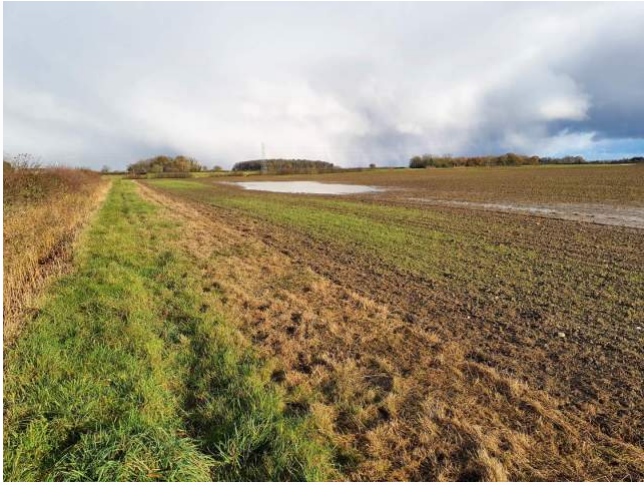
OTHER	Looking east over E8 and E11 from NE corner of E10 close to NW corner of E11.	E

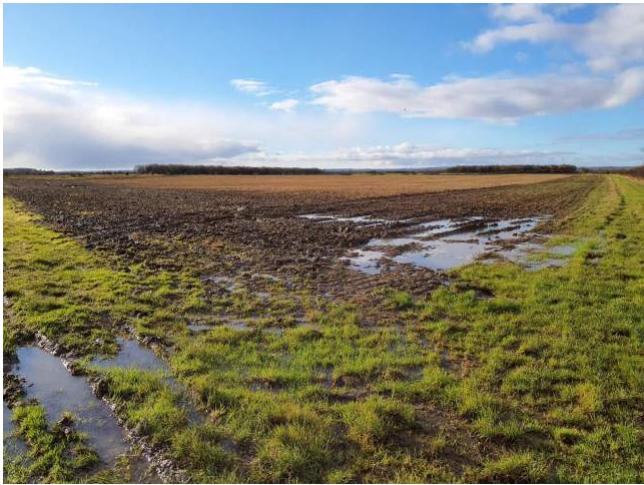
OTHER	Northern portion of E10 from NE corner looking SW.	SW

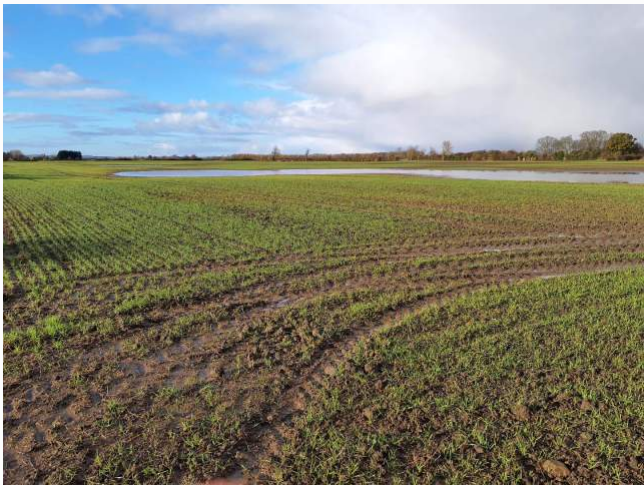
OTHER	E9 from its SE corner looking west. E10 to South.	W

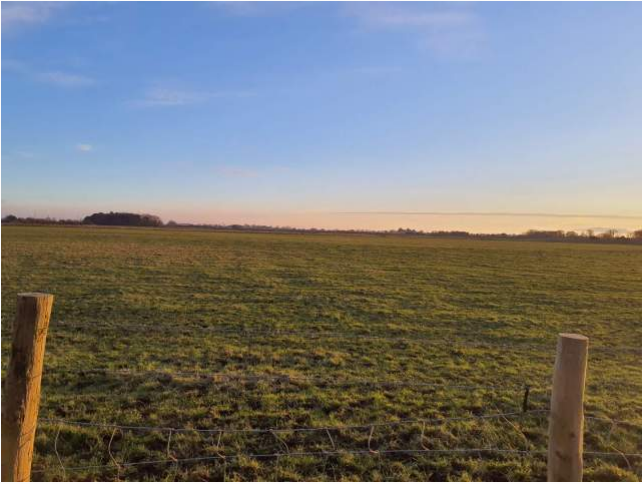
Select Feature	Description	Direction Taken	
OTHER	Area south of area boundary looking at potential cable route Norman.	S

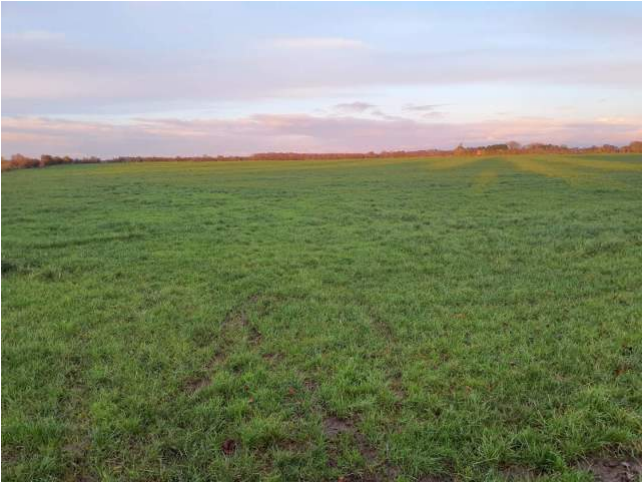
OTHER	View from SW corner of e13 and e14 looking NW	NW

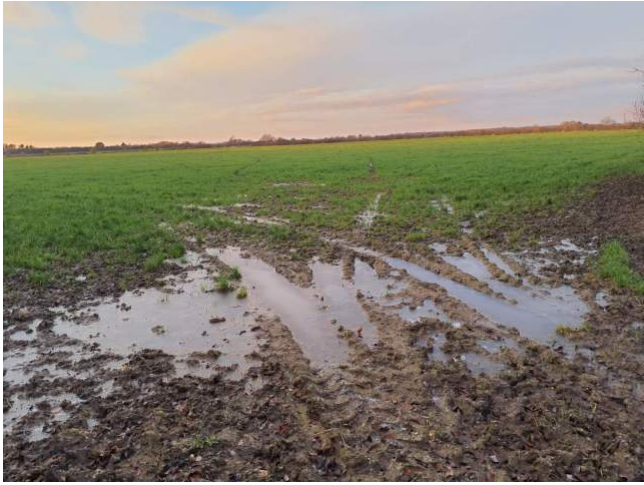
OTHER	View from SE corner of E13 and E14 looking nw.	NW

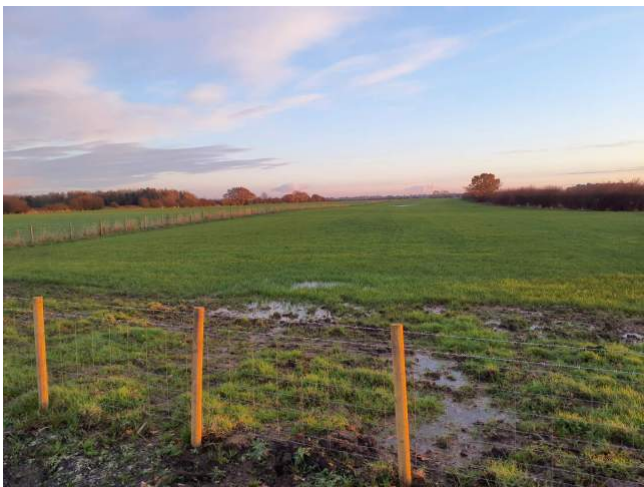
OTHER	View of E17 from northern border (Carr Lane) looking south.	S

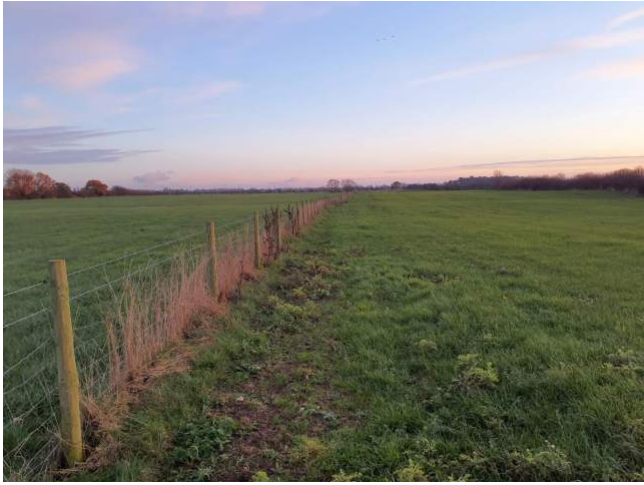
OTHER	From centre of E17 looking south. Tractor in distance is southern boundary.	S

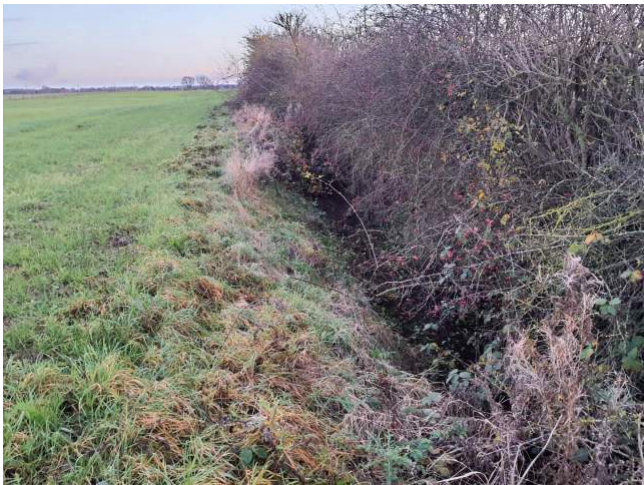
OTHER	As above but looking north.	N	 
OTHER	Ditch between E16 and E17 looking south. Runs to border at both ends.	S

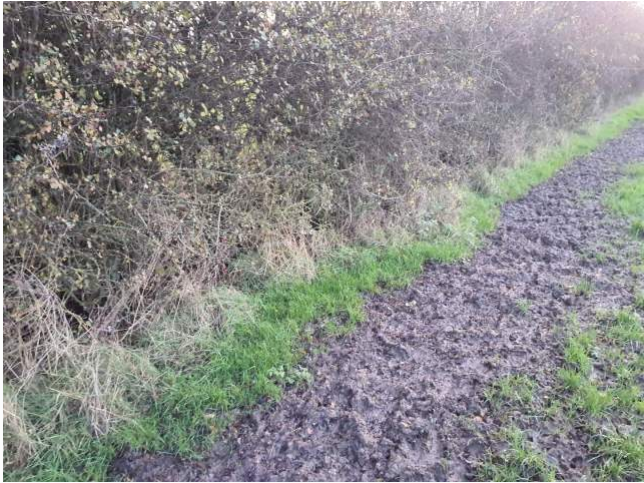
OTHER	Ditch between E15 and E16. Runs east to west.	E

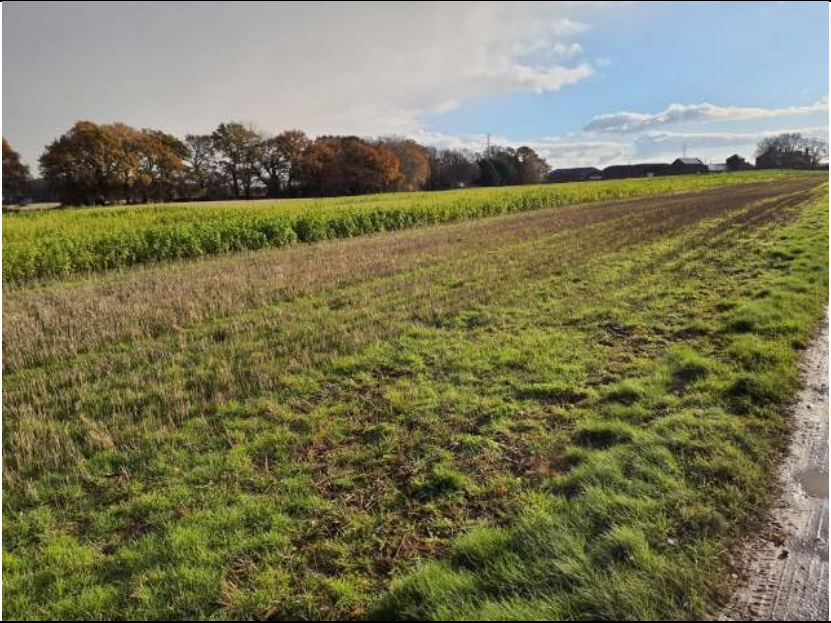
E3	<p>E3 from western edge looking south. Treeline marks eastern edge. Farming buildings mark southern edge. Access road is western edge.</p>	S

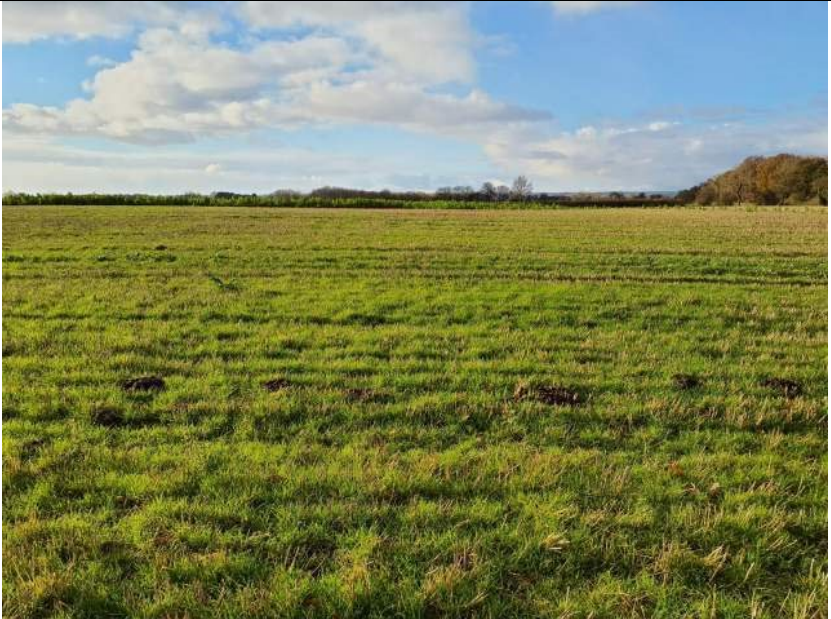
E4	<p>E4 from eastern edge looking west towards E5. Hedge in distance marks the boundary. Trees to right mark northern edge. Access road is eastern edge</p>	W

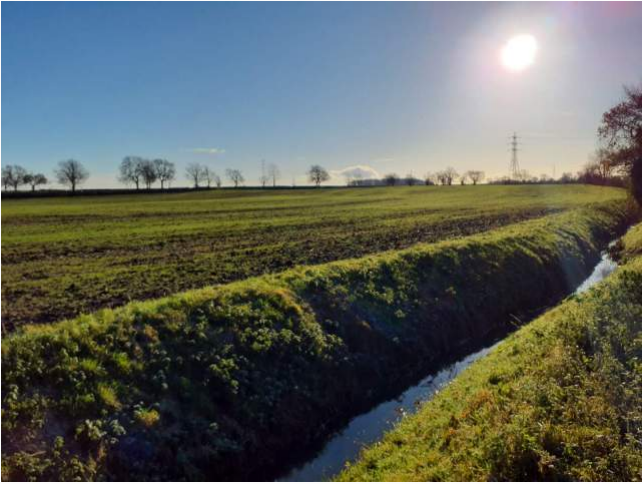
Select Feature	Description	Direction Taken	
OTHER	From SE corner of F15 looking south to F17. Pylon is on south boundary of F17	S

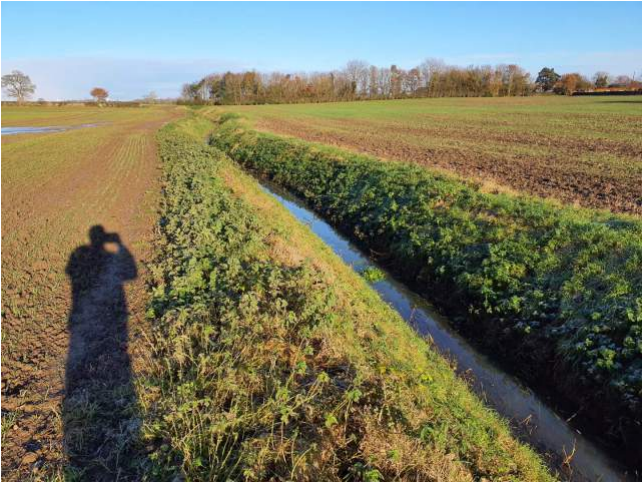
4d. Surface waters on site	Ditch between F15, F16 and F17. Picture taken from SE corner of f15 looking north.	N

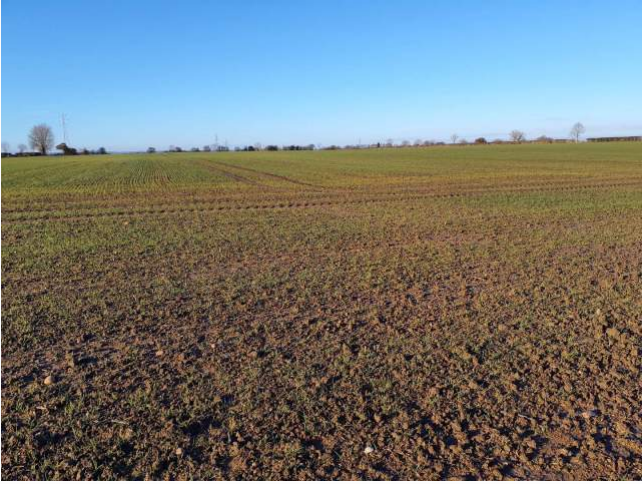
OTHER	F15 from its SE corner looking NW. Pylons not in F15.	NW

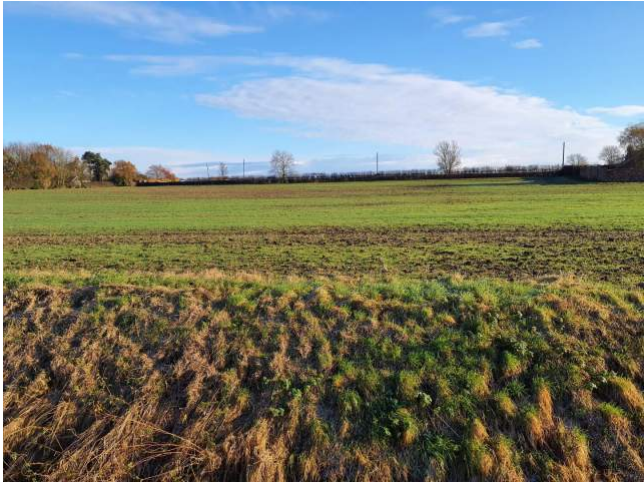
OTHER	F16 from approximate centre of F15's eastern boundary looking east. Shows hedge marking Eastern boundary of f16 with road behind	E
