## Land Parcel C, Site Walkover Photographs

Site Walkover Questionnaire.

Date	30/11/2023
Project Name	Peartree solar farms
Project No.	323165
Site Name	Area D
GPS Location	53° 51' 51.965" N 0° 20' 28.8" W
Site Engineer	Matthew Fenton
Accompanied by	
Site Engineer Arrival Time	30/11/2023, 08:00
Site Engineer Departure Time	30/11/2023, 10:30
Other RSK Staff On Site	
Weather Conditions	<div><div><input type="checkbox"/> Heavy Rain</div><div><input type="checkbox"/> Rain</div><div><input type="checkbox"/> Drizzle</div><div><input type="checkbox"/> Overcast</div><div><input checked="" type="checkbox"/> Cloudy</div><div><input checked="" type="checkbox"/> Sunny Spells</div><div><input type="checkbox"/> Sunny</div><div><input type="checkbox"/> Fog</div><div><input type="checkbox"/> Snow</div><div><input type="checkbox"/> Thunder</div><div><input type="checkbox"/> Hail</div></div>

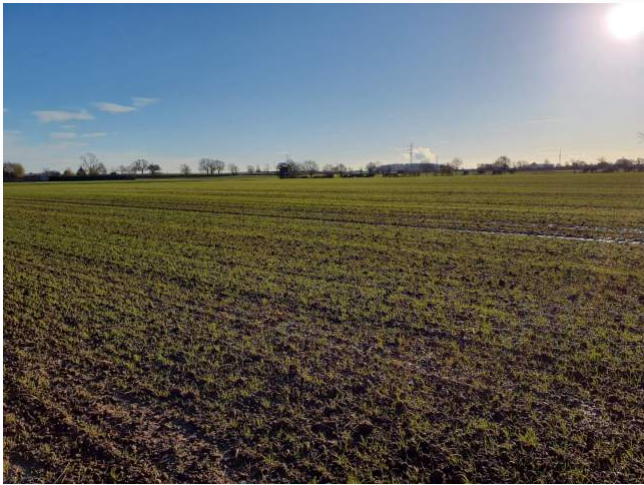
OTHER	From centre of Northern edge of f15 looking SE towards F17	SE

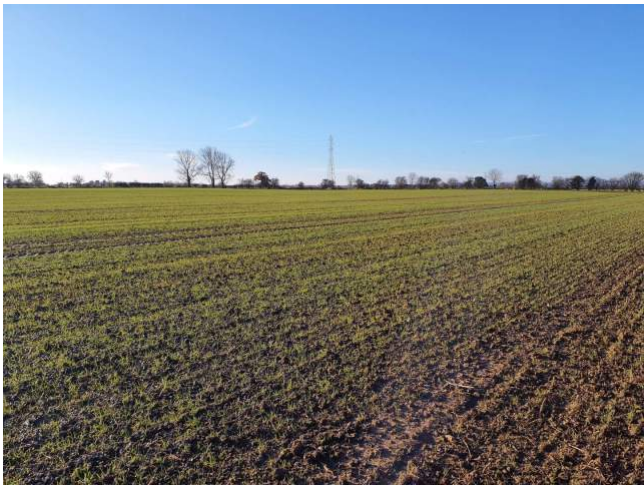
OTHER	From centre of Northern edge of f15 looking SW.	SW

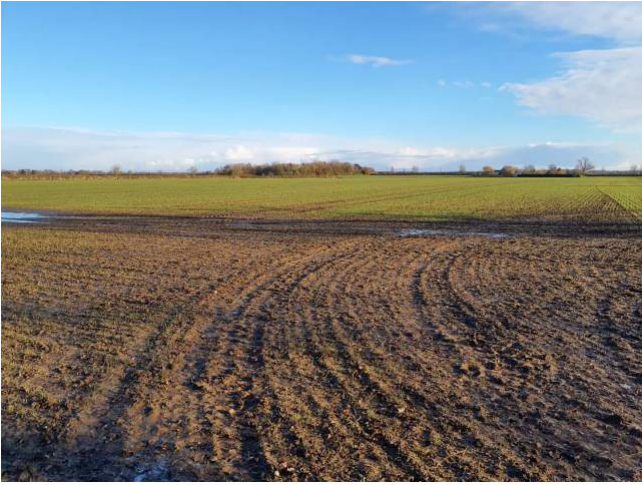
OTHER	From SW corner of f15 looking NE. F16 in background.	NE

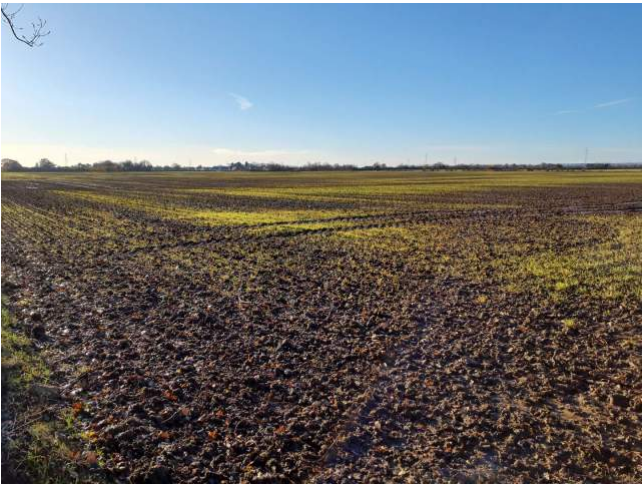
OTHER	From SW corner of F15 looking SW over potential cable route Stephenson.	SW

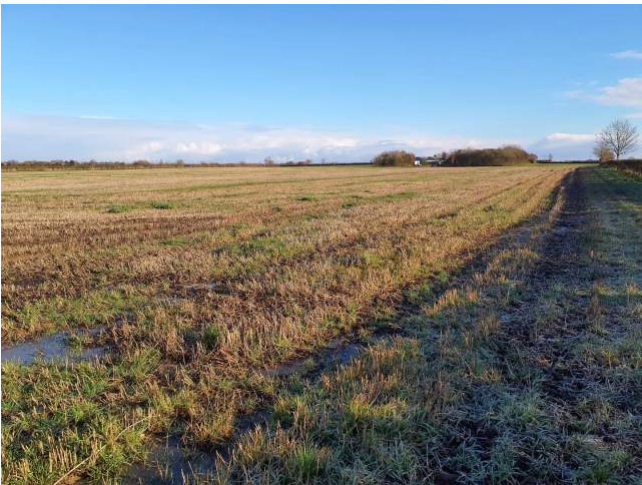
OTHER	From SW corner of f14 looking NE with f9 and f10 in distance.	NE

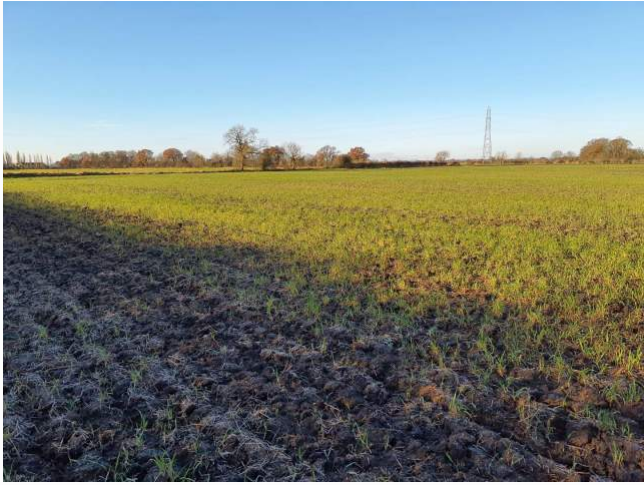
OTHER	NW ends of F1 and F2 looking NW from southern edge of F2	NW

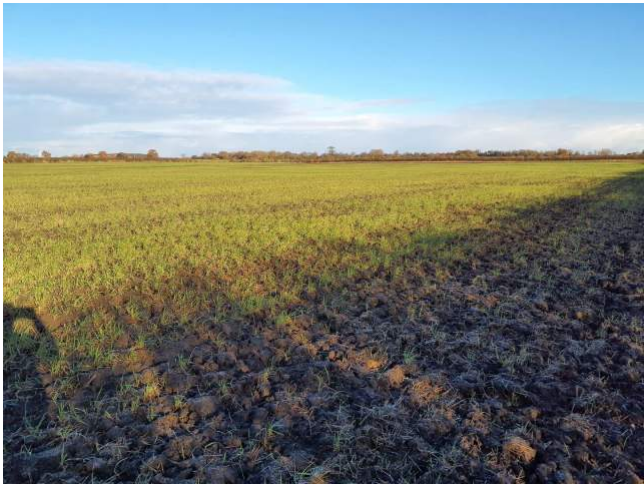
OTHER	From southern edge of F2 looking NE showing F2 and F1 northeastern ends.	NE

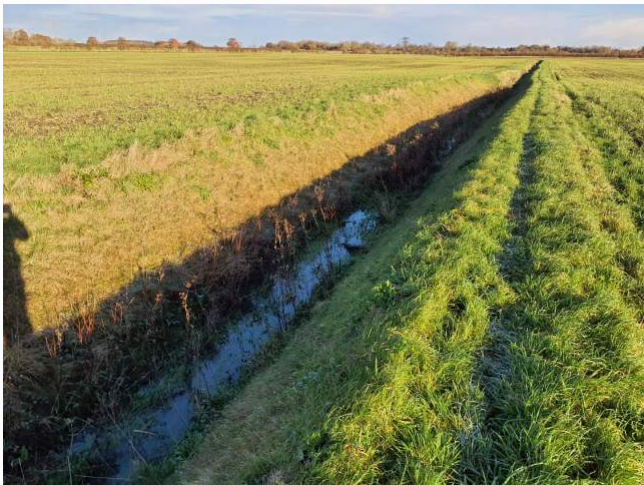
OTHER	Ditch on boundary between f1 and f2	E

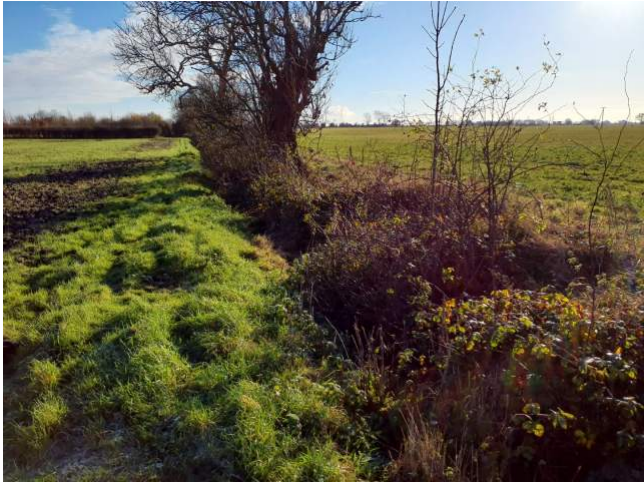
OTHER	Overgrown ditch by Western edge of F2.	S

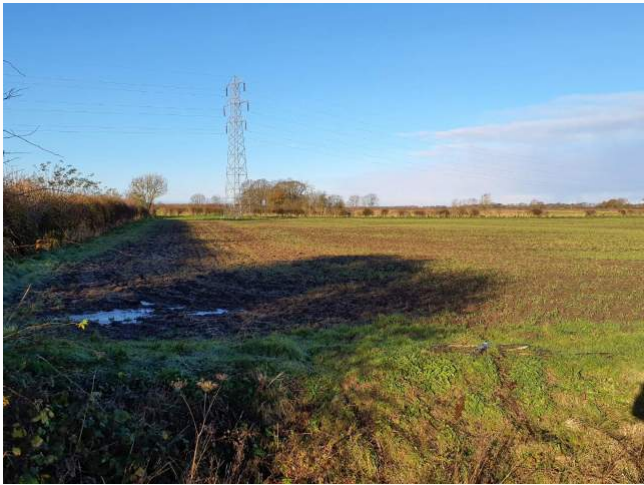
OTHER	Pylon in northwestern corner of f1, taken from NW corner of F2.	N

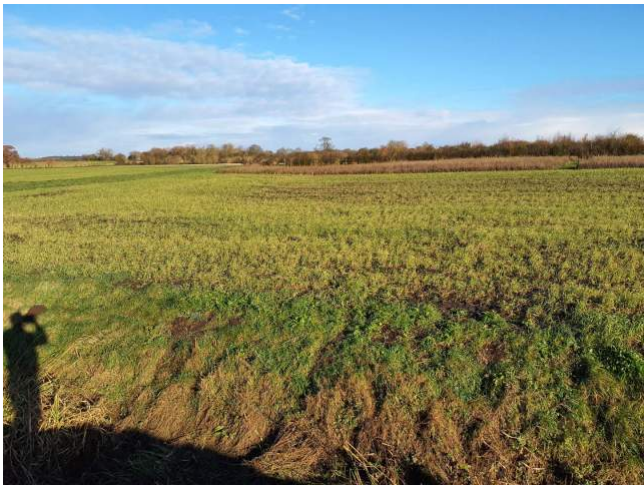
OTHER	Western edge of F3 looking NE showing F3 and north-eastern corner of F1. F3 is bound on all sides by the ditch.	NE

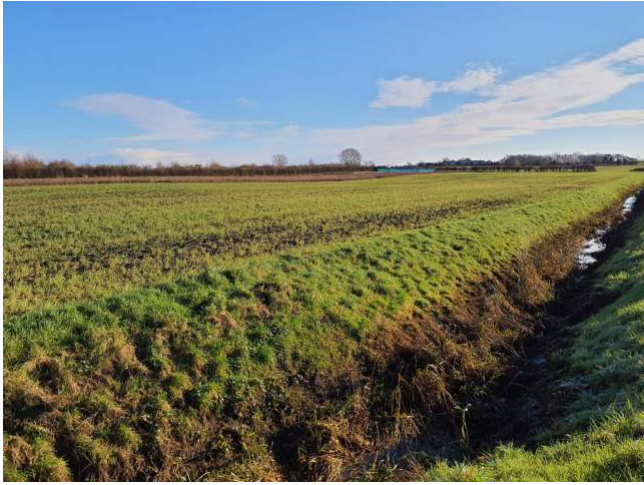
OTHER	Western edge of F3 looking SE.	SE

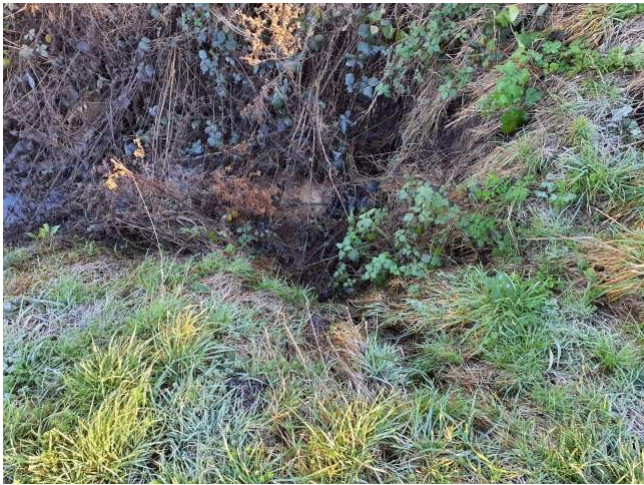
OTHER	Drain at SE corner of F3	N

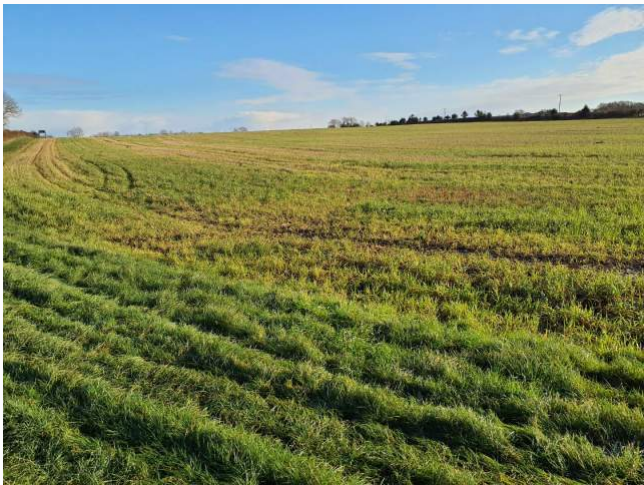
OTHER	SW corner of F3 looking east over F7.	E

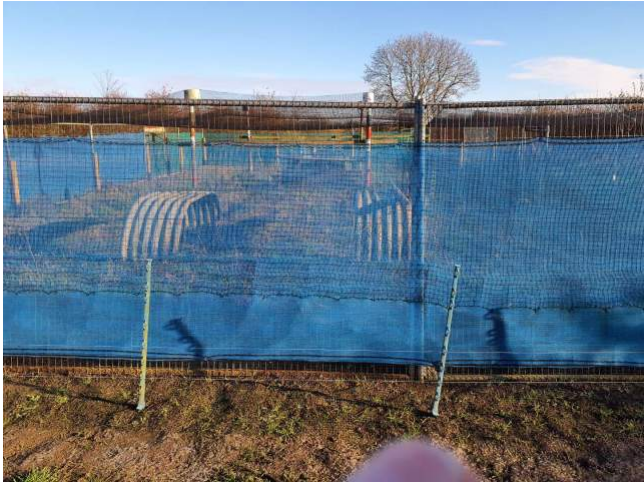
OTHER	Empty bird keep at SE corner of F3.	E

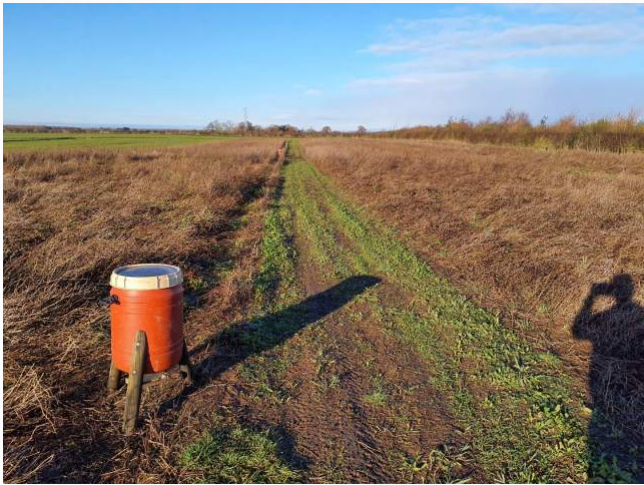
OTHER	Feeders in marshier area on east of F3.	N

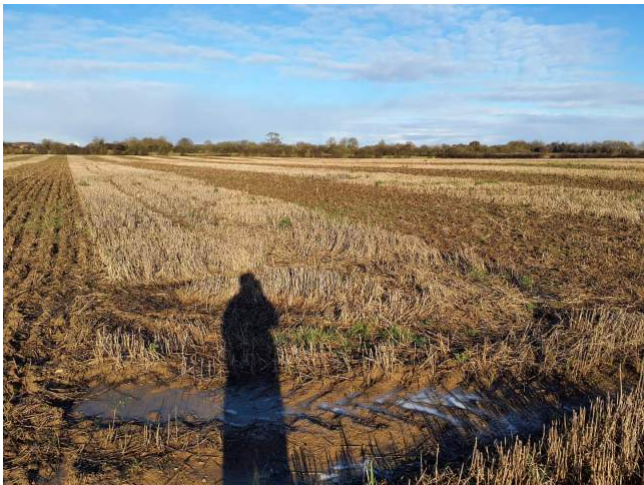
OTHER	F4 looking north from southwestern boundary	N

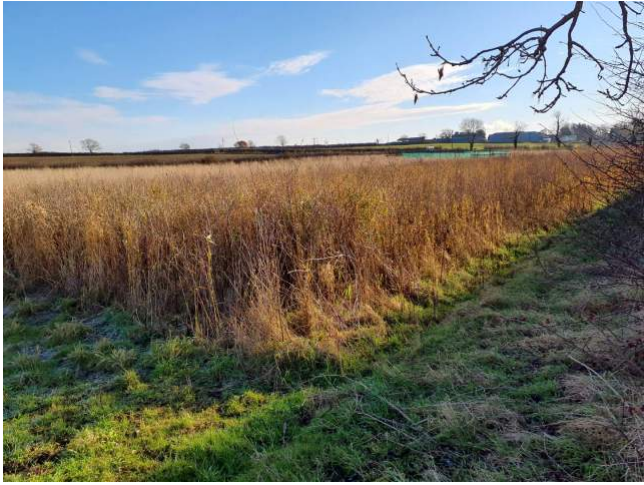
OTHER	Same as above looking south over f5 showing another bird enclosure in boggier ground.	S

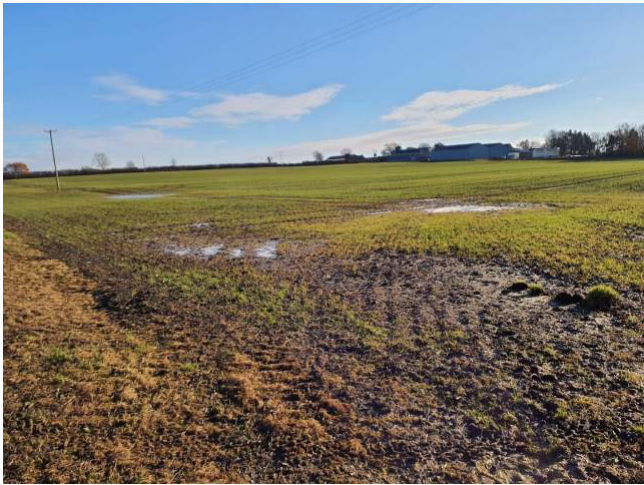
OTHER	Looking SE from SW corner of f5 over f9 and f10. Pylons run E-W extending west over F8. They divert south when they meet the road.	SE

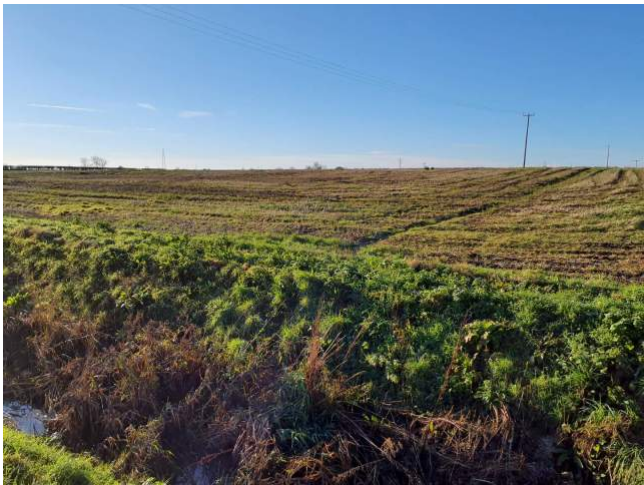
OTHER	Looking SW over F8 from SW corner of F5. Note ditch between f8 and f9 and slight crest on F8 with pylons continuing from F9.	SW

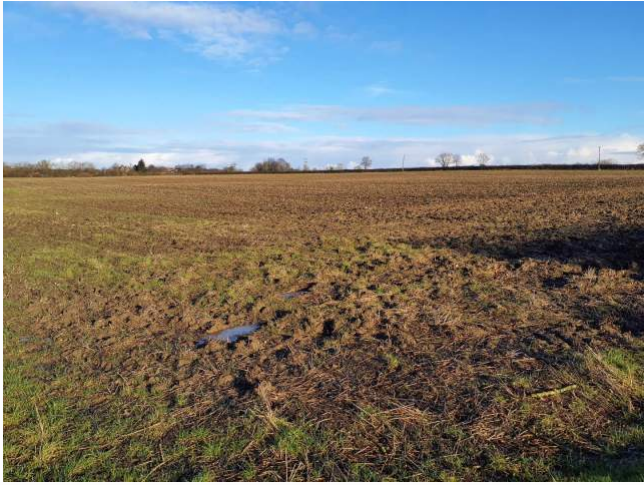
OTHER	Looking ne over F6 with road as Eastern boundary marked by pylons/Meaux Road.	NE

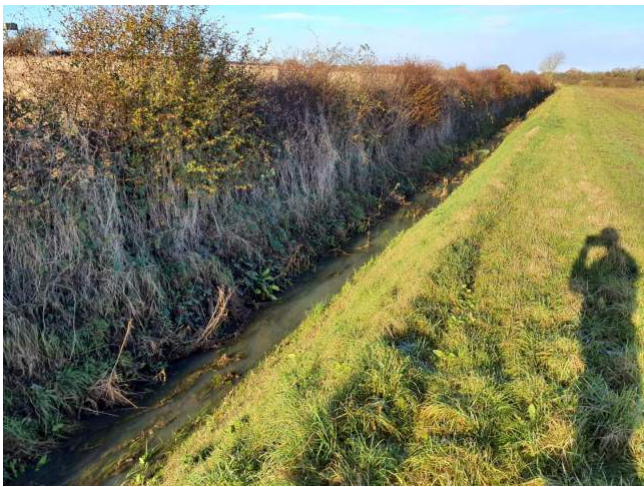
OTHER	Ditch along Western boundary of F6. Runs N-S.	N

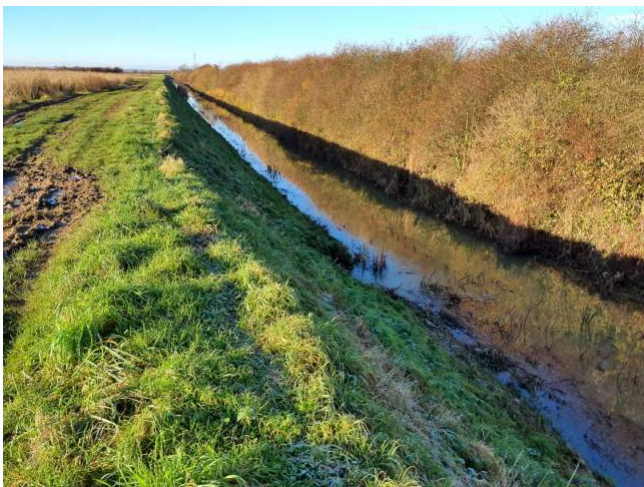
OTHER	Holderness drain that marks northern border. Fields drain into it. Photo E-W	W

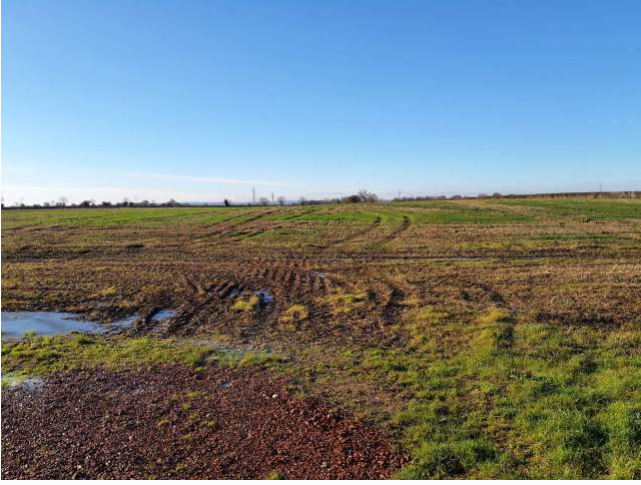
OTHER	F14 from Eastern edge looking west. F15 to the left.	W

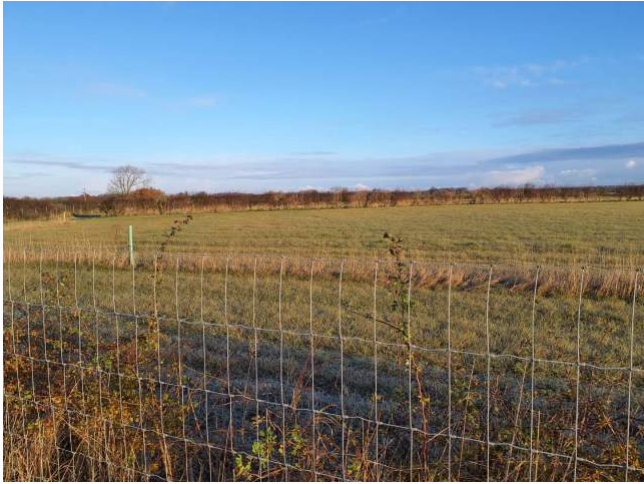
Select Feature	Description	Direction Taken	
1a. Main land use(s)	Land parcel below and to SW of F11 looking north taken from farm track.	N

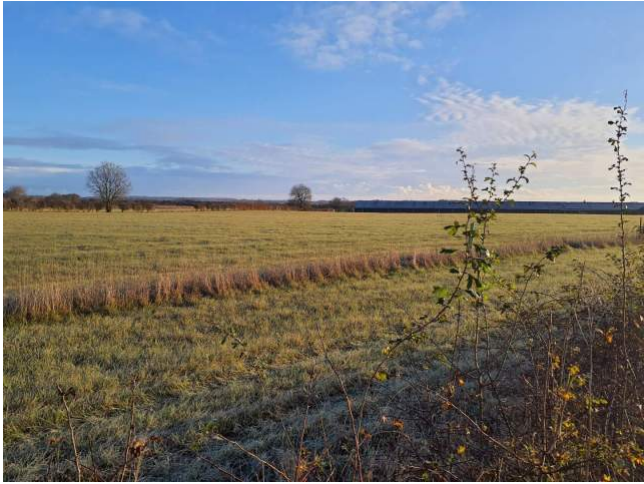
1a. Main land use(s)	As above but looking NE	NE

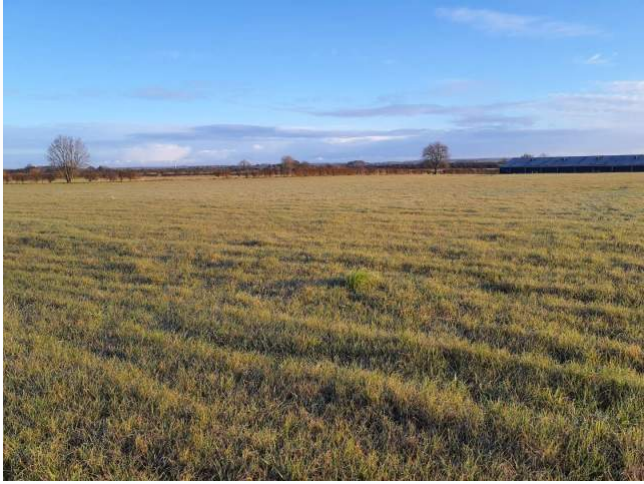
1a. Main land use(s)	Corner below F11 SW corner looking NE	NE

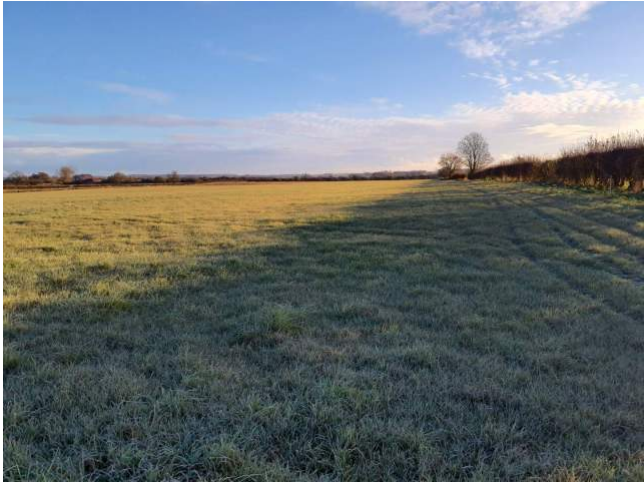
OTHER	SW corner of F11 looking east	E

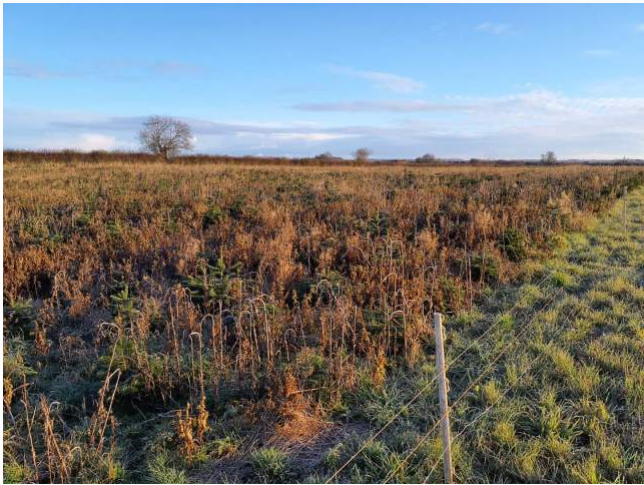
OTHER	NW corner of F11 looking NE showing more vegetation. Bound by electric fence.	NE

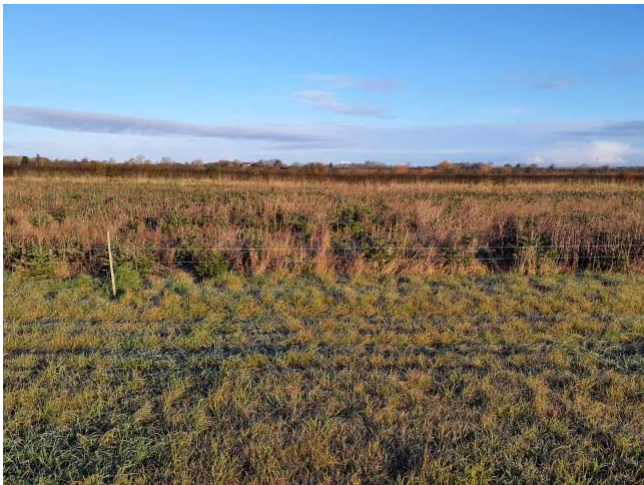
OTHER	Centre of F11 looking N from top of slight crest	N

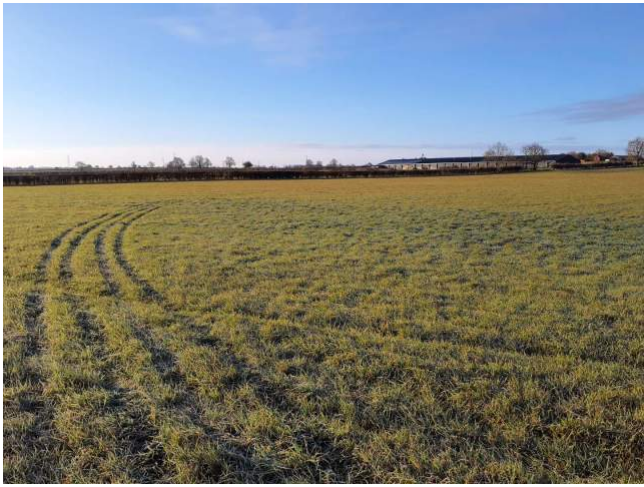
OTHER	Looking south west from Eastern edge of f11	SW

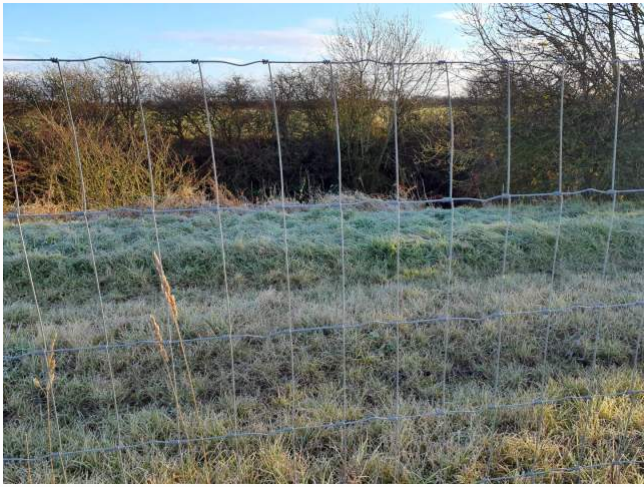
OTHER	Looking east from Eastern boundary of f11 showing fence, farm track then Holderness drain.	E

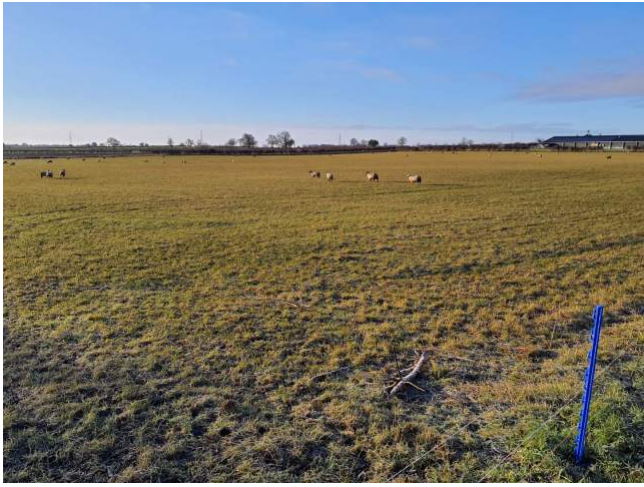
OTHER	Looking south from northern border of f12. Ground here is damp.	S

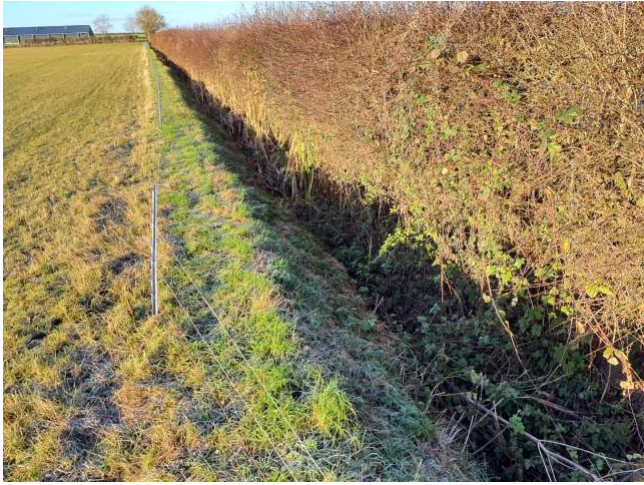
OTHER	Ditch as boundary between f11 and f12. Picture going E-W.	W

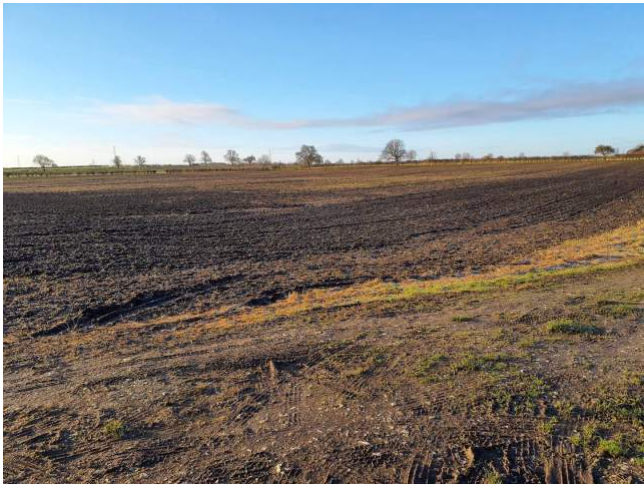
OTHER	F13 looking SW from NE corner	SW

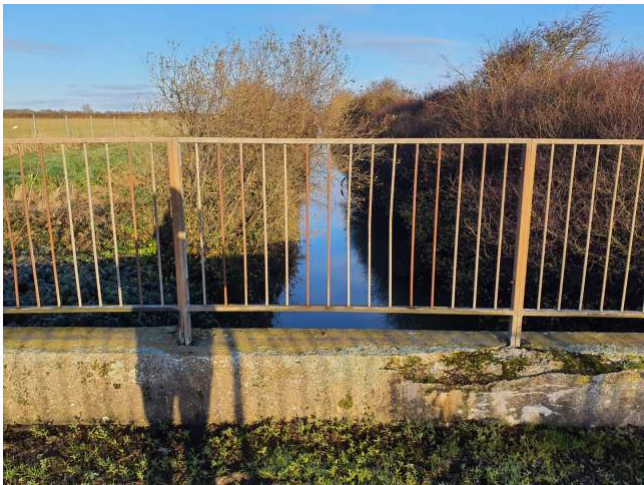
OTHER	Bridge at ne boundary of f13/SE boundary of f12 looking N over holderness drain	N

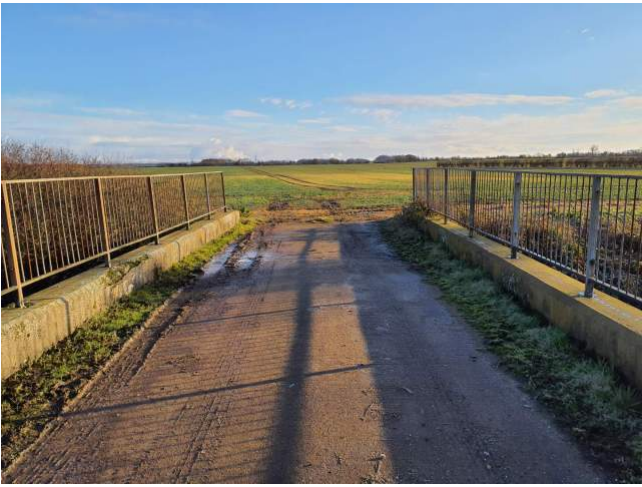
OTHER	As above but looking east	E

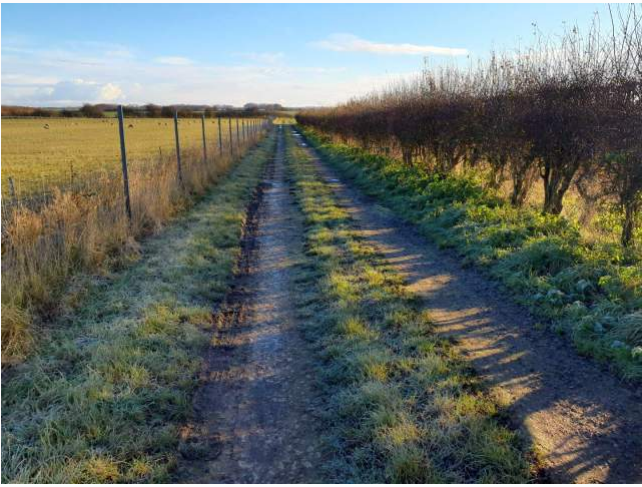
OTHER	Looking east down track between f12 to north and f13 to the south. Stood at sw and nw corner respectively	E

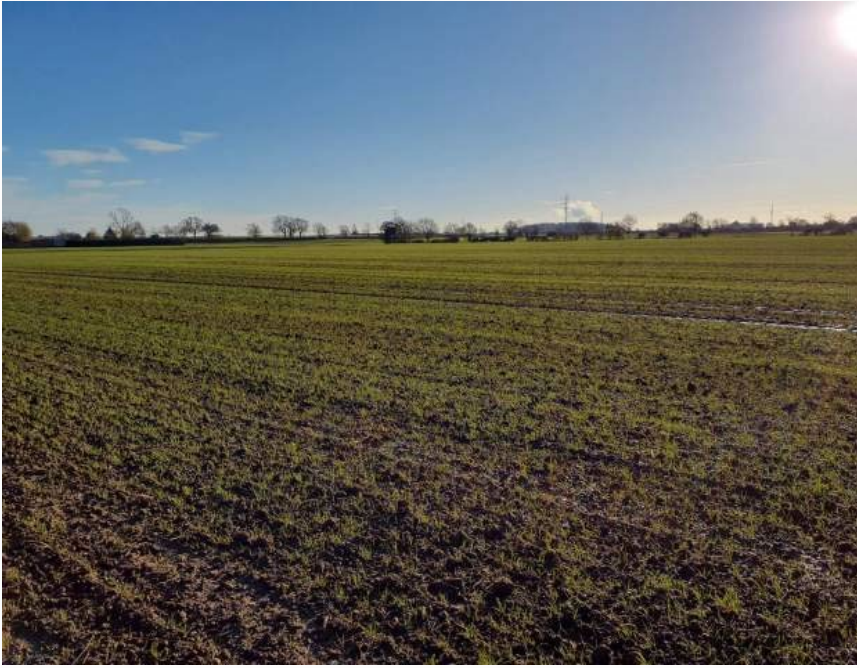
F5	From centre of Northern edge of F15 looking SE towards F17	SE

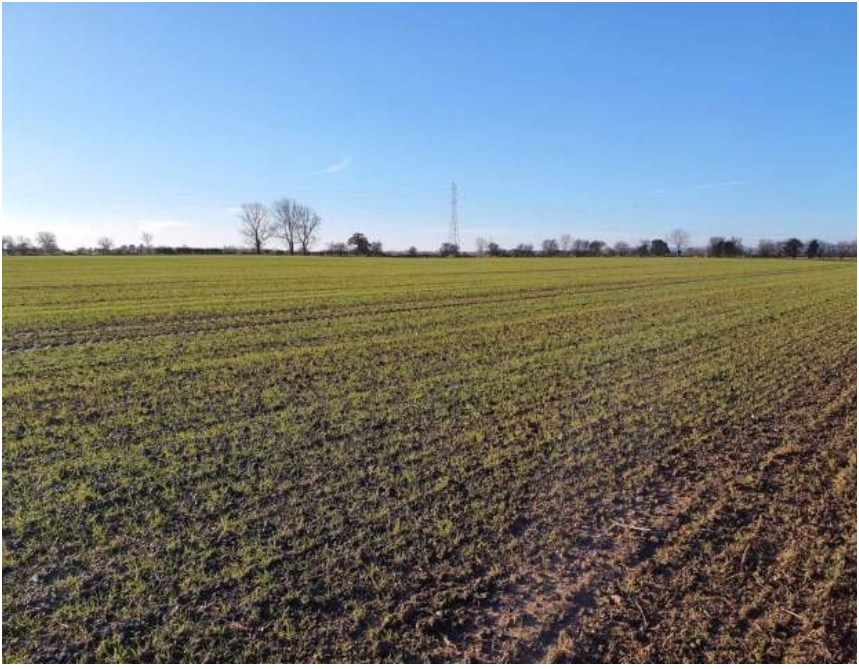
F6	From centre of Northern edge of F15 looking SW.	SW

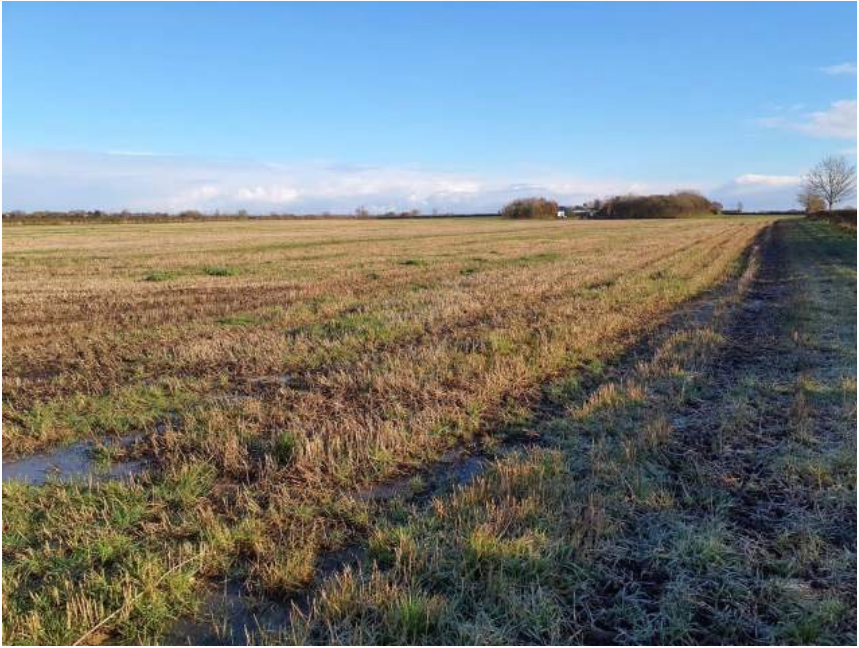
F9	From SW corner of F14 looking NE with F9 and F10 in distance.	NE

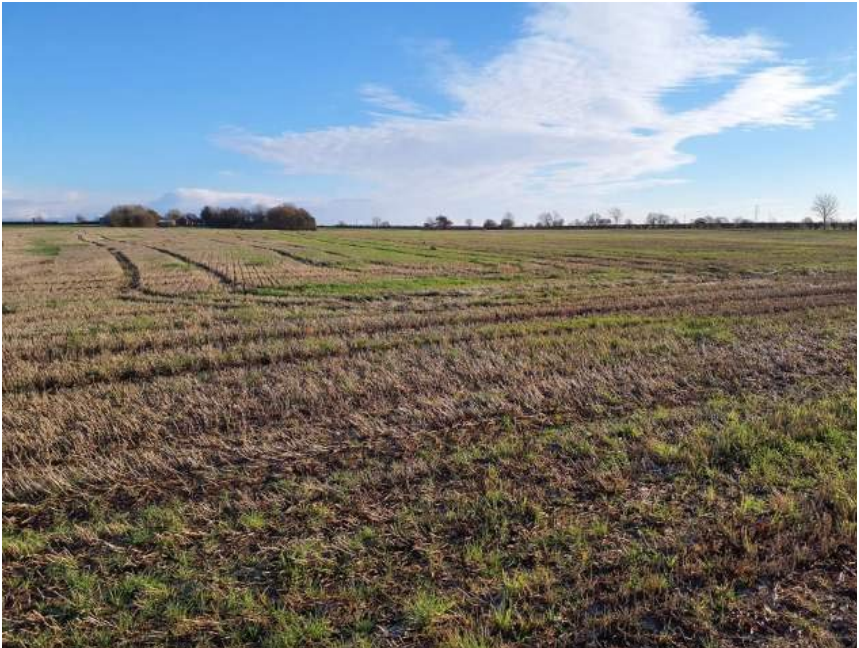
F10	NW corner of F14 looking SE. Farm building is eastern boundary.	SE

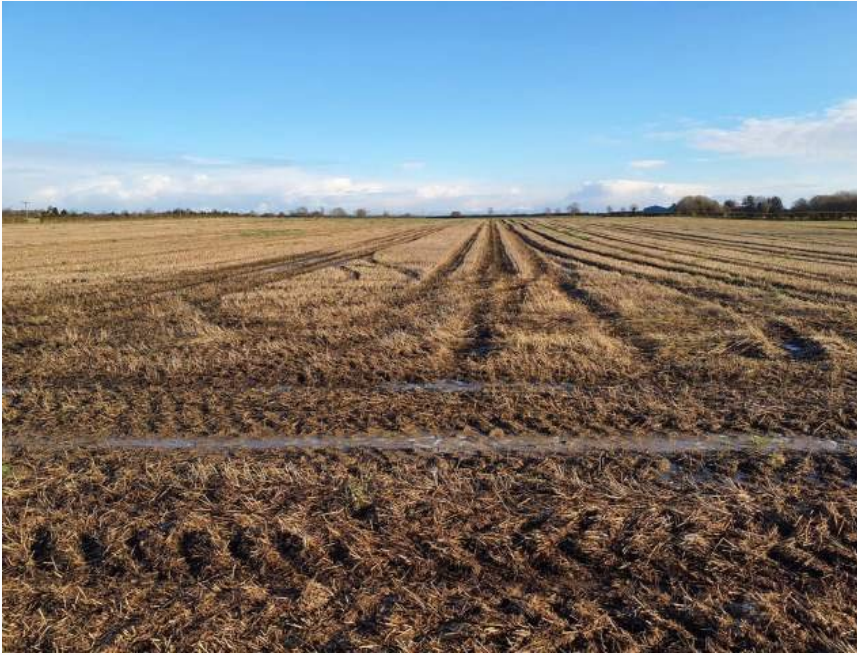
F11	Between F7 and F14 looking east towards F8 and F9	E

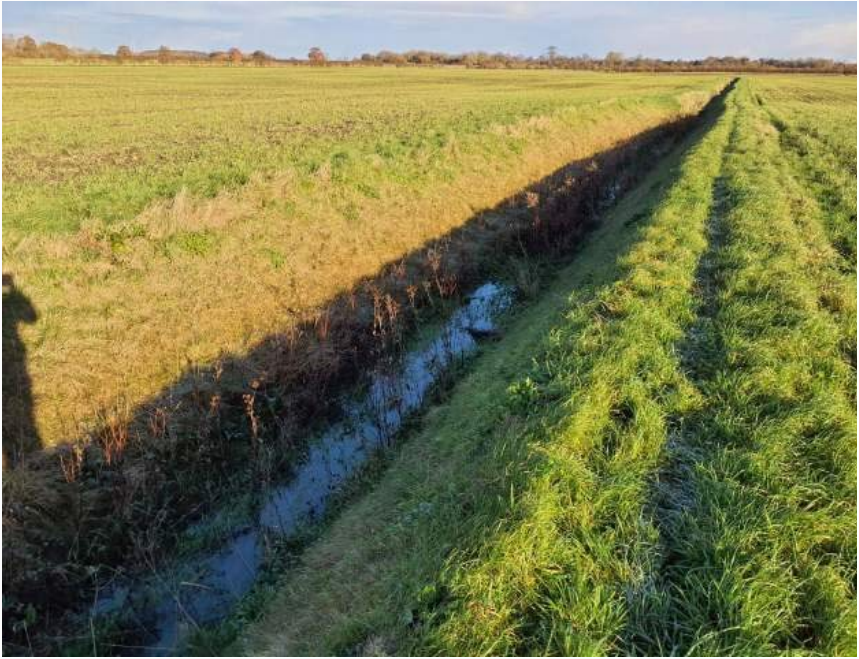
F15	Ditch on boundary between F1 and F2	E

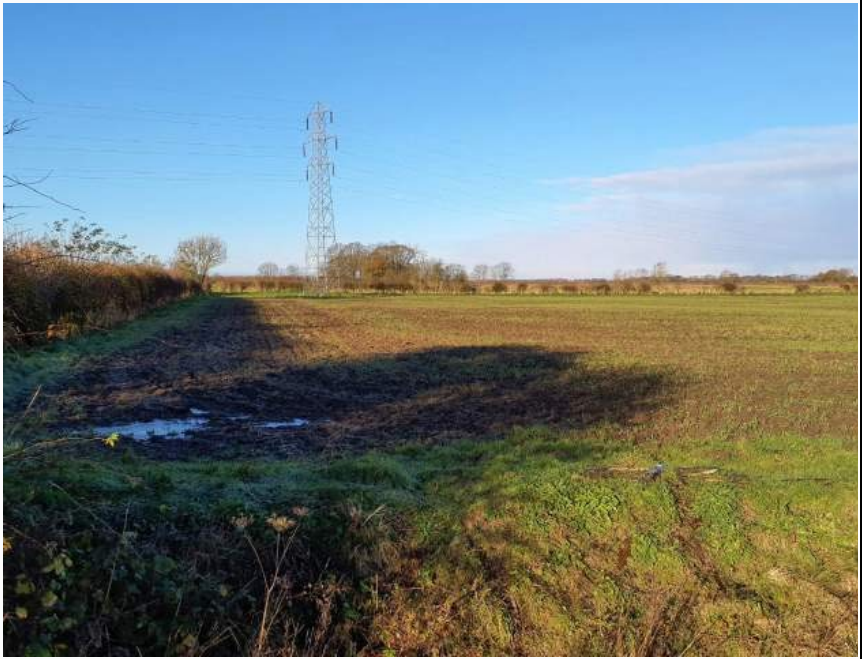
F17	Pylon in northwestern corner of F1, taken from NW corner of F2.	N

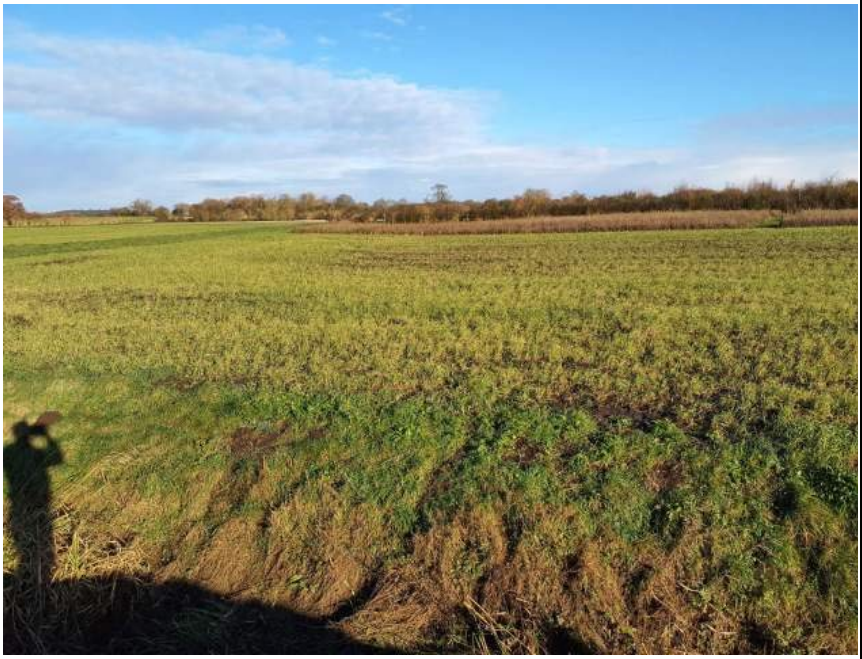
F18	Western edge of F3 looking NE showing F3 and north-eastern corner of F1. F3 is bound on all sides by the ditch.	NE

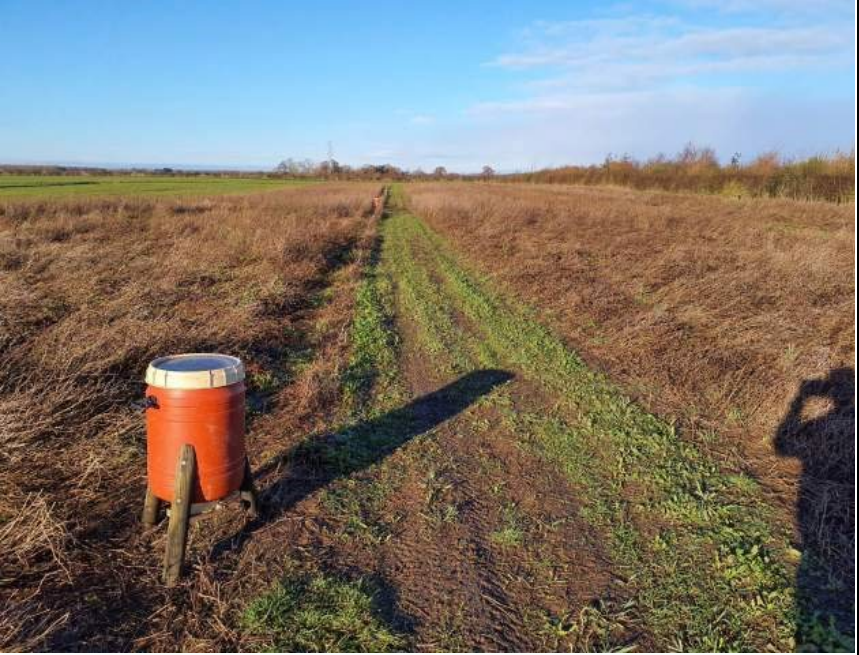
F23	Feeders in marshier area on east of F3.	N

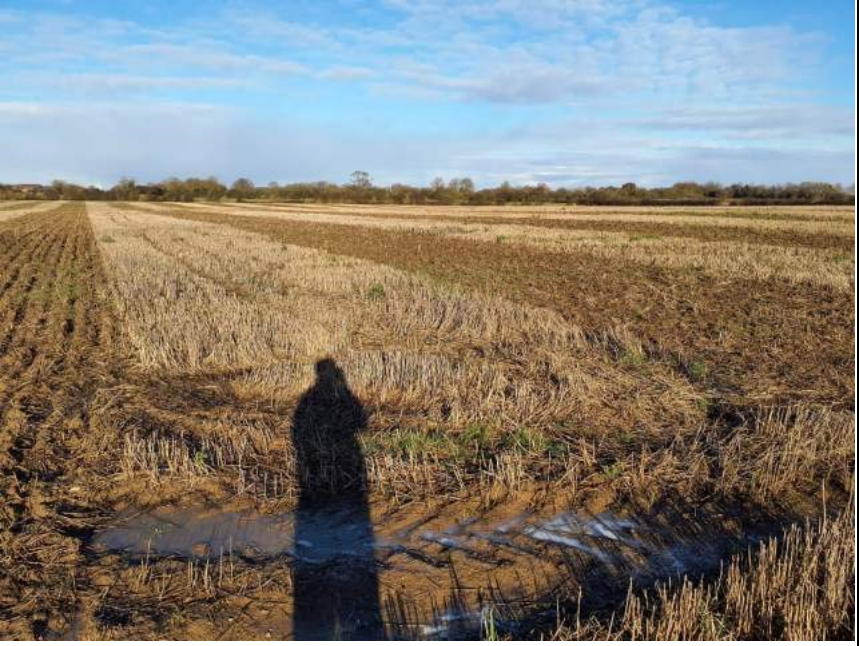
F24	F4 looking north from south-western boundary	N

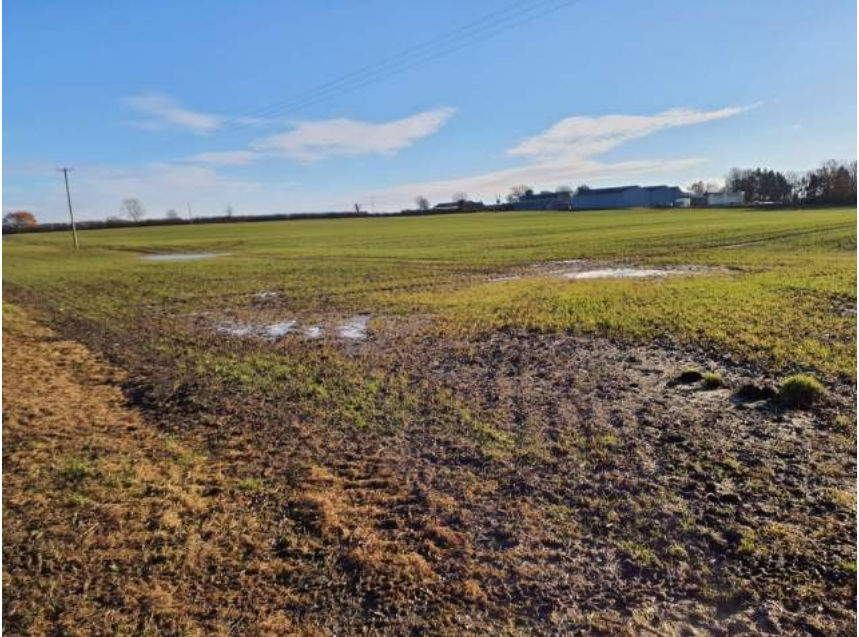
F29	<p>Looking SE from SW corner of F5 over F9 and F10. Pylons run E-W extending west over F8. They divert south when they meet the road.</p>	SE

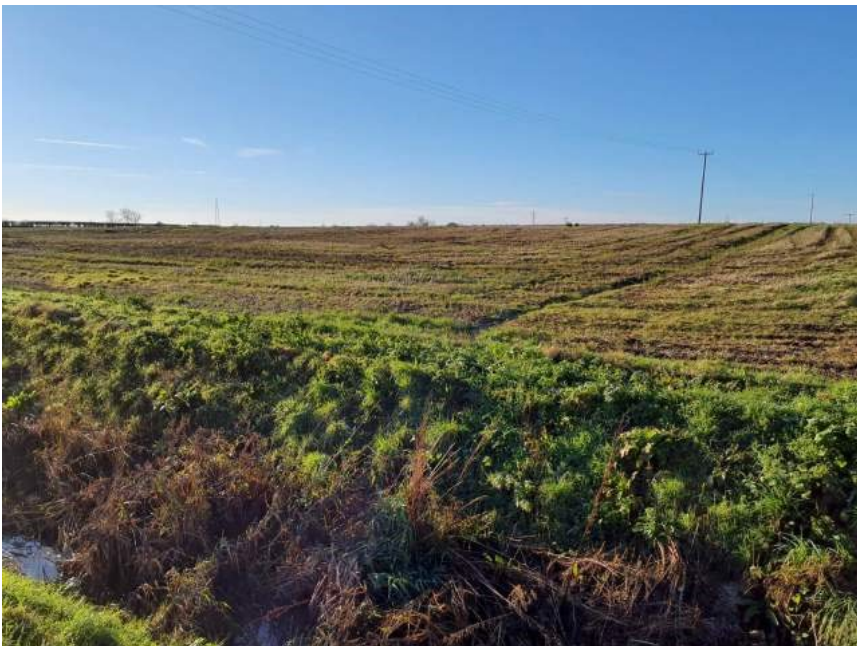
F30	<p>Looking SW over F8 from SW corner of F5. Note ditch between F8 and F9 and slight crest on F8 with pylons continuing from F9.</p>	SW

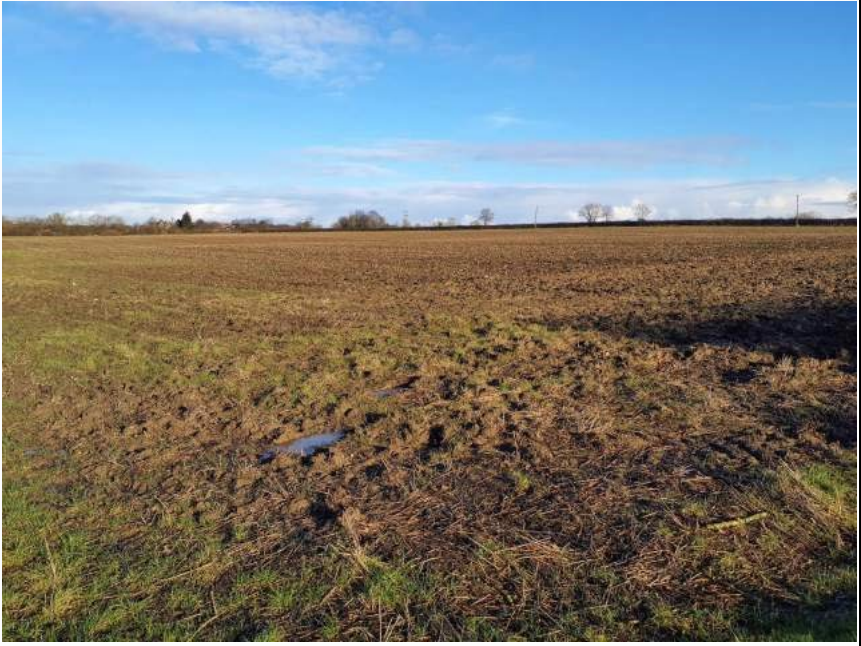
F31	Looking ne over F6 with road as Eastern boundary marked by pylons/ Meaux Road.	NE

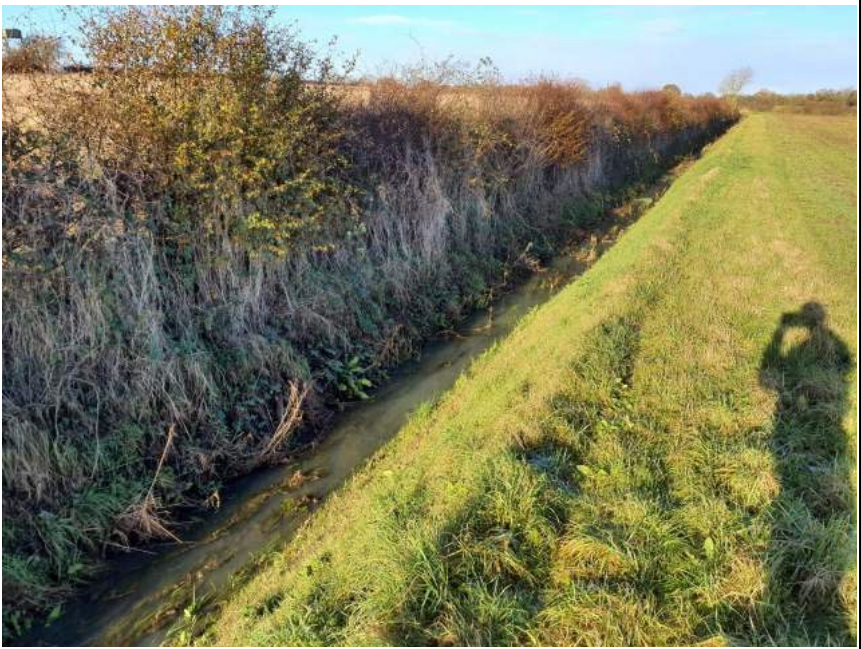
F32	Ditch along Western boundary of F6. Runs N-S.	N

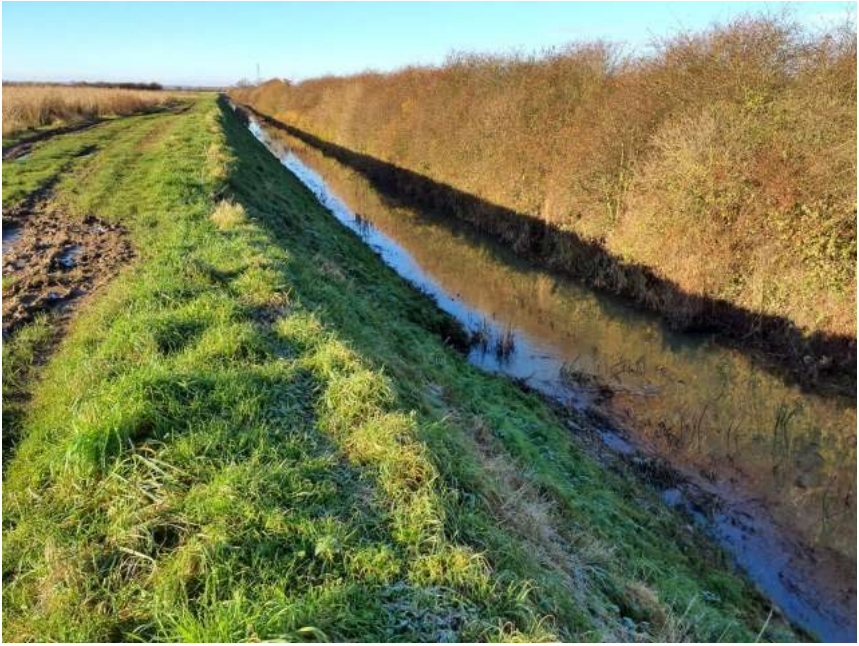
F33	Holderness drain that marks northern border. Fields drain into it. Photo E-W	W

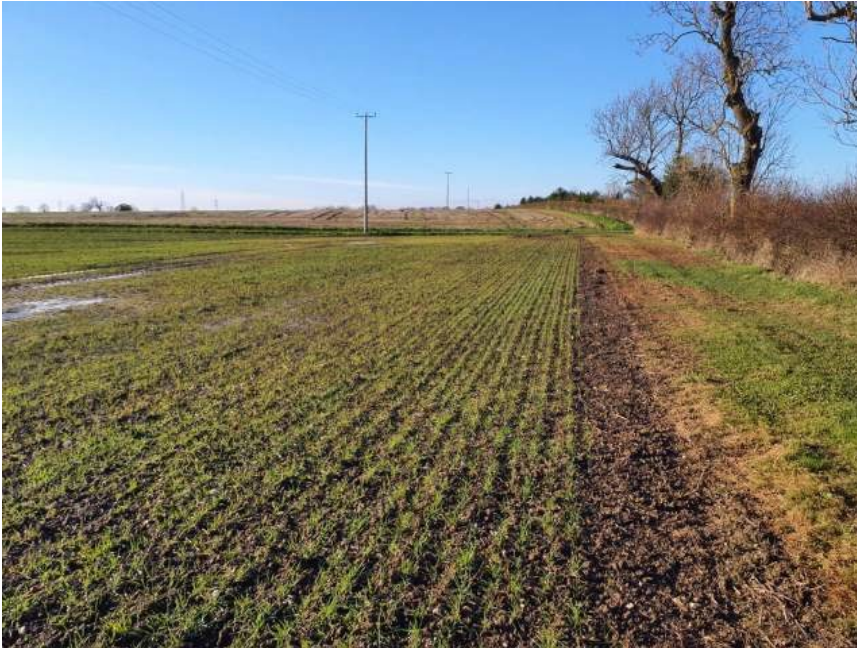
F34	Pylons running down northern edge of F10,9,8 looking west. Pylons run to Meaux road and then south along Meaux road.	W

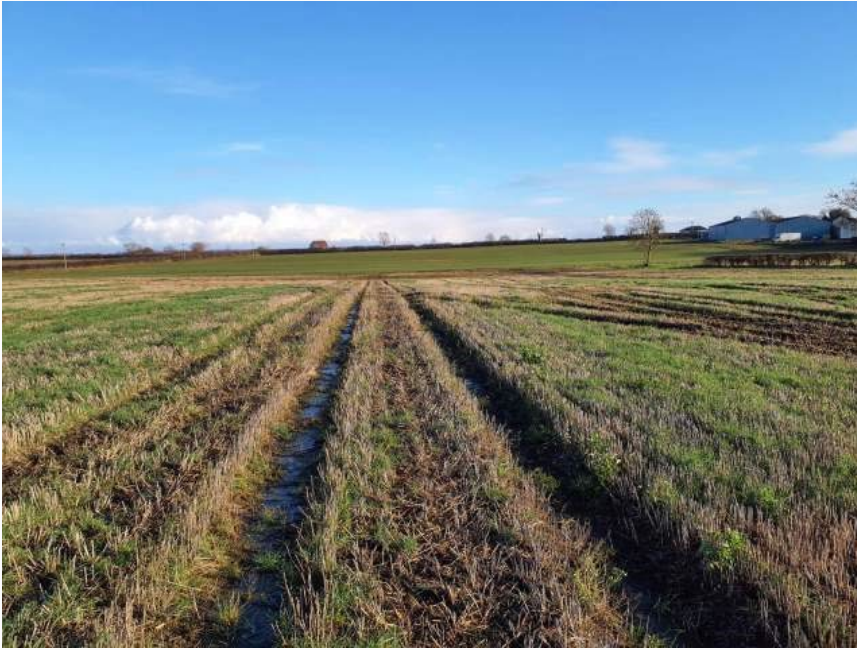
F35	From middle of F8 looking east over F9 and F10 towards Meaux Road.	E
