## Land Parcel C, Site Walkover Photographs

Site Walkover Questionnaire.

Date	30/11/2023
Project Name	Peartree solar farms
Project No.	323165
Site Name	Area D
GPS Location	53° 51' 51.965" N 0° 20' 28.8" W
Site Engineer	Matthew Fenton
Accompanied by	
Site Engineer Arrival Time	30/11/2023, 08:00
Site Engineer Departure Time	30/11/2023, 10:30
Other RSK Staff On Site	
Weather Conditions	<div><div><input type="checkbox"/> Heavy Rain</div><div><input type="checkbox"/> Rain</div><div><input type="checkbox"/> Drizzle</div><div><input type="checkbox"/> Overcast</div><div><input checked="" type="checkbox"/> Cloudy</div><div><input checked="" type="checkbox"/> Sunny Spells</div><div><input type="checkbox"/> Sunny</div><div><input type="checkbox"/> Fog</div><div><input type="checkbox"/> Snow</div><div><input type="checkbox"/> Thunder</div><div><input type="checkbox"/> Hail</div></div>

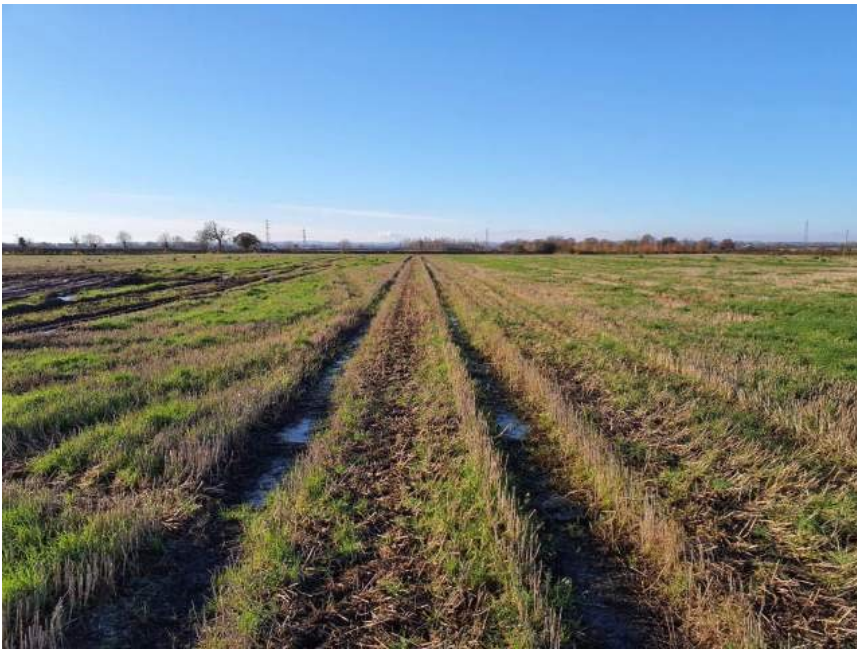
F36	Same position looking west over F7 with f2 to north and F14 to South.	W

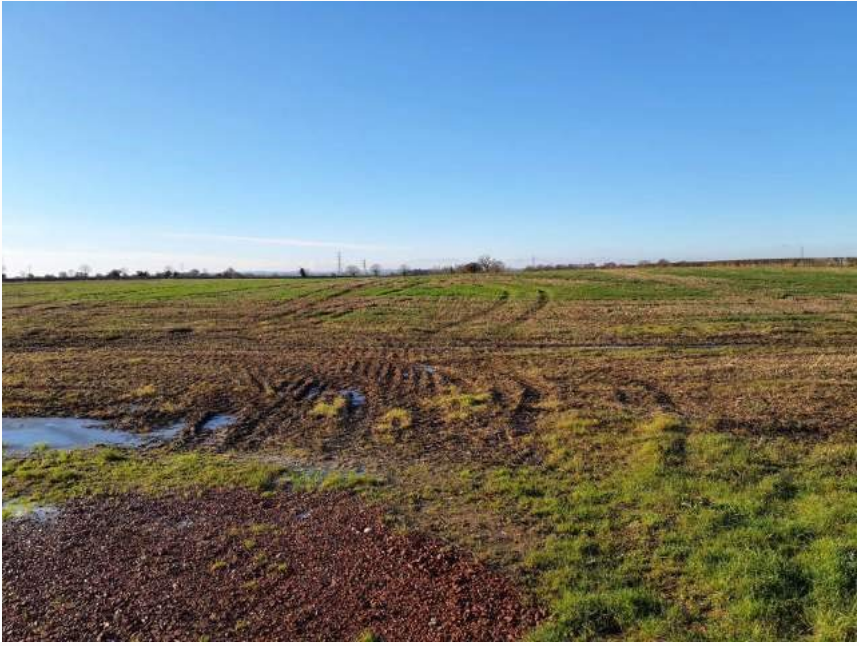
F37	F14 from Eastern edge looking west. F15 to the left.	W

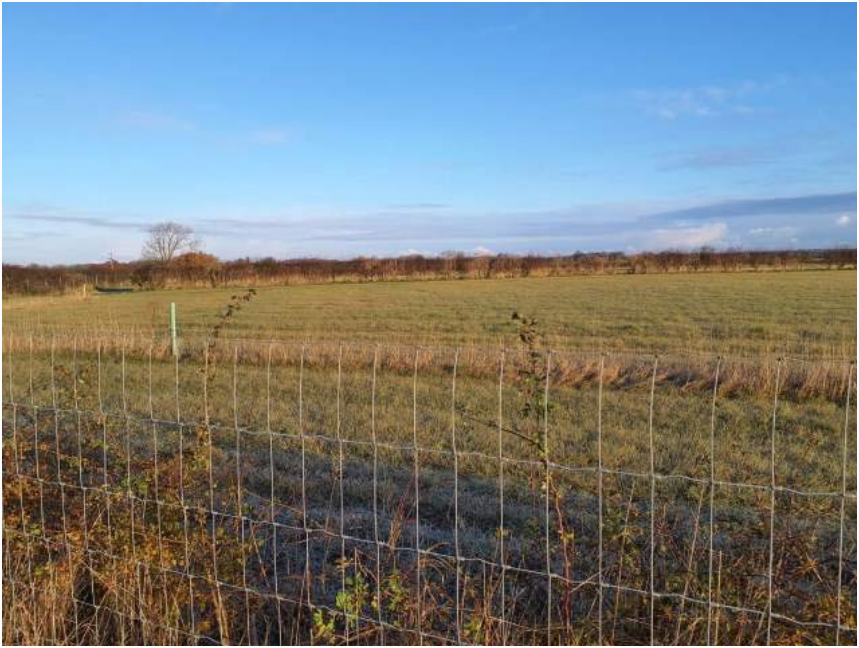
F38	Land parcel below and to SW of F11 looking north taken from farm track.	N

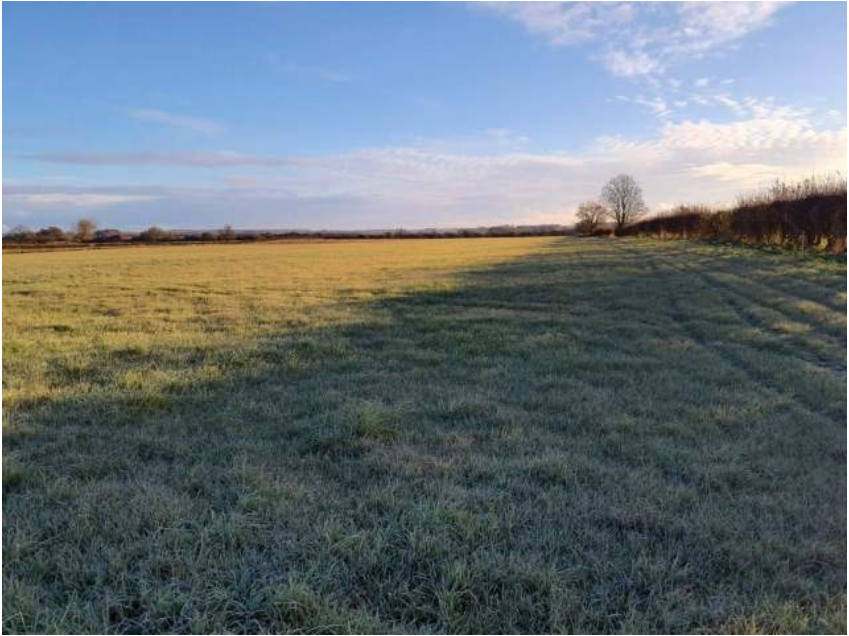
F41	SW corner of F11 looking east	E

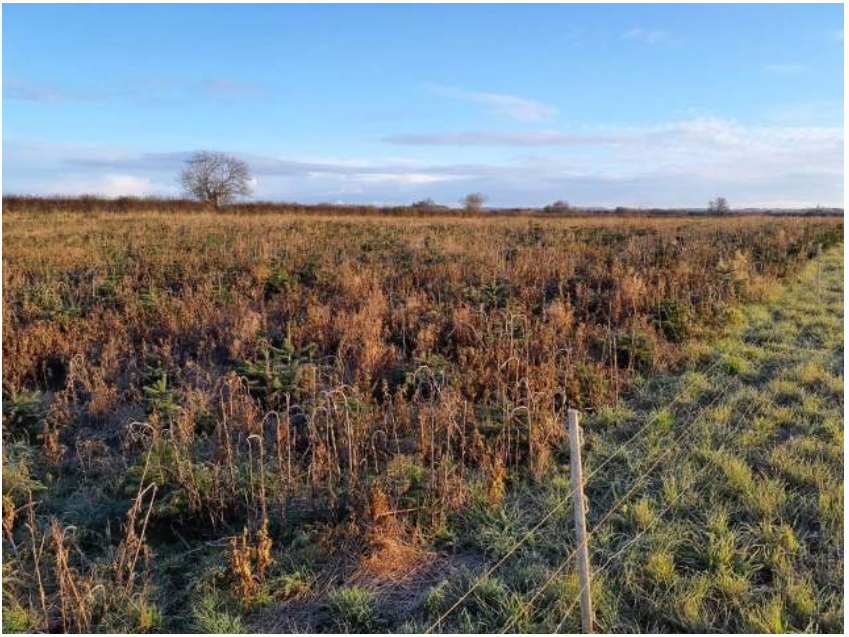
F42	NW corner of F11 looking NE showing more vegetation. Bound by electric fence.	NE

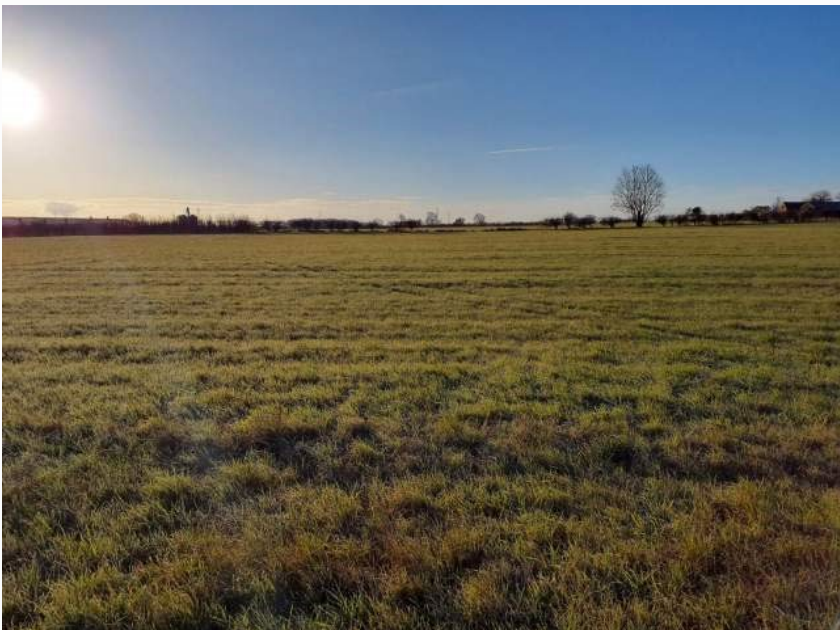
F43	Centre of F11 looking N from top of slight crest	N	 
F44	Centre of F11 looking south from top of slight crest	S

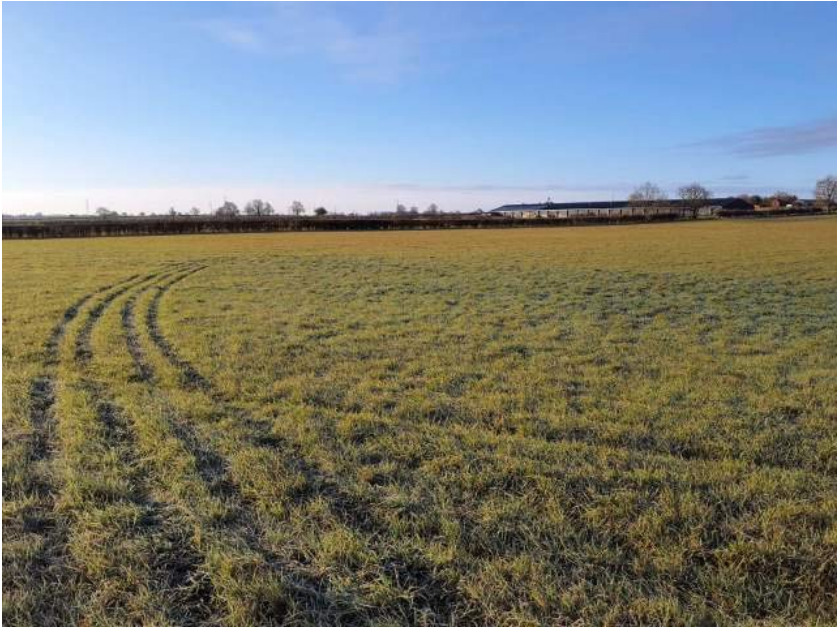
F47	Looking south west from Eastern edge of F11	SW

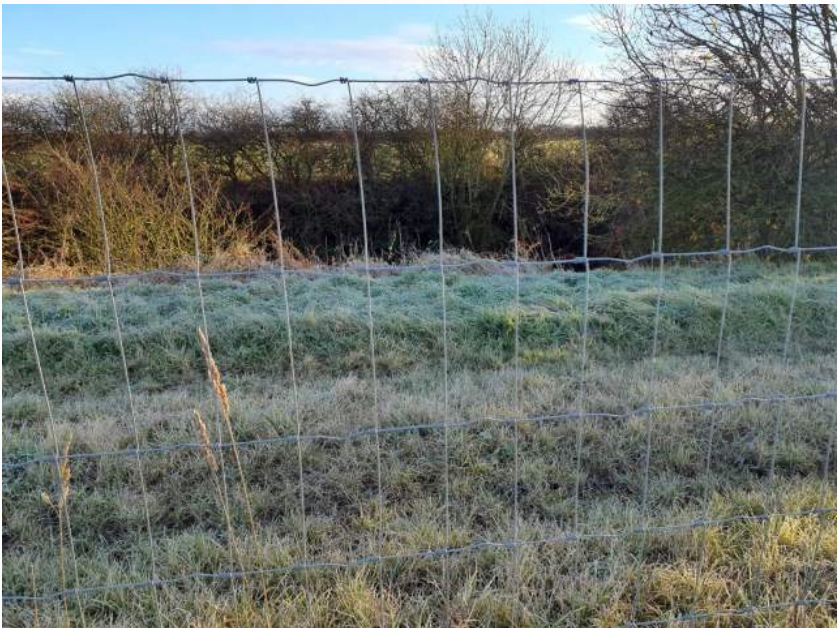
F48	Looking east from Eastern boundary of F11 showing fence, farm track then Holderness drain.	E
