Site Walkover Questionnaire.

Date	15/03/2024
Project Name	One earth solar
Project No.	323323
Site Name	Route 7: one earth solar
GPS Location	53° 14' 25.439" N 0° 47' 6.863" W
Site Engineer	Euan Gray-Stephens
Accompanied by	
Site Engineer Arrival Time	15/03/2024, 09:07
Site Engineer Departure Time	
Other RSK Staff On Site	
Weather Conditions	<div><input type="checkbox"/> Heavy Rain</div> <div><input type="checkbox"/> Rain</div> <div><input type="checkbox"/> Drizzle</div> <div><input type="checkbox"/> Overcast</div> <div><input checked="" type="checkbox"/> Cloudy</div> <div><input type="checkbox"/> Sunny Spells</div> <div><input type="checkbox"/> Sunny</div> <div><input type="checkbox"/> Fog</div> <div><input type="checkbox"/> Snow</div> <div><input type="checkbox"/> Thunder</div> <div><input type="checkbox"/> Hail</div>
Any Other Details	
Due Diligence report?	<div><input checked="" type="checkbox"/> No</div> <div><input type="checkbox"/> Yes</div>

1a. Main land use(s)	Field 35 green crop	N

APPENDIX F TECHNICAL BACKGROUND

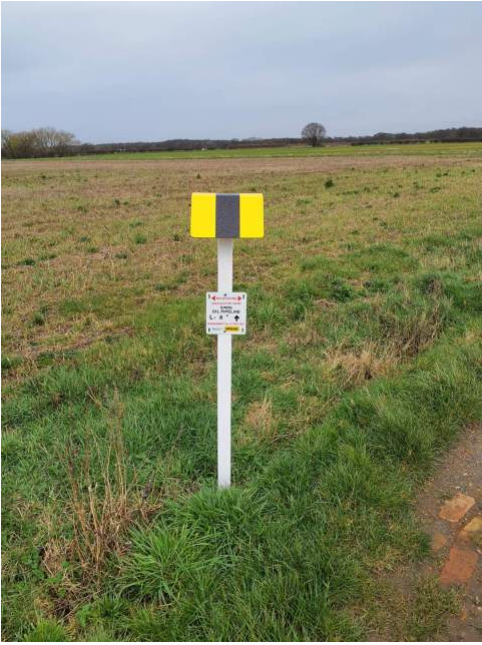
5c. Buried and overhead services	Oil pipeline marker field 27 and 30 boundary	NE

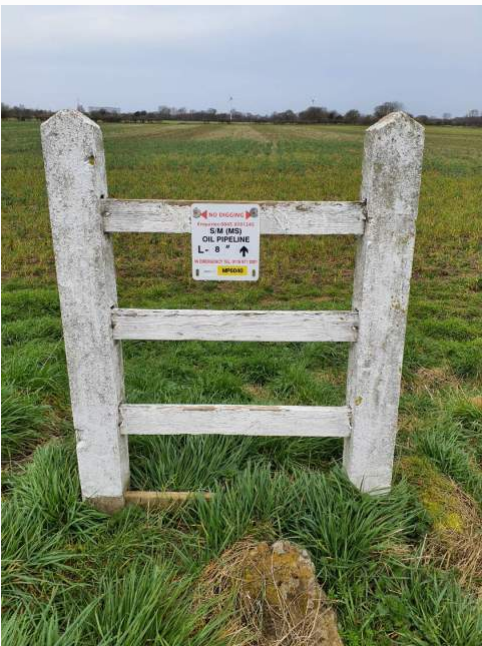
5c. Buried and overhead services	Oil pipe filed 10 boundary	N

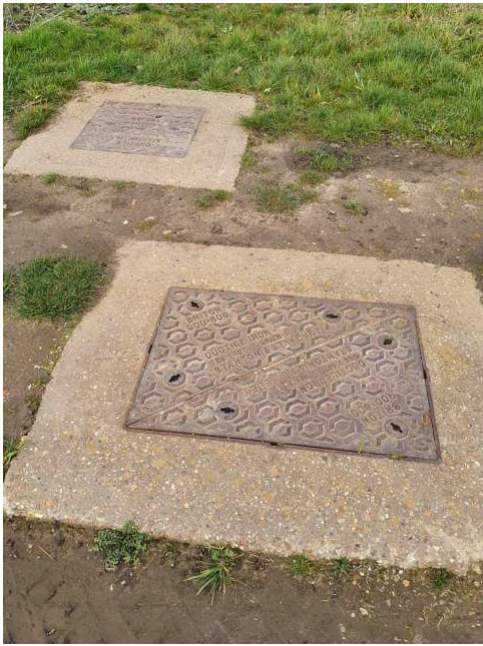
5c. Buried and overhead services	Manholes in road between fields	N

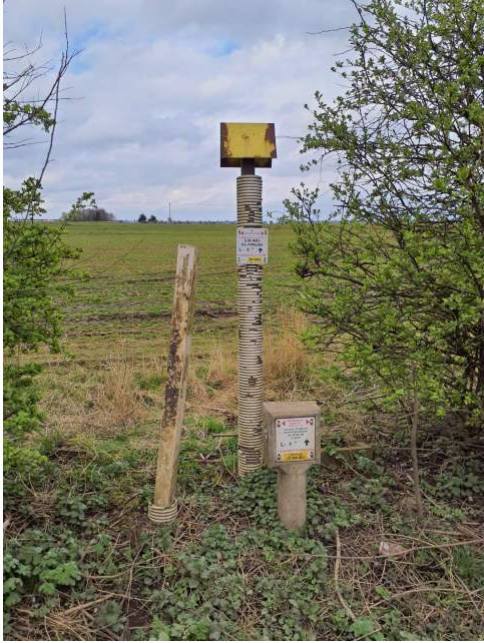
5c. Buried and overhead services	Oil pipe into field not part of development off the road	N

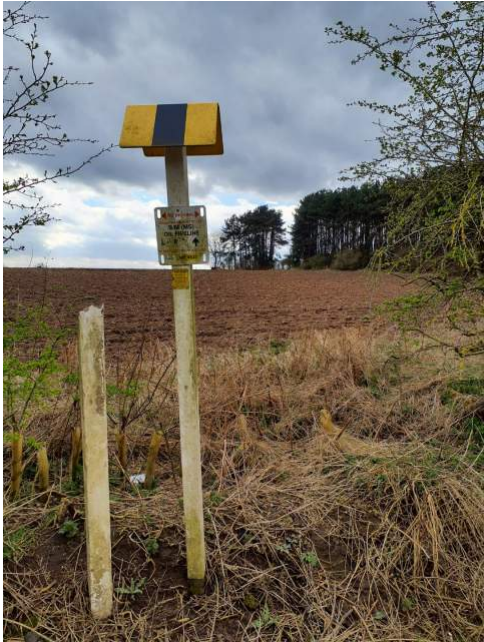
5c. Buried and overhead services	Oil pipe field 70	SW

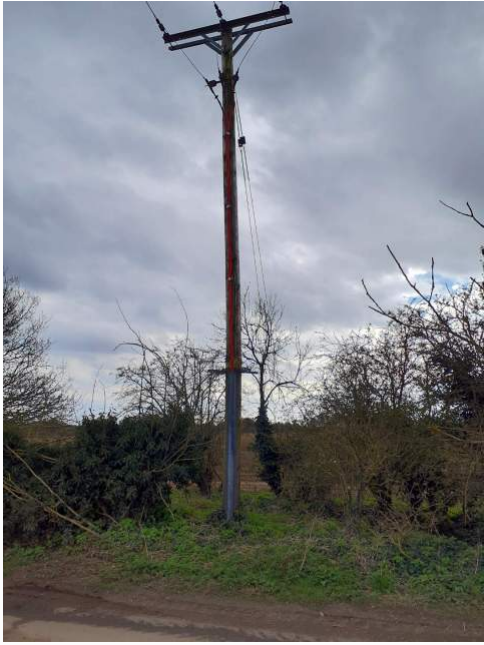
5c. Buried and overhead services	End of power line into underground cable, likely going into filed 70 to the south	S

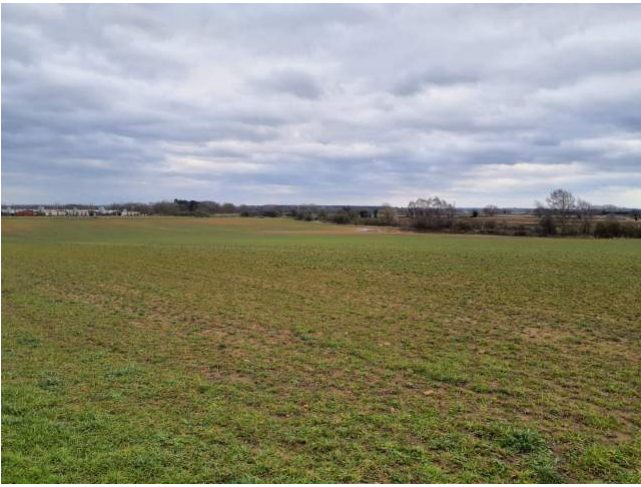
3a. Site Topography	Low point and dipping in centre of field 81	SE

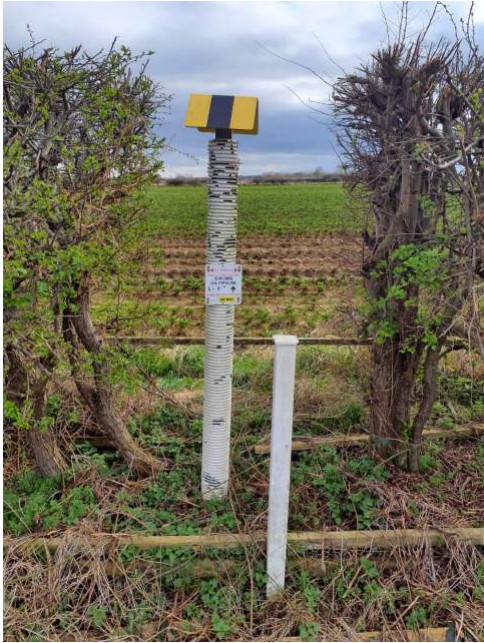
5c. Buried and overhead services	Oil pipe into field 94/95	S

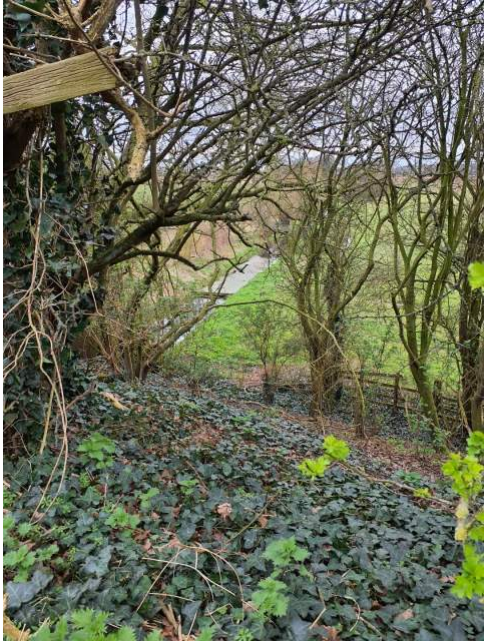
4f. Visual evidence of contamination of surface waters	Silt/leach trap in ditches in field 82. Green algae (?) Build up behind it	W

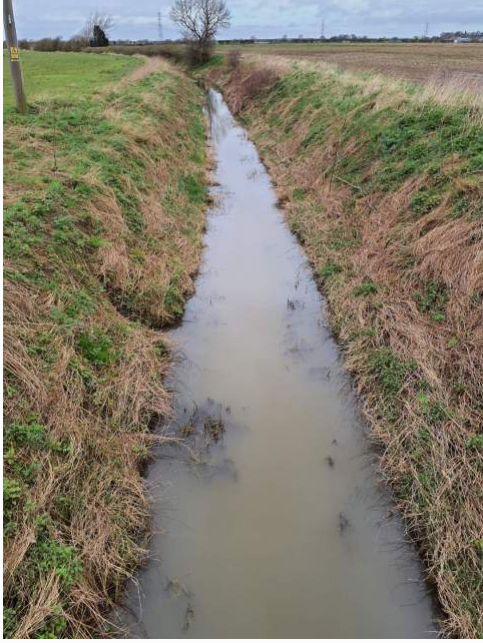
4e. Surface waters adjacent (within 250m)	Adjacent ditch flowing to trent. Murky discoloured	W

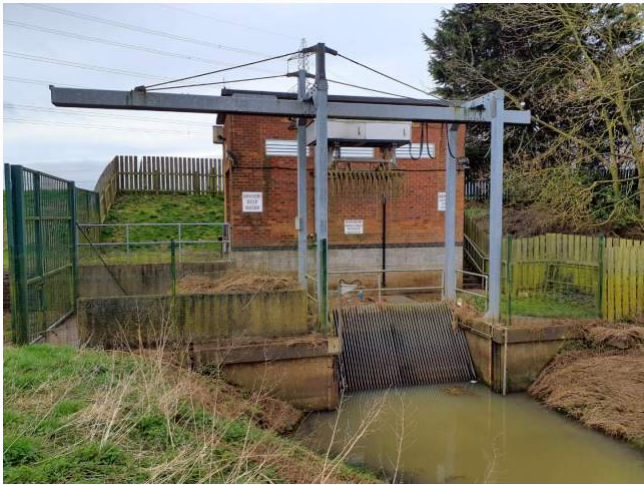
1c. Adjacent land use(s)	Pump station and sluice	E

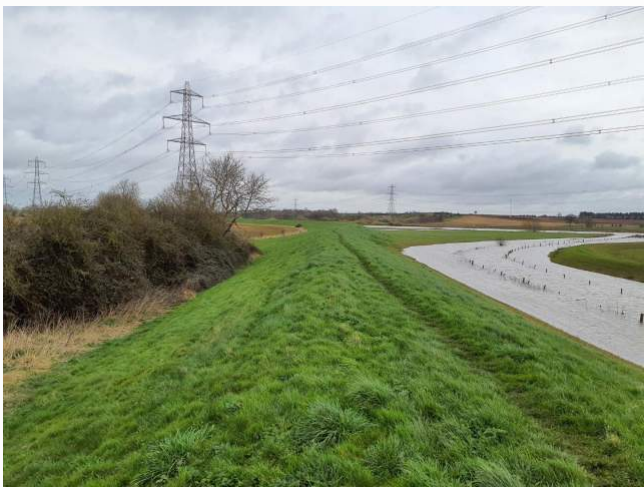
1d. Site boundaries.	Appreciate 4m tall bund Eastern boundary	N

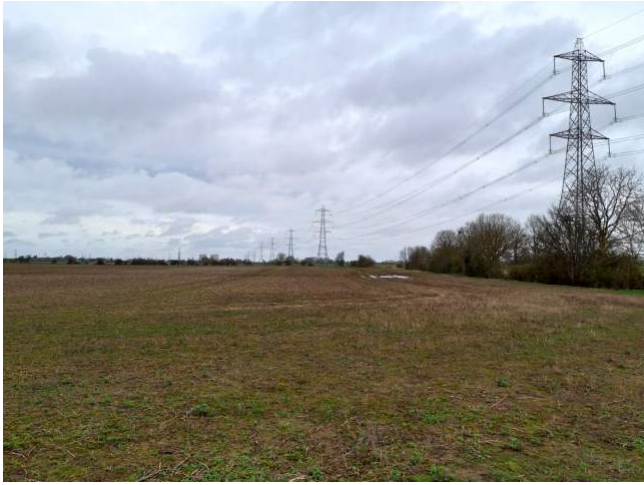
1a. Main land use(s)	Bare crop and pylons	N

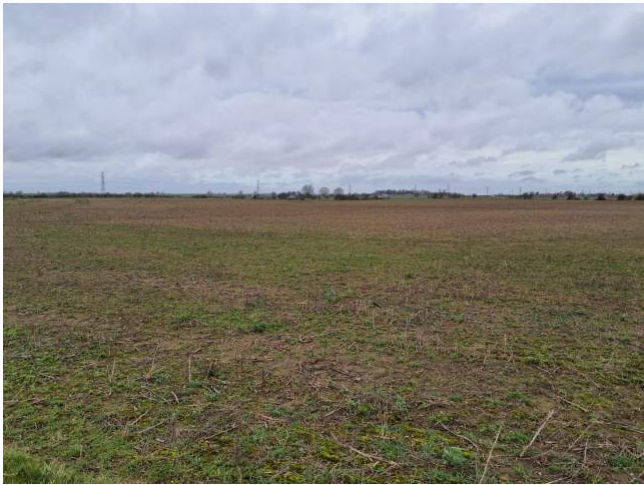
1a. Main land use(s)	Bare crop	NW

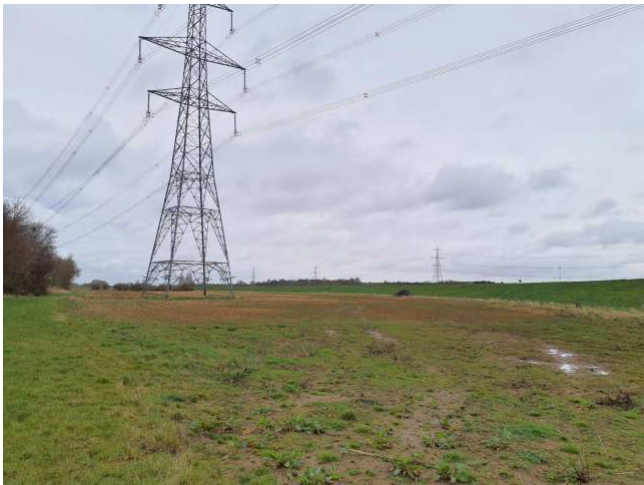
1c. Adjacent land use(s)	Bare adjacent field	N

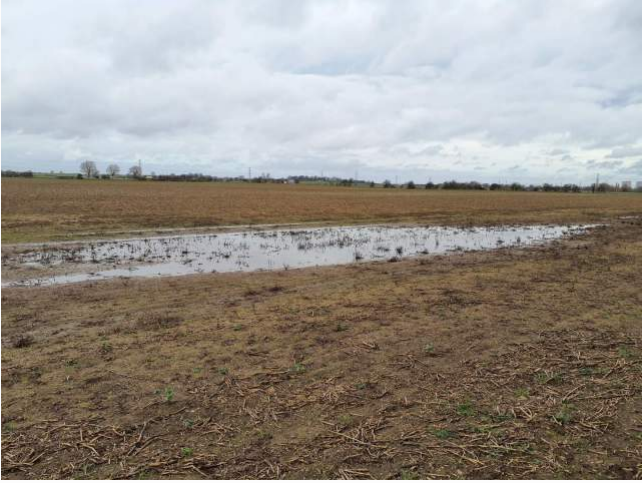
4i. Waterlogging or flooding	Local surface flooding	NW

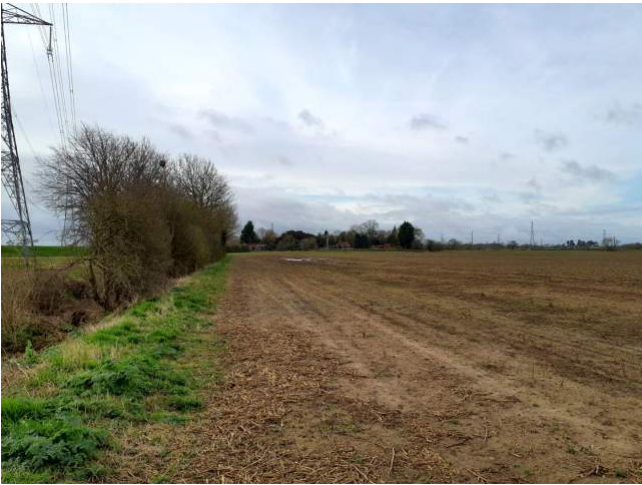
1d. Site boundaries.	Field 35 east boundary	S

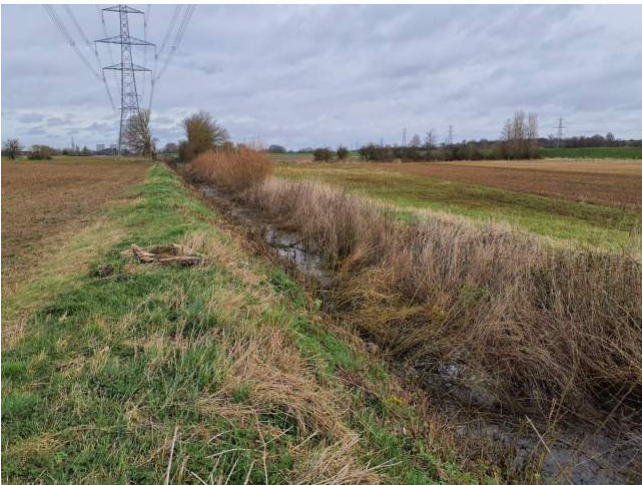
1d. Site boundaries.	Boundary and ditch	NE

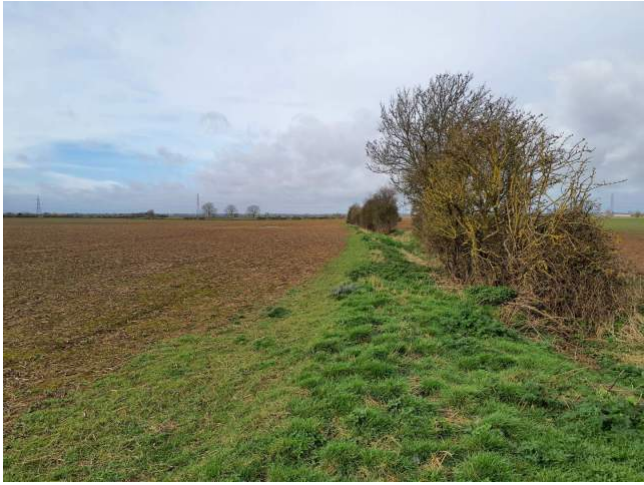
1a. Main land use(s)	Field 35 bare	W

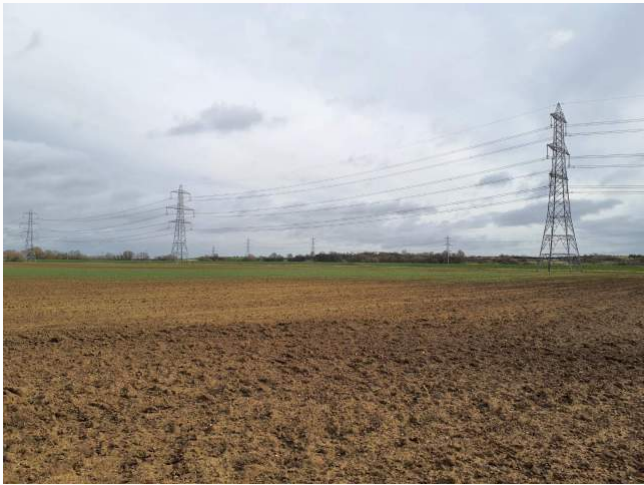
1a. Main land use(s)	Field 35 recently plowed or drilled and planted, some bare some green	NE

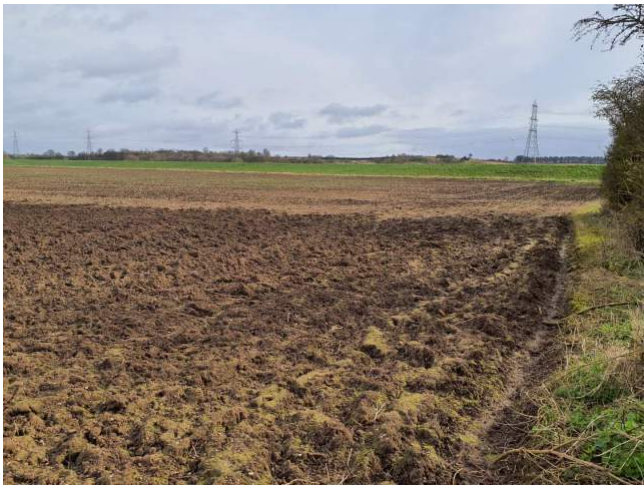
1a. Main land use(s)	Recently plowed or drilled field 35	NE

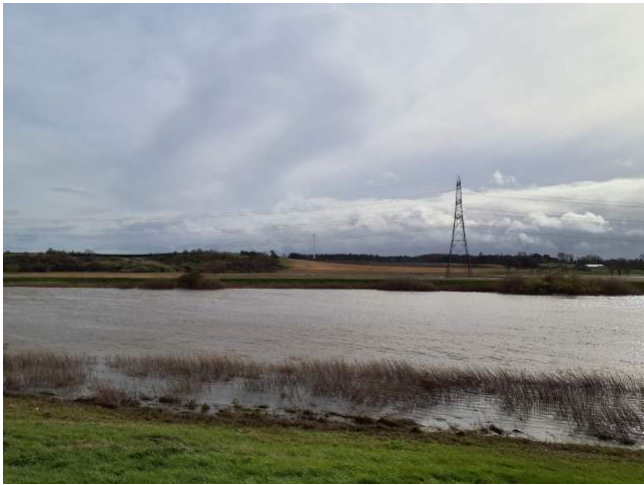
3a. Site Topography	Dipping field adjacent to the Reservoir	E

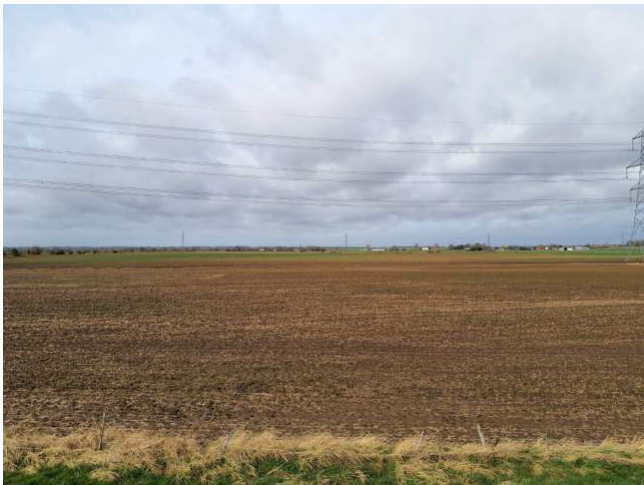
1a. Main land use(s)	Field 35 recently plowed and planted	W

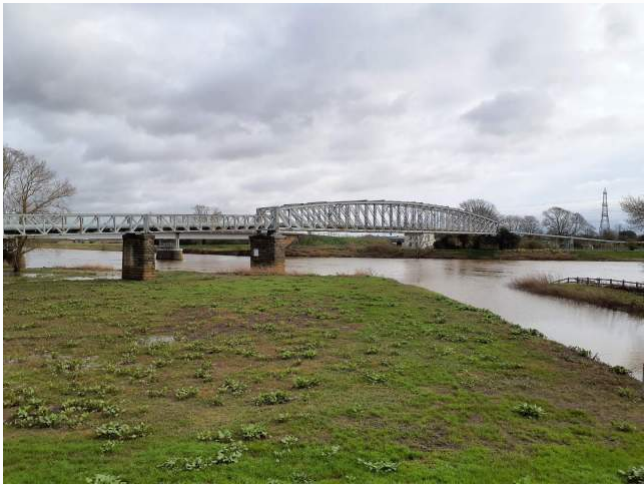
1c. Adjacent land use(s)	Detour - Dunham pipeline bridge	NE

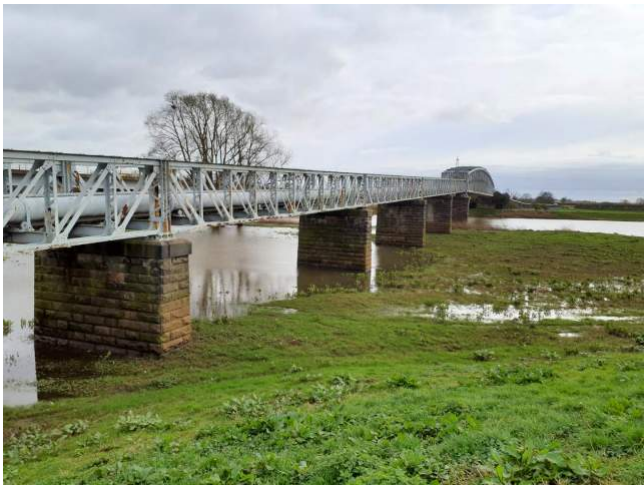
1b. Current site activities.	Dunham pipeline bridge	E

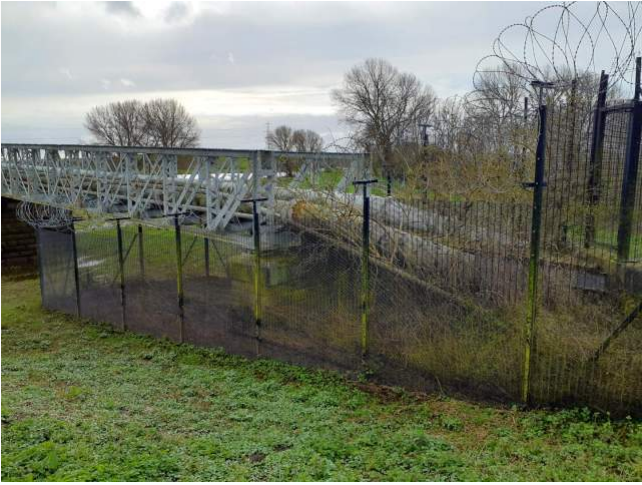
1c. Adjacent land use(s)	Detour - Dunham, pipeline bridge	SE

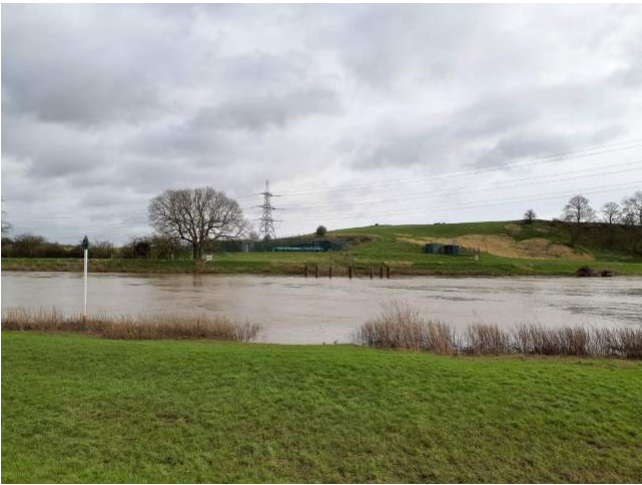
1c. Adjacent land use(s)	Detour - unkmo2n infrastructure. Large pipeline, generations or electrical boxes and very tall barbed fence, east side of trent	E

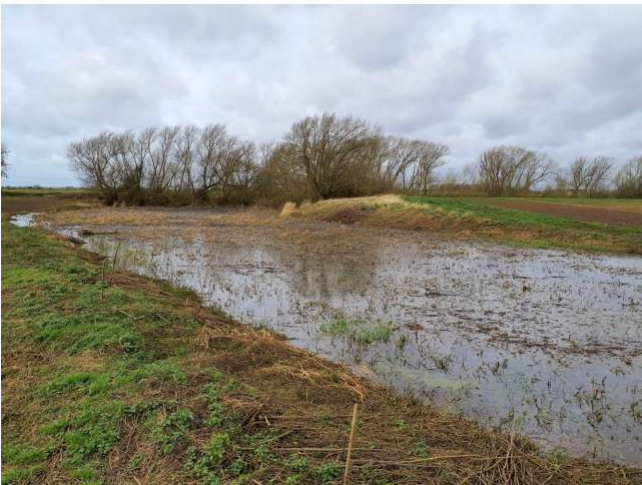
4e. Surface waters adjacent (within 250m)	Pond immediately adjacent to to north Eastern sector	W

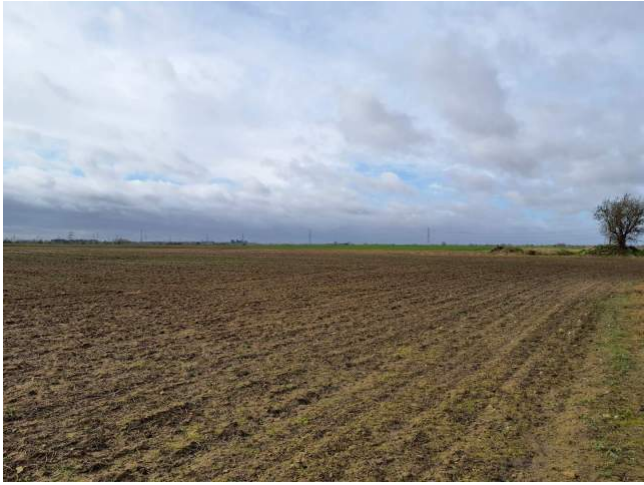
1a. Main land use(s)	North East corner of field 35	SW

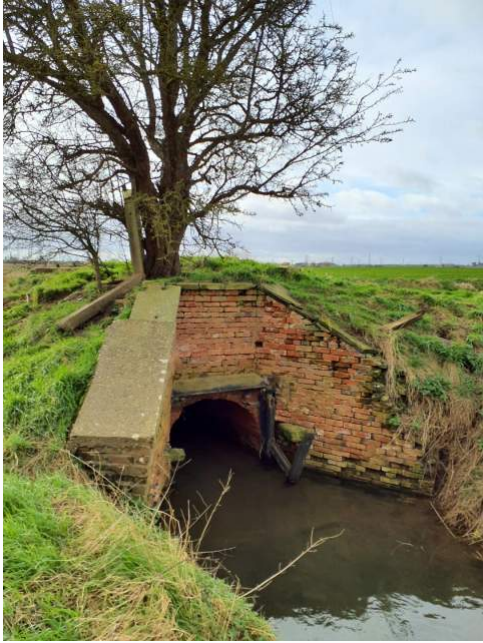
4d. Surface waters on site	Culvert into ditches	SW

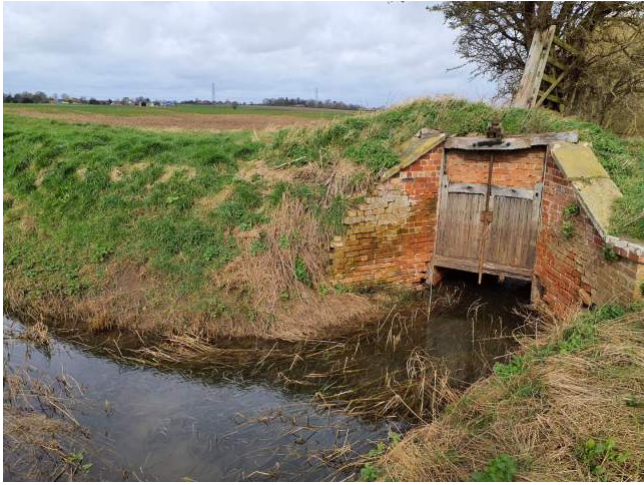
4g. Site drainage	Sluice	N

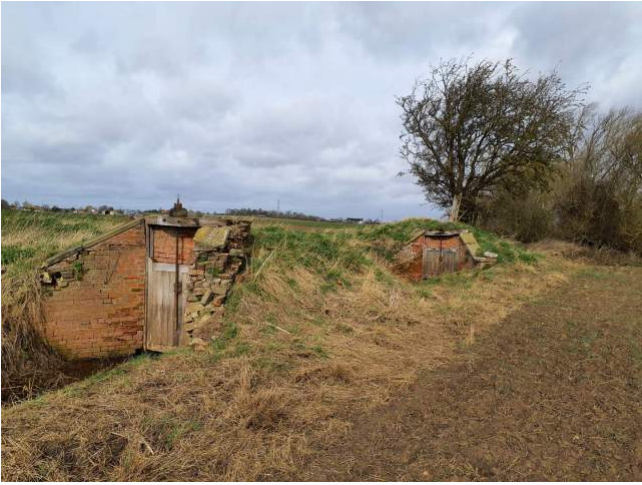
4g. Site drainage	Sluice gates	N

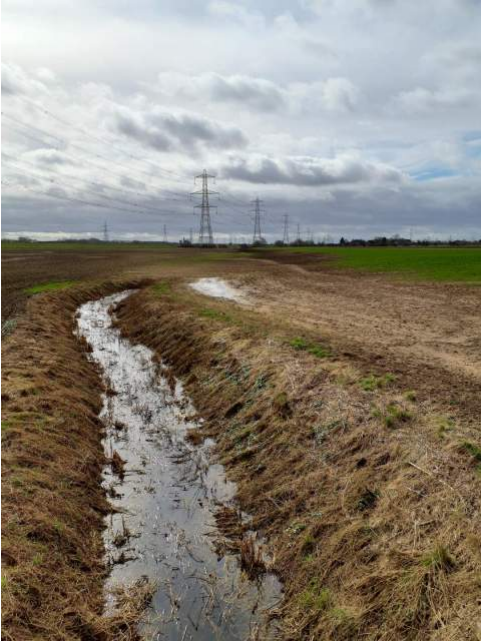
4g. Site drainage	Likely drainage system subsurface running south, flowing north jnto the sluice gates	S

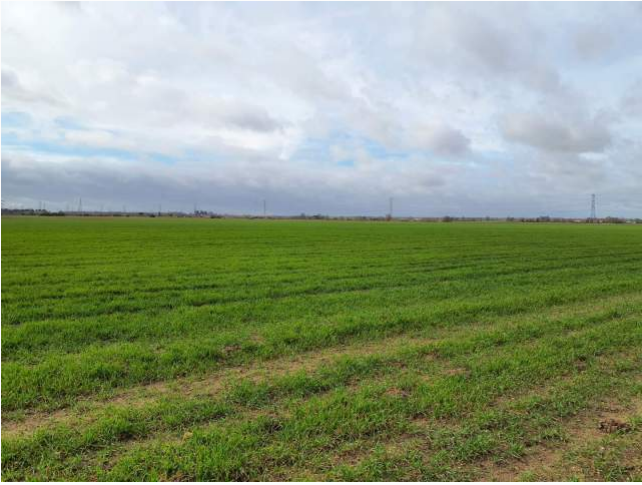
1a. Main land use(s)	Field 35 green crop	SW

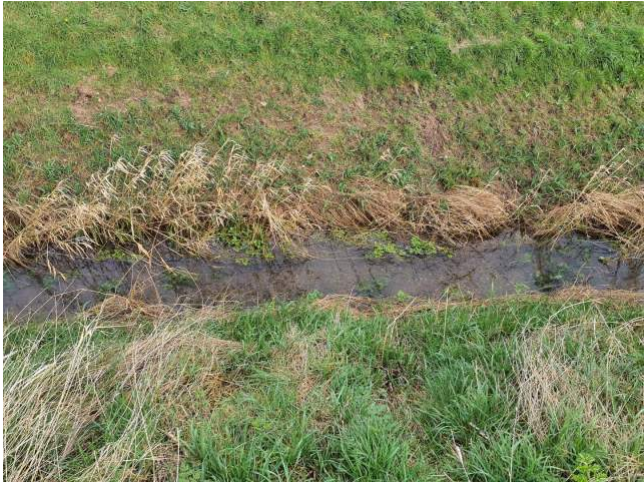
4d. Surface waters on site	Clear water in drainage ditches northern boundary	N

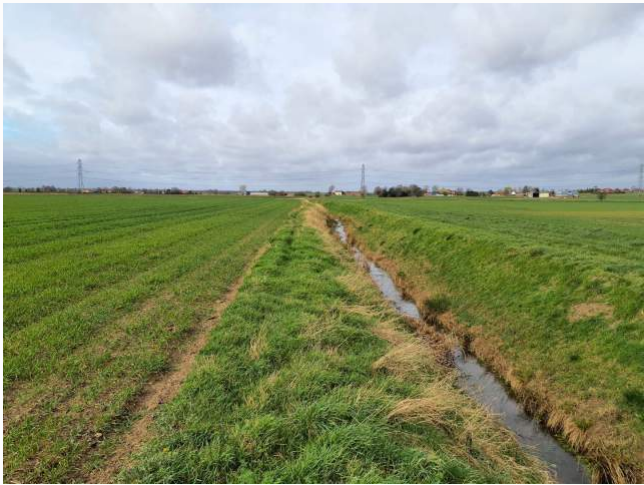
1d. Site boundaries.	Northern boundary	W

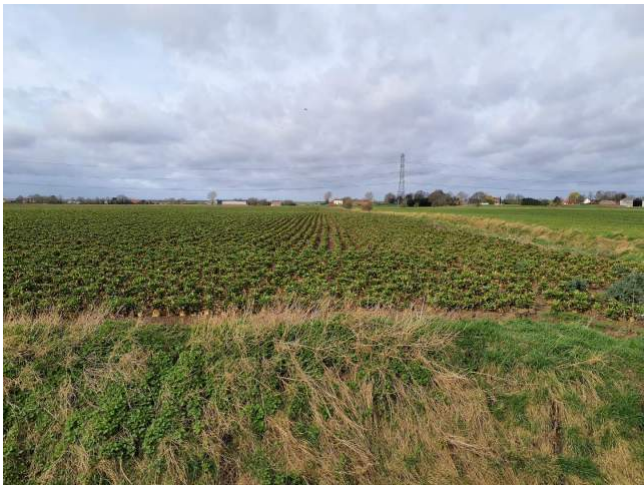
1a. Main land use(s)	Turnips or root veg field 24	W

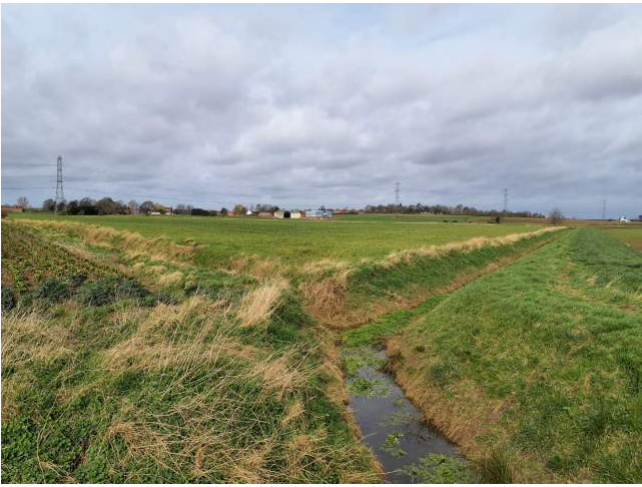
1a. Main land use(s)	Pasture in field 14	N

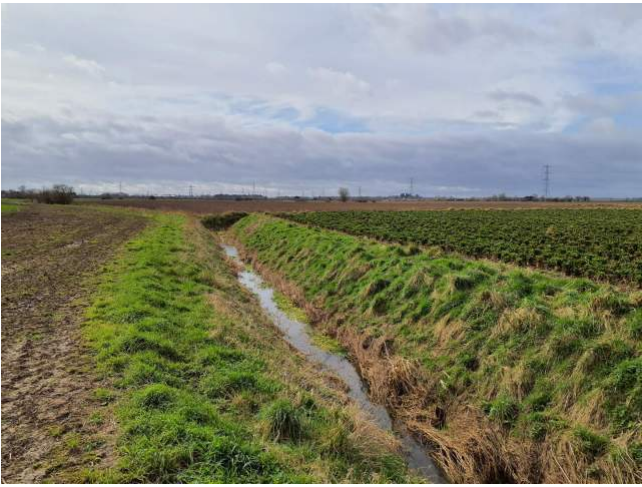
1a. Main land use(s)	Field 35 and 24 boundary with drainage, clear water.	SW

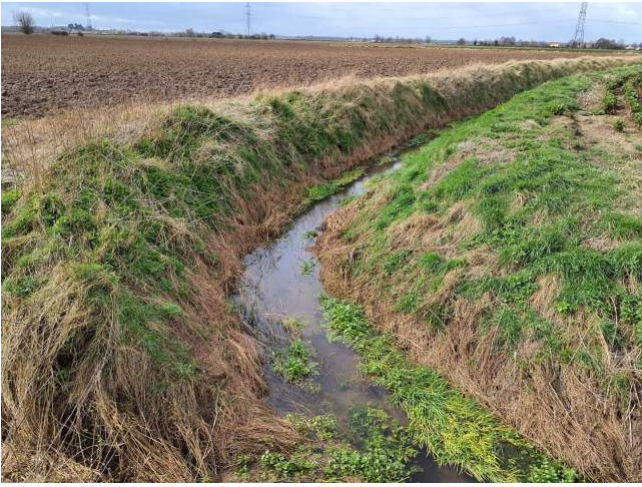
4d. Surface waters on site	Filed 24 dritche	SW

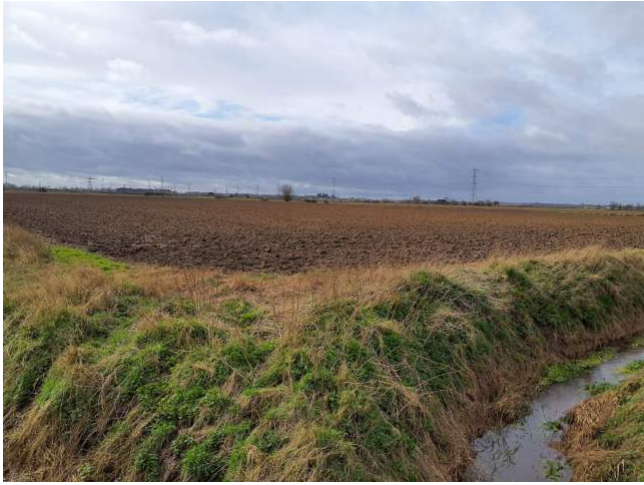
1a. Main land use(s)	Field 35 bare area, centre west	SW

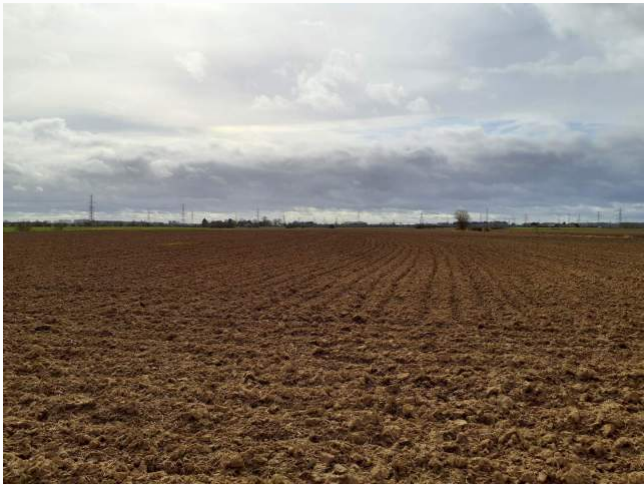
1a. Main land use(s)	Bare and plowed area of field 35	S

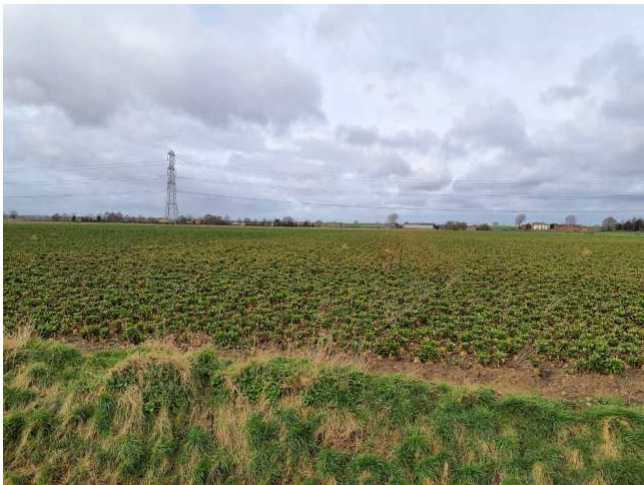
1a. Main land use(s)	Turnips or root veg in field 24 & pylons	W

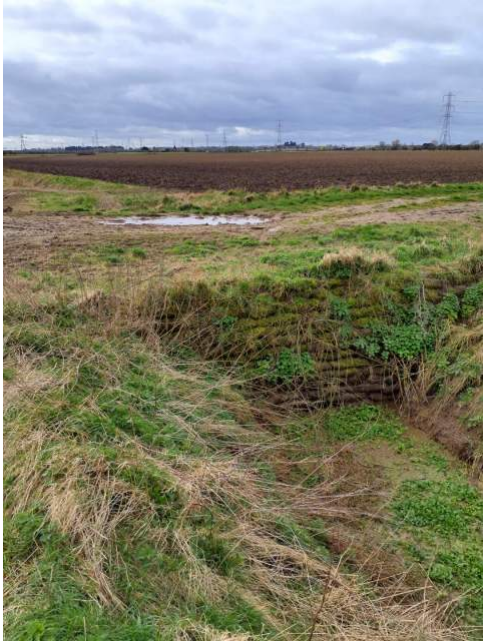
2a. Access constraints - general.	For access - culverts over deep ditches into field 24 and 35	SW

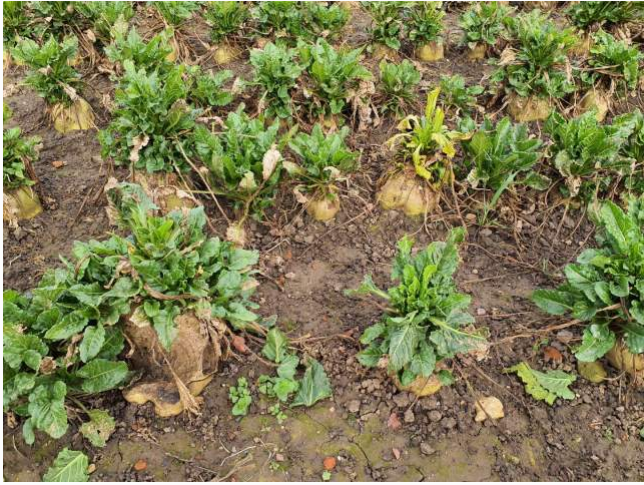
1a. Main land use(s)	Field 24 veg, many rotten.	N

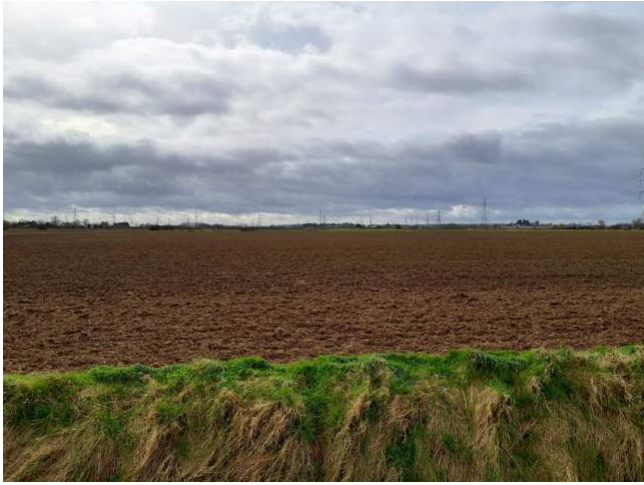
1a. Main land use(s)	Filed 35 west sector bare and plowed	S

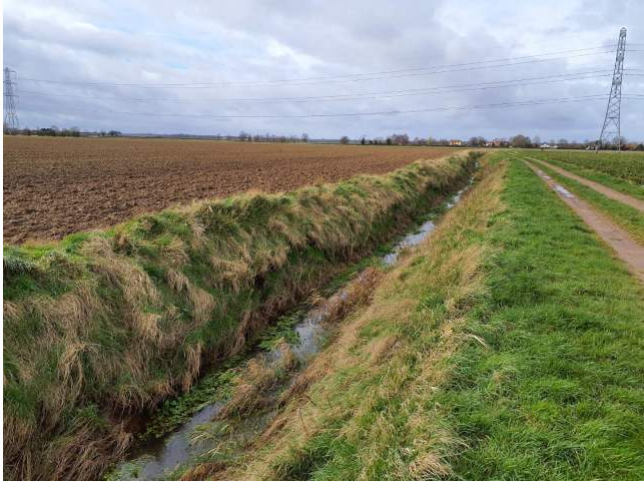
4d. Surface waters on site	Surface ditches deep and wide, water mostly clear	N

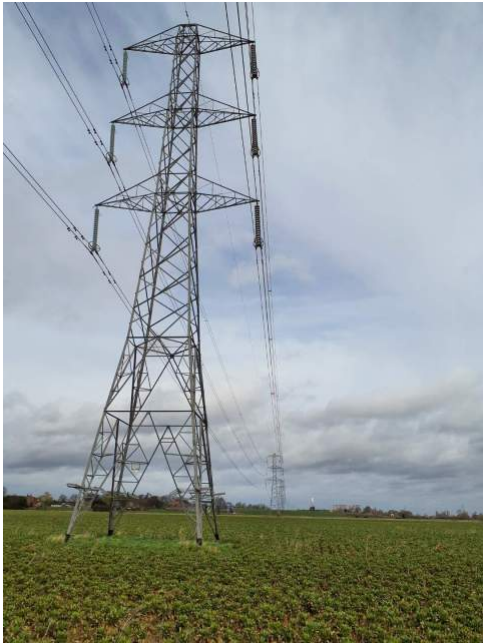
5c. Buried and overhead services	Pylons going north field 24	N

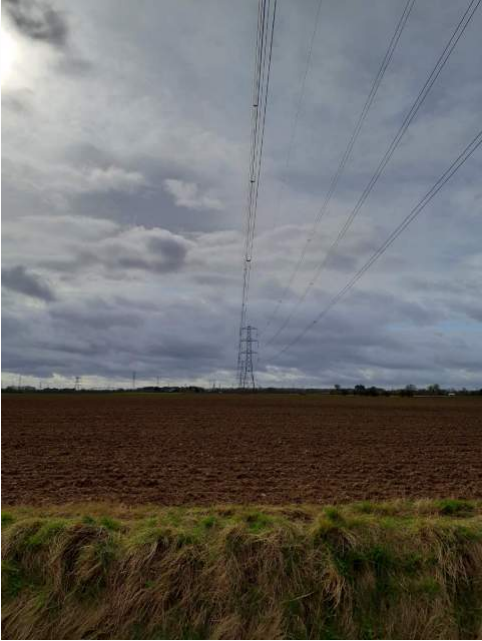
<p>5c. Buried and overhead services</p>	<p>Pylons south filed 335</p>	<p>S</p>

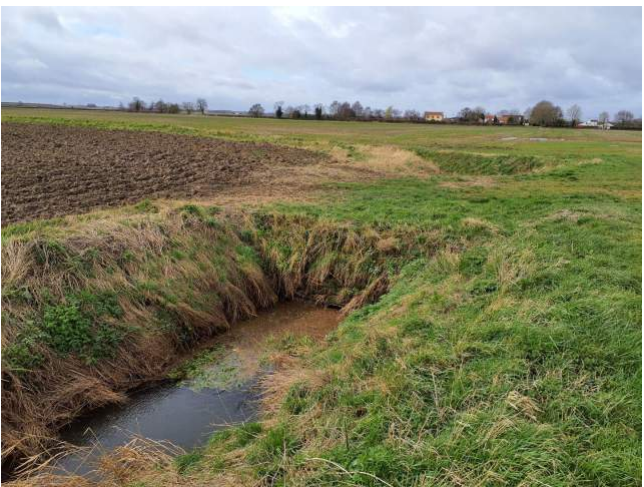
<p>2a. Access constraints - general.</p>	<p>Culvert and access into field 35 over ditches</p>	<p>W</p>

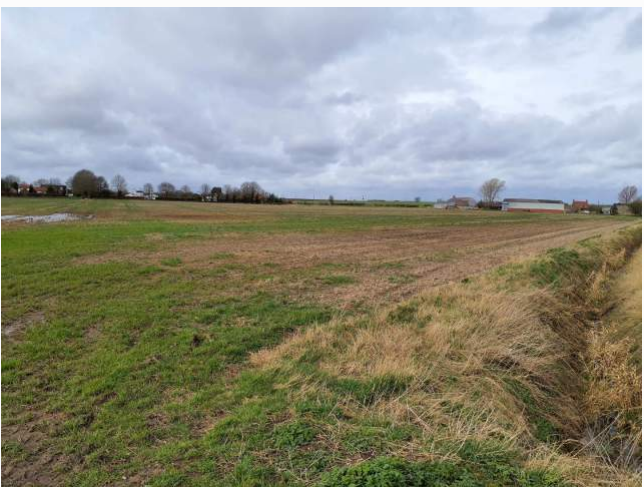
<p>1a. Main land use(s)</p>	<p>Field 29 shaved with some green crop</p>	<p>NW</p>

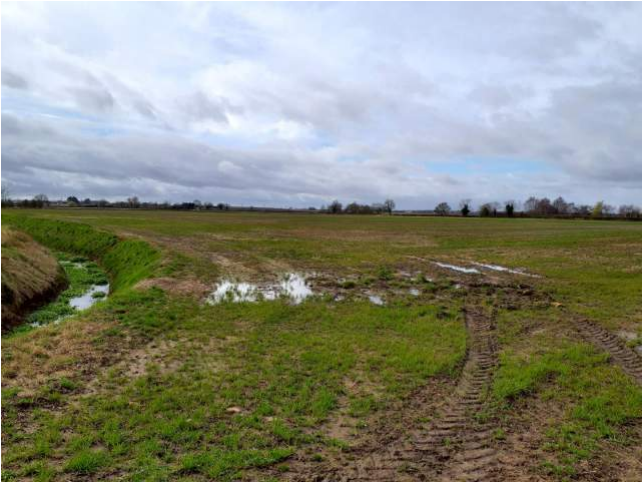
1a. Main land use(s)	Filed 29 green crop	SW

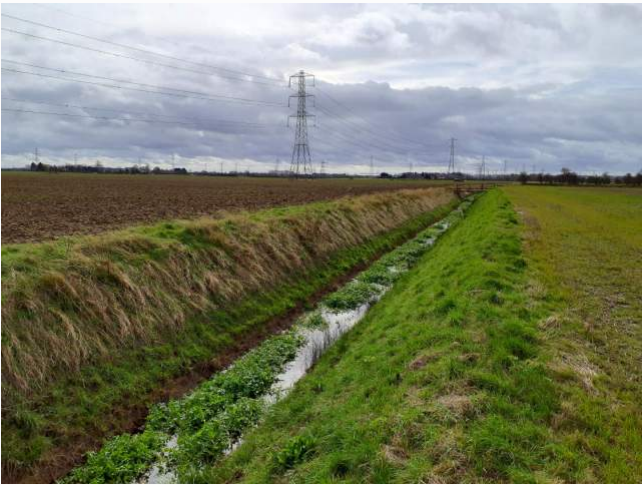
4d. Surface waters on site	5m wide 4 m deep ditcheswith bridge between field 42 and 35	S

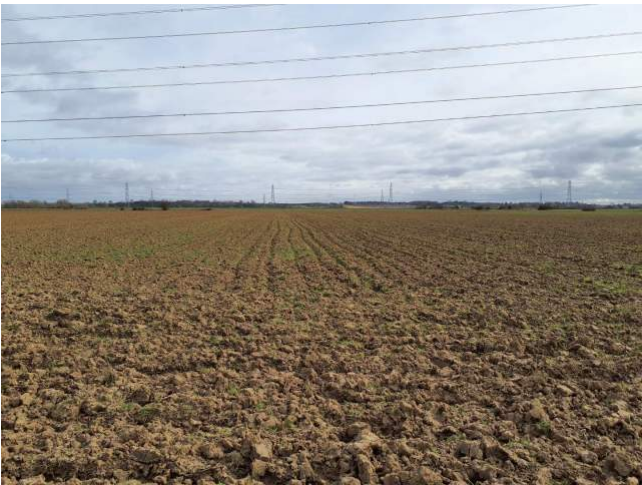
1a. Main land use(s)	Field 35 plowed and bare east	E

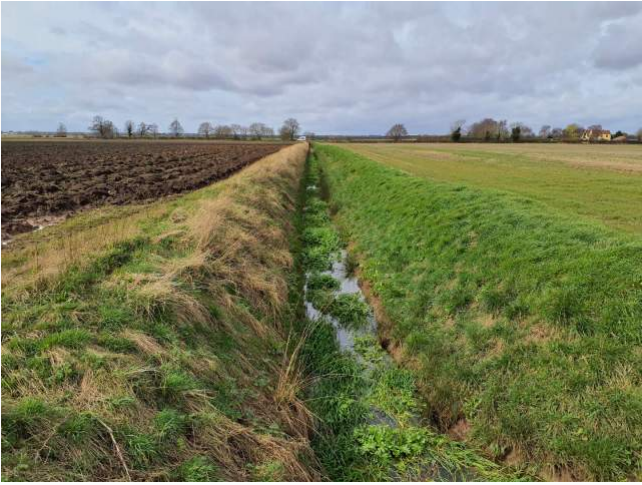
4d. Surface waters on site	Ditches between field 42 and 52	W

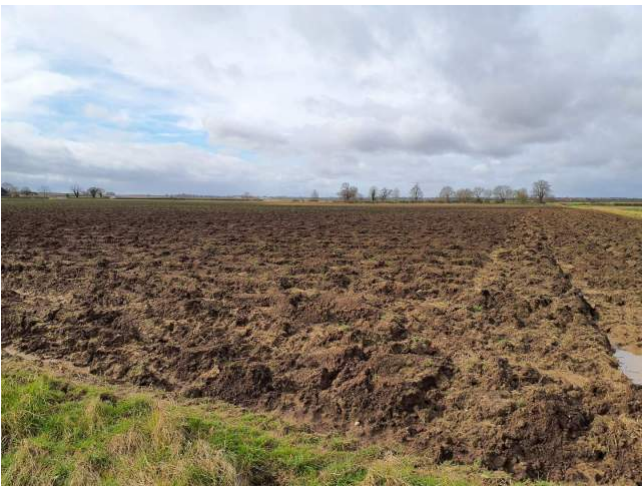
1a. Main land use(s)	Filed 52 plowed	SW

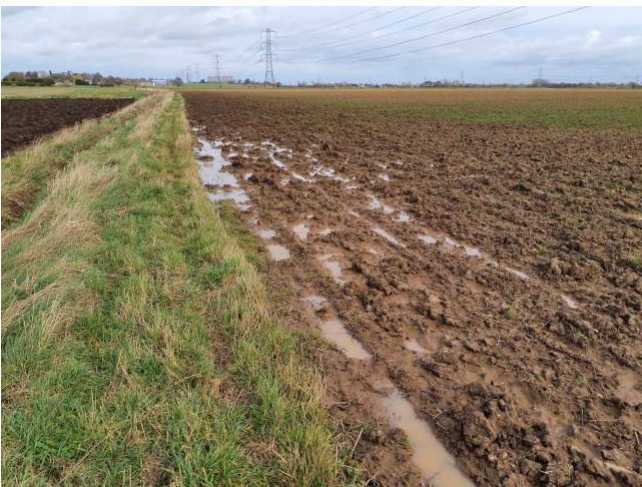
1a. Main land use(s)	Filed 35 and 52 surface water near boundary	N

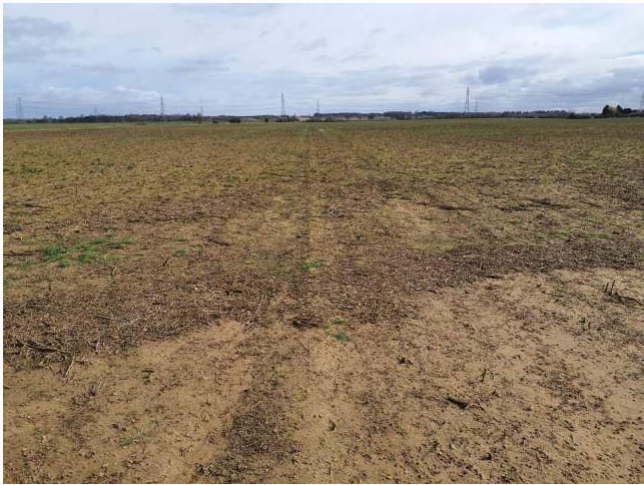
1a. Main land use(s)	Field 35 west sector bare	E

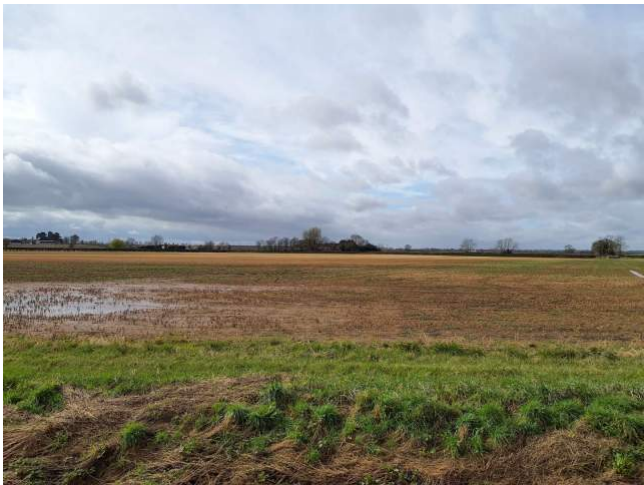
1a. Main land use(s)	Field 63 bare shaved	SW

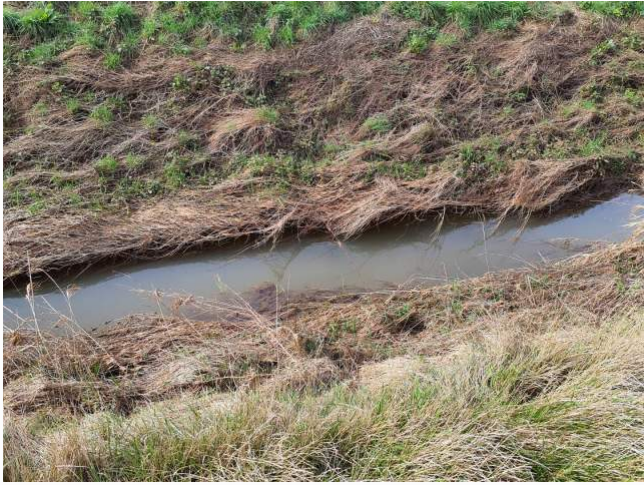
4f. Visual evidence of contamination of surface waters	Murky green water beside field 63	SW

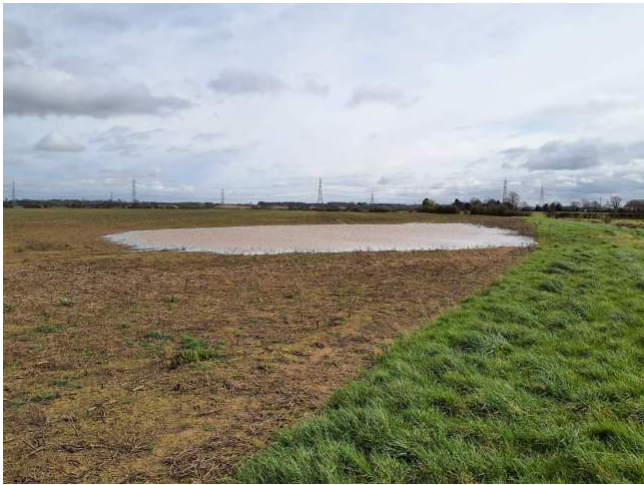
4i. Waterlogging or flooding	Flooding west sector field 35, low spot	E

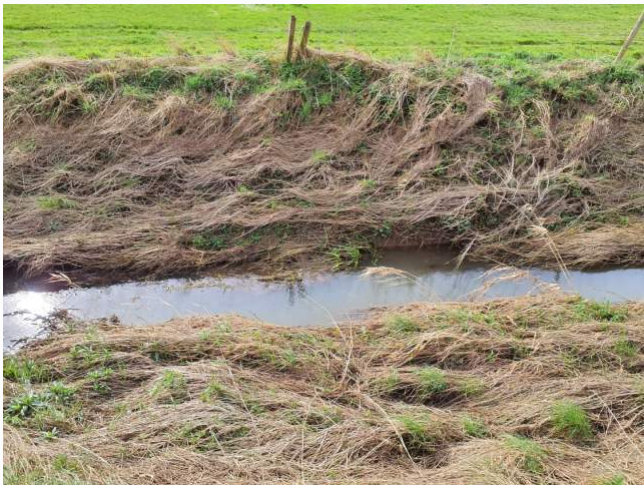
4f. Visual evidence of contamination of surface waters	Green murky water in ditches	S

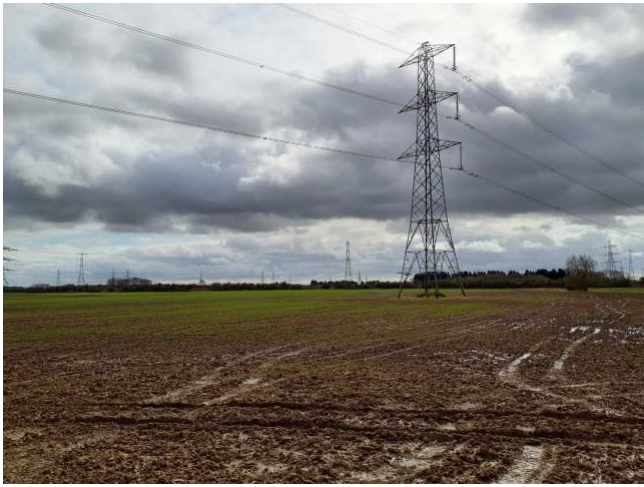
1a. Main land use(s)	Field 72 green crop	S

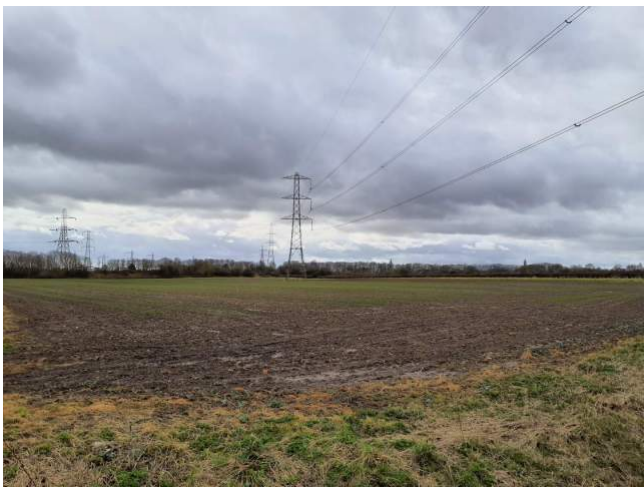
1a. Main land use(s)	Field 75 bare	W	 
1a. Main land use(s)	Field 76 green crop	SW

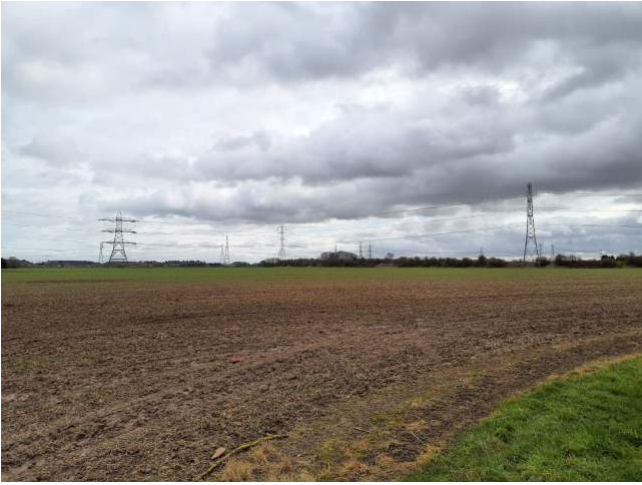
5c. Buried and overhead services	Medium and large pylons, several lines over field 72	E

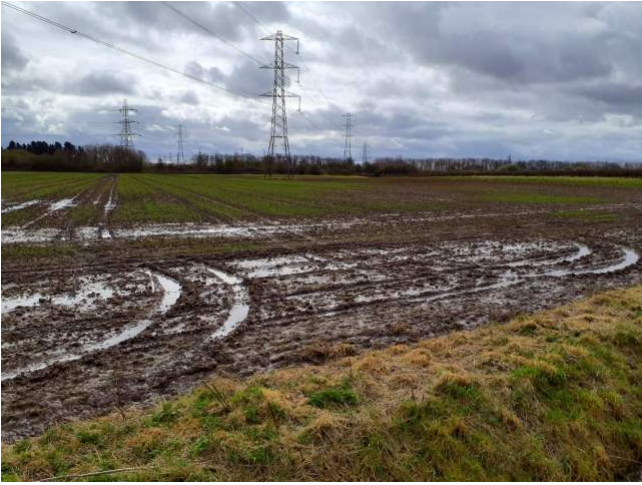
4i. Waterlogging or flooding	Local surface water on field 76	S
